Champlain Tower South Condominium  
8777 Collins Avenue  
Surfside, FL 33154

**REMEDIATION OF THE CHAMPLAIN TOWERS CONDOMINIUM**  
**ENGINEER'S ESTIMATE OF THE PROBABLE CONSTRUCTION COST**  
**THOMAS E. HENZ, PE, INC. CONSULTING ENGINEERS**

**Re: Champlain Towers South Condominium  
Structural Field Survey Report  
MC Job# 18217**

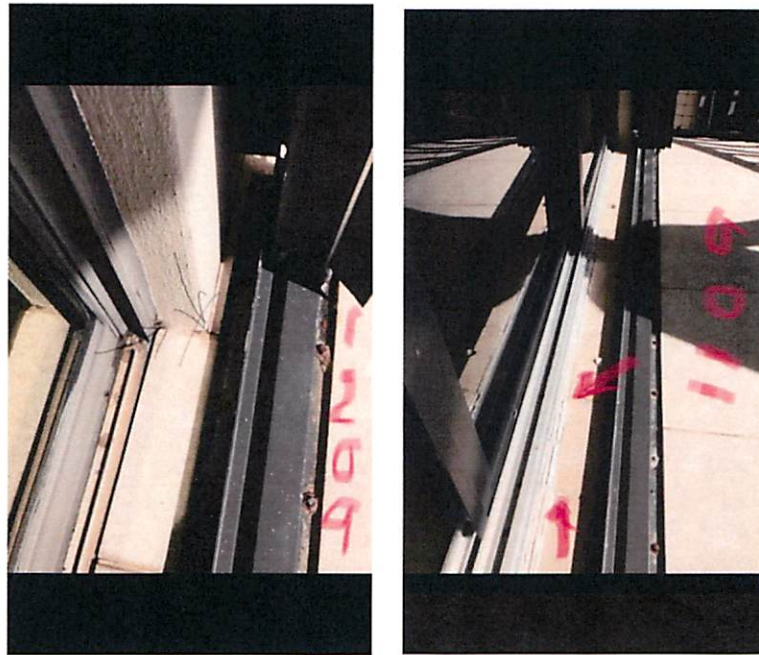
- A. MC understands some unit owners have complained of flooding into the interior space of their unit during a hurricane event. MC has concluded that this infiltration is occurring through the balcony sliding glass doors & windows due to the lack of proper flashing at the sill of these doors & windows and deteriorated exterior perimeter sealant between the window/door frames and masonry/concrete walls. MC recommends that the exterior sealant be removed / replaced at the sliding glass door & window perimeter to assist in providing a water-tight condition. Unfortunately, the new sliding doors in unit 209 and above were not installed properly and were fabricated too tall to allow the base flashing to be properly installed, so these unit owners have no choice but to discard the newly purchased doors and have them completely refabricated.

Figure A1: Exterior sealant past its serviceable lifespan at sealant between the window/door frames and masonry/concrete walls & balcony floors

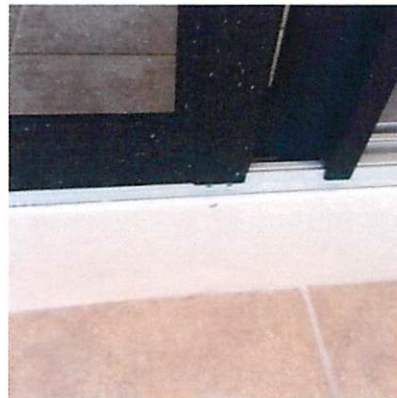
Figure A2: Newly installed sliding door at unit 209 that was not properly flashed

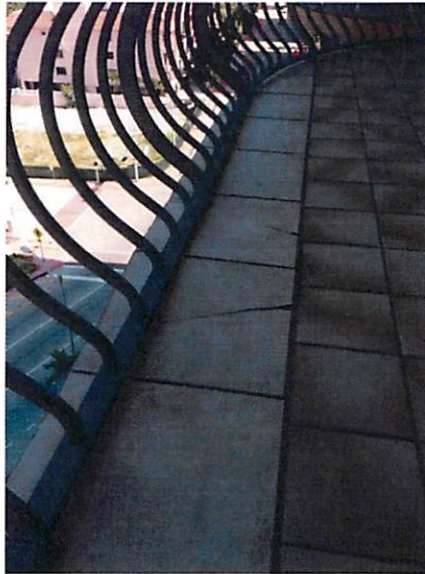
- B. MC observed that the majority of the balconies were furnished with tile or some other floor covering by choice of the tenant, making it impossible to observe the condition of the topside of the balcony slabs. Several instances were noted where balcony tile was damaged, such as in Unit 1008. Based on MC experience, cracked tile usually means structural damage exists to the balcony slab that must be repaired per the requirements of the International Concrete Repair Institute (ICRI) prior to the installation of a pedestrian waterproofing membrane.

Figure B: Damaged balcony tile that must be removed to fix structural damage

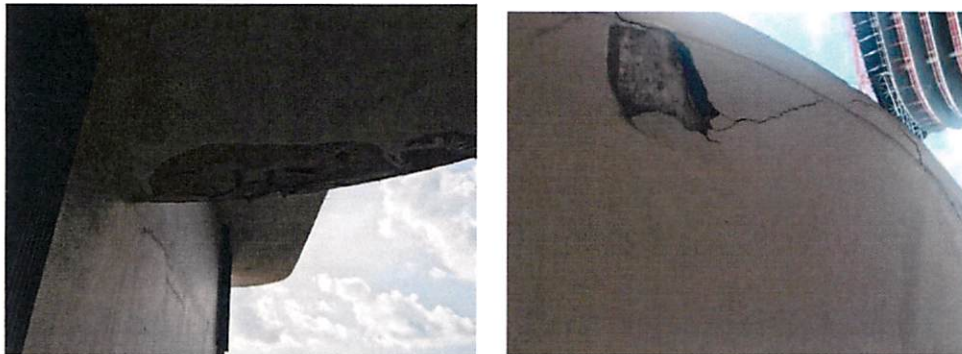
- C. MC found it fairly typical that the concrete slab edges of the balconies are experiencing concrete spalling or cracking. MC sees this as a common source of water infiltration and a main cause of the commonly found, sub-surface deterioration at the exterior soffits under the railings. MC requires that the balcony slab edges be further investigated and repaired in accordance with the recommendations of the ICRI to prevent future water penetration.

Figure C: Concrete spall at balcony slab edge in units 1008 & 211

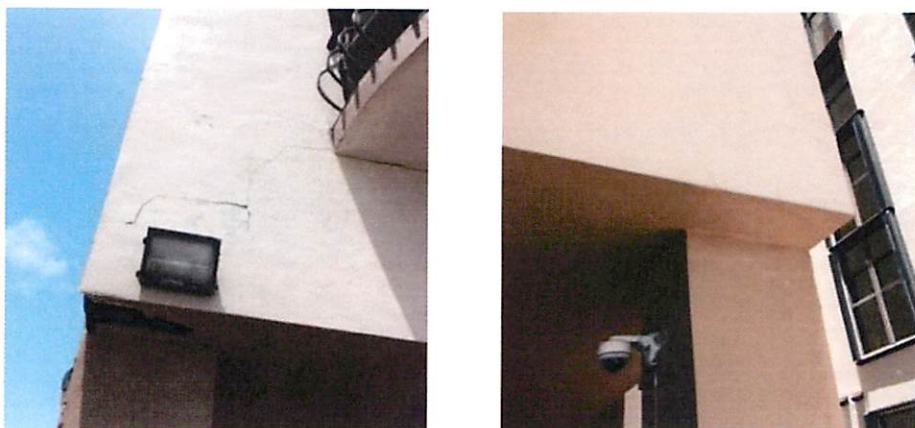
- G. Significant cracking in the stucco exterior façade often occurs at the mortar bed joint between the top of the concrete floor slab and first block masonry course. Although MC does not see this crack as a source of water infiltration into the condominium units, such cracks need to be routed and repointed to prevent future water permeation. All significant façade stucco cracking is to be repaired in accordance with the recommendations of ICRI.

Figure G: Typical cracking in the stucco exterior facade.

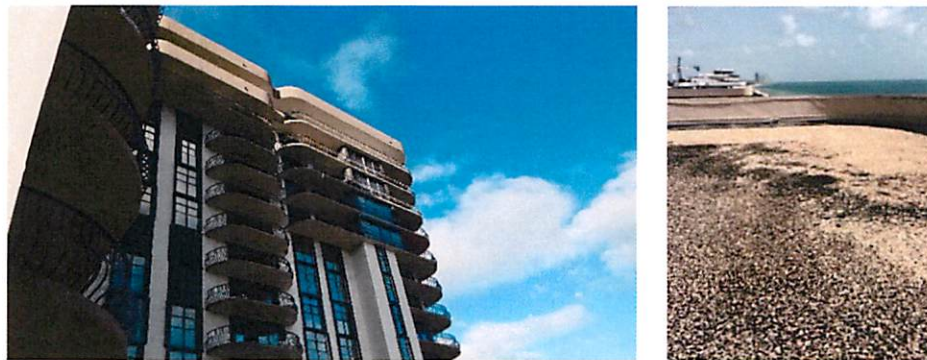
- H. MC observed the non-existence of window washing / suspension hooks that should have been installed face-mounted to the underside of the top-level balconies and spread throughout the roof of this building structure. This failure to have suspension hooks is a violation of the present-day Occupational Safety and Health Administration (OSHA) Rules and Regulations 29 CFR Part 1910 "Walking-Working Surfaces and Personal Protective Equipment (Fall Protection systems)" requirements and ANSI/IWCA I-14.1-2001 "Window Cleaning Safety Standard". MC recommends that new hooks be installed and waterproofed on the roof structural slab and underside of the top-level balcony slabs that meet the requirements of OSHA 29 CFR Part 1926.502 "Fall Protection Systems Criteria and Practices" and ANSI/IWCA 1-14.1 prior to the commencement of façade and balcony restoration. Furthermore, MC recommends that our office meet with the contractor who is to perform the façade restoration work and the present window washing contractor so that the new fall protection system anchor quantity and location can be agreed upon to assure adequate anchor coverage for all future contractors who will be suspended on the exterior of the Champlain Towers South Condominium.

Figure H: No suspension hooks at the underside of the balconies and on the roof.

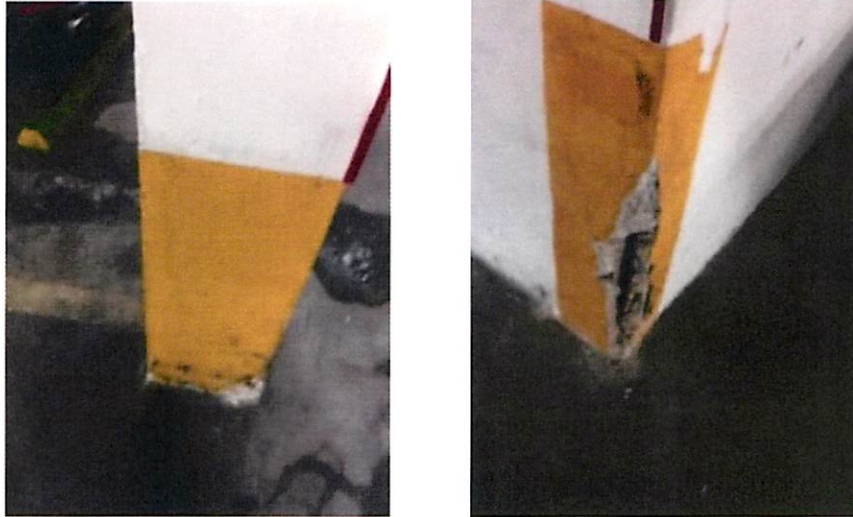
- J. Abundant cracking and spalling of varying degrees was observed in the concrete columns, beams, and walls. Several sizeable spalls were noted in both the topside of the entrance drive ramp and underside of the pool/entrance drive/planter slabs, which included instances with exposed, deteriorating rebar. Though some of this damage is minor, most of the concrete deterioration needs to be repaired in a timely fashion. All cracking and spalling located in the parking garage shall be repaired in accordance with the recommendations of ICRI.

Figure J1: Typical cracking and spalling at parking garage columns

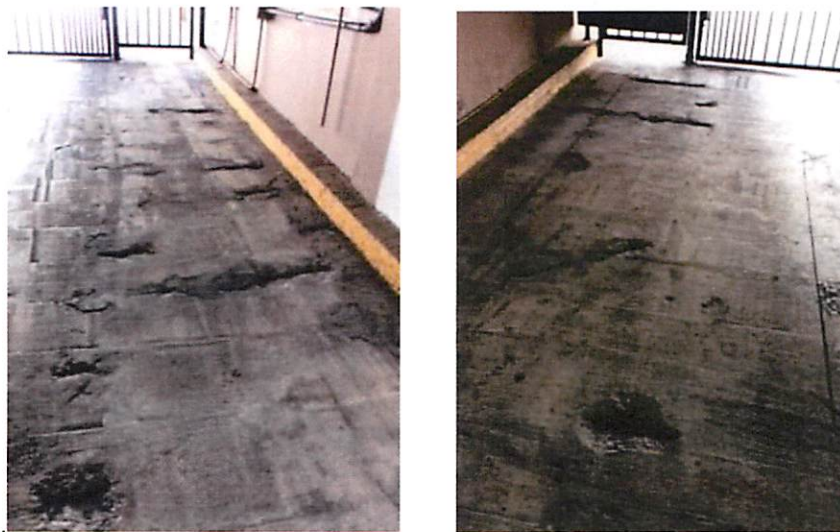
Figure J2: Spalling with exposed steel reinforcement at topside of garage deck.

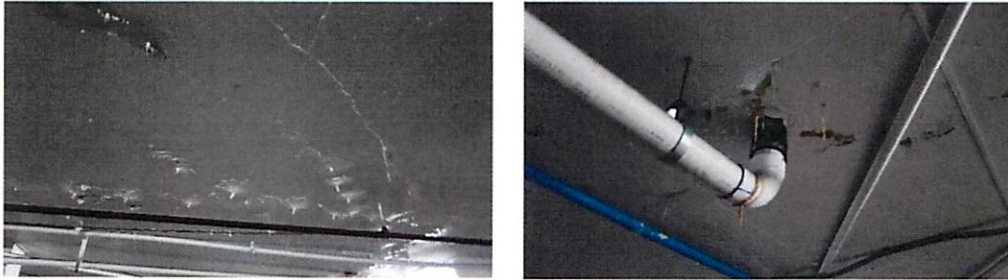
- K. MC visual observations revealed that many of the previous garage concrete repairs are failing resulting in additional concrete cracking, spalling and leaching of calcium carbonate deposits. At the underside of Entrance/Pool deck where the slab had been epoxy-injected, new cracks were radiating from the originally repaired cracks. The installed epoxy is not continuous as observed from the bottom of the slab, which is evidence of poor workmanship performed by the previous contractor. The injection ports were not removed, and the surfaces were not ground smooth at the completion of the injection. Leaching of calcium carbonate deposits in numerous areas has surely caused CTS to pay to repaint numerous cars. This leaching will continue to increase until proper repairs are completed. MC is convinced that the previously installed epoxy injection repairs were ineffective in properly repairing the existing cracked and spalled concrete

Figure K1: Previously installed failed injection repairs with leaching forming

slabs. MC recommends that the Entrance/Pool deck concrete slabs that are showing distress be removed and replaced in their entirety. Unfortunately, all of these failed slab areas are under brick pavers, decorative stamped concrete and planters which require completed waterproofing replacement. All repaired concrete slabs located in the parking garage are to be repaired in accordance with the recommendations of ICRI.

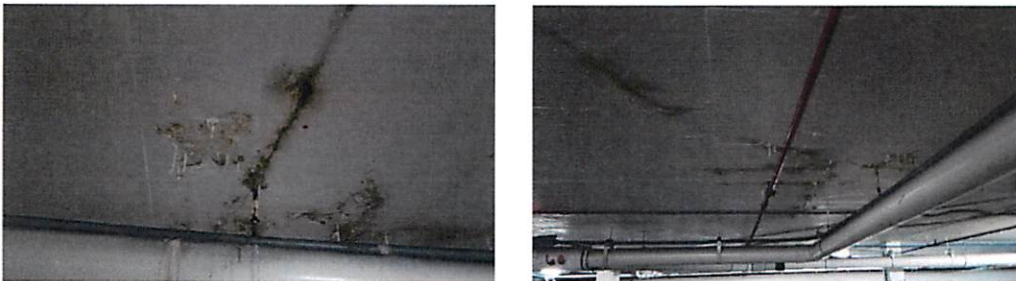
Figure K2: More previously installed failed injection repairs with leaching forming
