**Re: Champlain Towers South Condominium  
Structural Field Survey Report  
MC Job# 18217**

Morabito Consultants, Inc. (MC) is pleased to submit this structural engineering report of the Field Survey completed at the existing Champlain Towers South Condominium Complex (CTS) in Surfside, FL. The scope of this project includes a review of the existing 12 story plus penthouse 136-unit residential building, below-grade parking garage and at-grade exterior entrance drive, pool and recreation area. MC reviewed a representative sample of ~68 condominium units (half of the total units found in the building) along with the roof, exterior façade (observed from the balconies surveyed), parking garage, pool deck, and general common areas. The goal of our study was to understand and document the extent of structural issues that require repair and/or remediation in the immediate and near future. As a part of this report, MC has prepared an estimate (that is attached to this report) of the probable construction cost to construct the required structural repairs & maintenance that MC recommends being completed. These documents will enable the Condominium Board to adequately assess the overall cond

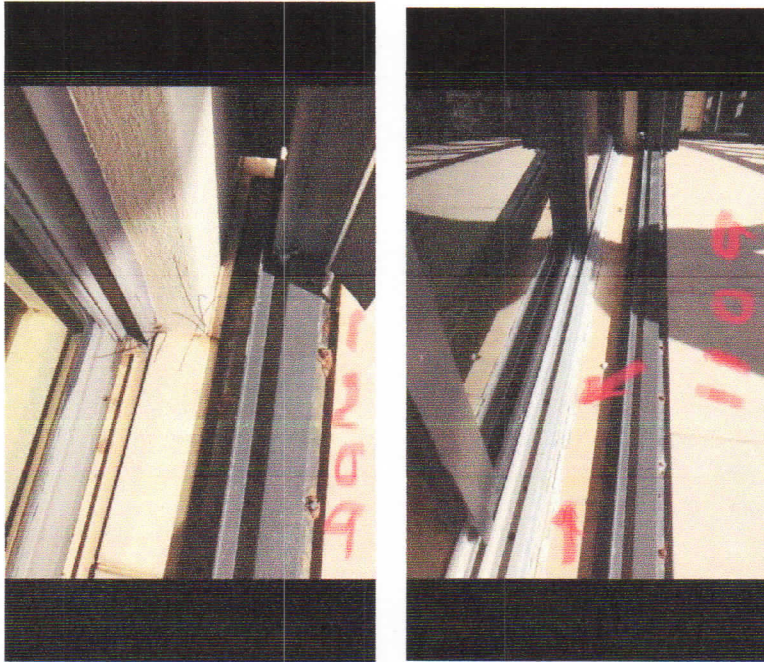
- A. MC understands some unit owners have complained of flooding into the interior space of their unit during a hurricane event. MC has concluded that this infiltration is occurring through the balcony sliding glass doors & windows due to the lack of proper flashing at the sill of these doors & windows and deteriorated exterior perimeter sealant between the window/door frames and masonry/concrete walls. MC recommends that the exterior sealant be removed / replaced at the sliding glass door & window perimeter to assist in providing a water-tight condition. Unfortunately, the new sliding doors in unit 209 and above were not installed properly and were fabricated too tall to allow the base flashing to be properly installed, so these unit owners have no choice but to discard the newly purchased doors and have them completely refabricated.

Figure A1: Exterior sealant past its serviceable lifespan at sealant between the window/door frames and masonry/concrete walls & balcony floors

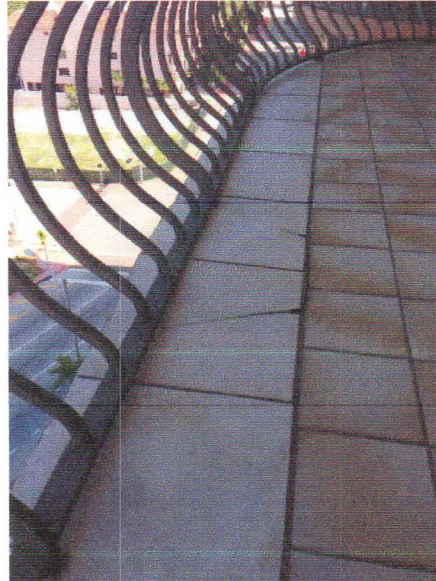
- B. MC observed that the majority of the balconies were furnished with tile or some other floor covering by choice of the tenant, making it impossible to observe the condition of the topside of the balcony slabs. Several instances were noted where balcony tile was damaged, such as in Unit 1008. Based on MC experience, cracked tile usually means structural damage exists to the balcony slab that must be repaired per the requirements of the International Concrete Repair Institute (ICRI) prior to the installation of a pedestrian waterproofing membrane.

Figure B: Damaged balcony tile that must be removed to fix structural damage

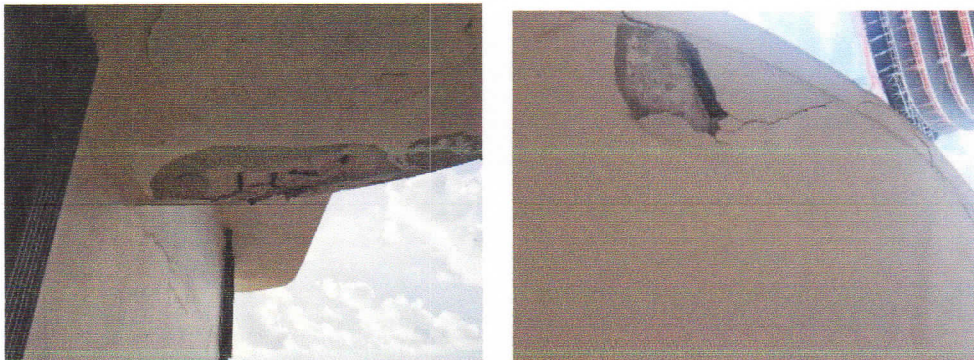
- C. MC found it fairly typical that the concrete slab edges of the balconies are experiencing concrete spalling or cracking. MC sees this as a common source of water infiltration and a main cause of the commonly found, sub-surface deterioration at the exterior soffits under the railings. MC requires that the balcony slab edges be further investigated and repaired in accordance with the recommendations of the ICRI to prevent future water penetration.

Figure C: Concrete spall at balcony slab edge in units 1008 & 211

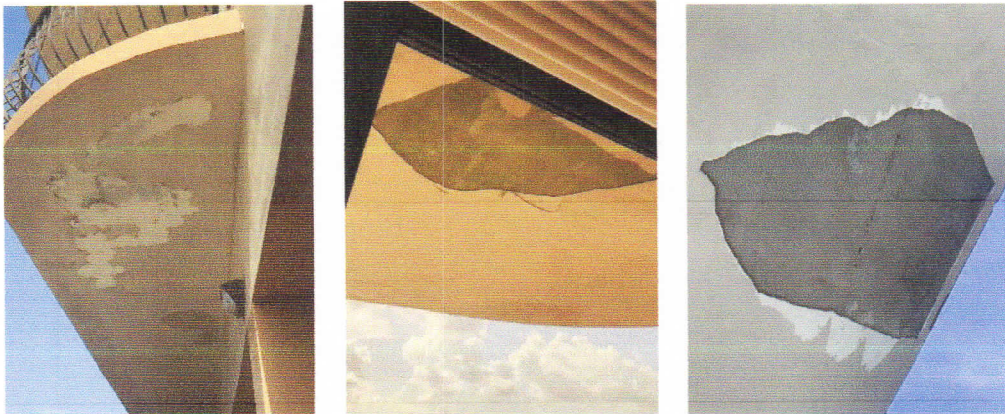
- D. Approximately half of the balcony soffits reviewed by MC show evidence of deterioration under the painted finished surface. These areas were identified by sounding the concrete with a golf club, checking for solidarity. In some cases, the paint finish had formed a bubble or pocket that was retaining water, while in other areas the painted soffit was peeled away leaving the concrete surface exposed. The extensive soffit damage is a systemic issue that can only be repaired by removing all of the balcony tile, repairing the damaged concrete surfaces at the top and bottom of the slab and protecting the slab by installing a pedestrian waterproofing membrane on all top-side balcony surfaces. Partial/full depth concrete repairs in these areas shall be performed in accordance with the recommendations of ICRI. It is important to note that installing tile on top of the concrete balcony surfaces results in the railing having inadequate height to meet the minimum guardrail height of 42" required by the Florida Building Code.

Figure D: Balcony Soffit paint spalling in units 208, 703, & 1301.

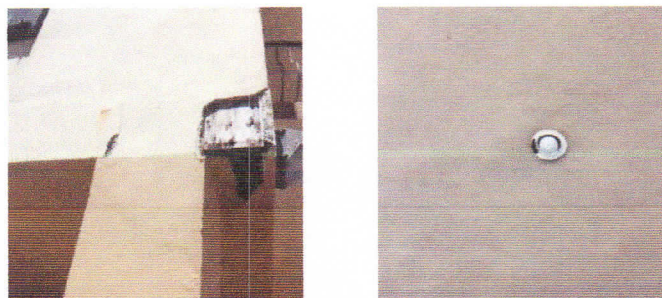
- E. Several areas of the entrance drive soffits under the second floor were observed by MC to have deteriorated black plywood. This condition was also observed at several light fixtures in the entrance soffit. MC could not get access into the soffit areas to observe the extent of the deteriorated soffits and support framing as CTS maintenance was too busy to assist us. MC is concerned that mold exists above these soffit areas and the soffit support framing is deteriorated which will require the complete removal and replacement of the entrance suspended soffit. Further investigation into this area is warranted.

Figure E: Deteriorated plywood soffit above entrance drive.

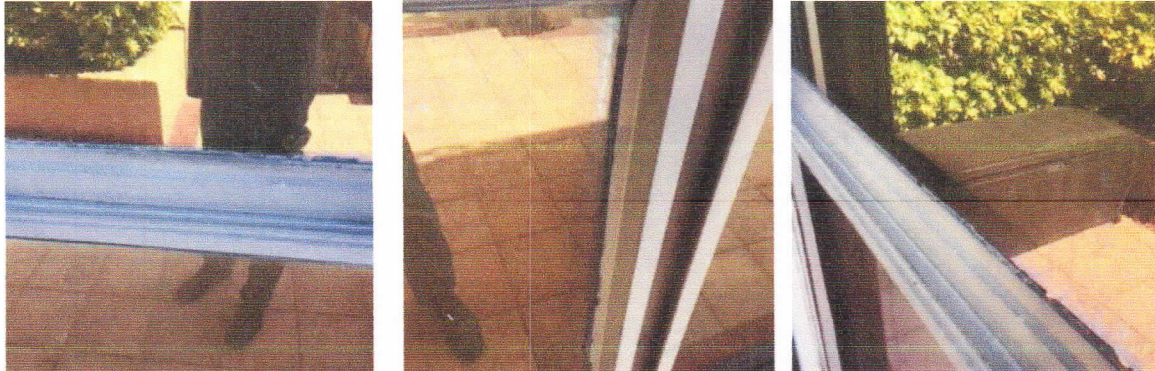
- F. It was brought to MC's attention that several units are experiencing water infiltration through the window frames and glazing as the windows are near the end of their functional lifespan. It is recommended that the window frame glazing (metal to glass), and perimeter sealant (metal to metal or metal to masonry/concrete) be removed and replaced for the entirety of the building to reduce future water penetration and minimize damage during hurricane events. MC recommends that the BOD strongly consider the replacement of all exterior windows and doors with impact resistant units.

Figure F: Exterior sealant at window frame that has aged past its serviceable lifespan

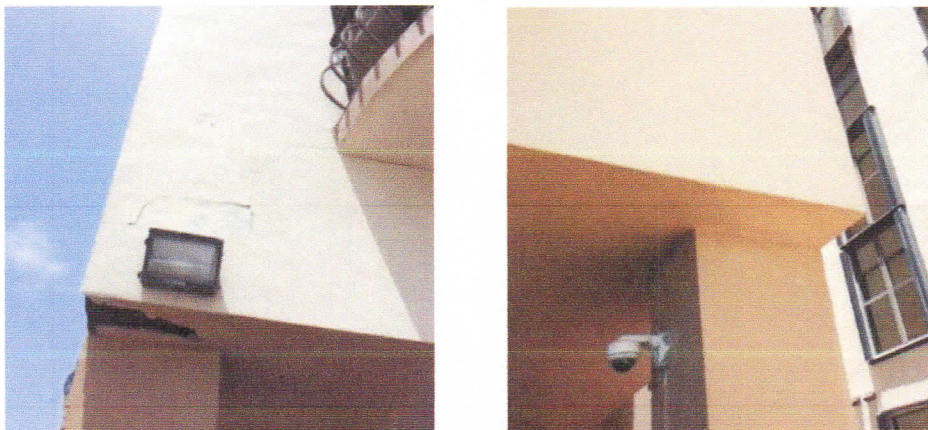
- G. Significant cracking in the stucco exterior façade often occurs at the mortar bed joint between the top of the concrete floor slab and first block masonry course. Although MC does not see this crack as a source of water infiltration into the condominium units, such cracks need to be routed and repointed to prevent future water permeation. All significant façade stucco cracking is to be repaired in accordance with the recommendations of ICRI.

Figure G: Typical cracking in the stucco exterior facade.

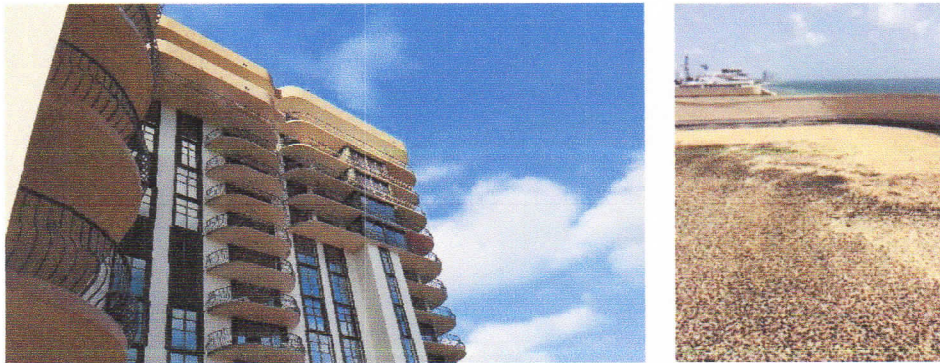
- H. MC observed the non-existence of window washing / suspension hooks that should have been installed face-mounted to the underside of the top-level balconies and spread throughout the roof of this building structure. This failure to have suspension hooks is a violation of the present-day **Occupational Safety and Health Administration (OSHA) Rules and Regulations 29 CFR Part 1910 "Walking-Working Surfaces and Personal Protective Equipment (Fall Protection systems)"** requirements and **ANSI/IWCA I-14.1-2001 "Window Cleaning Safety Standard"**. MC recommends that new hooks be installed and waterproofed on the roof structural slab and underside of the top-level balcony slabs that meet the requirements of **OSHA 29 CFR Part 1926.502 "Fall Protection Systems Criteria and Practices"** and **ANSI/IWCA 1-14.1** prior to the commencement of façade and balcony restoration. Furthermore, MC recommends that our office meet with the contractor who is to perform the façade restoration work and the present window washing contractor so that the new fall protection system anchor quantity and location can be agreed upon to assure adequate anchor coverage for all future contractors who will be suspended on the exterior of the Champlain Towers South Condominium.

Figure H: No suspension hooks at the underside of the balconies and on the roof.

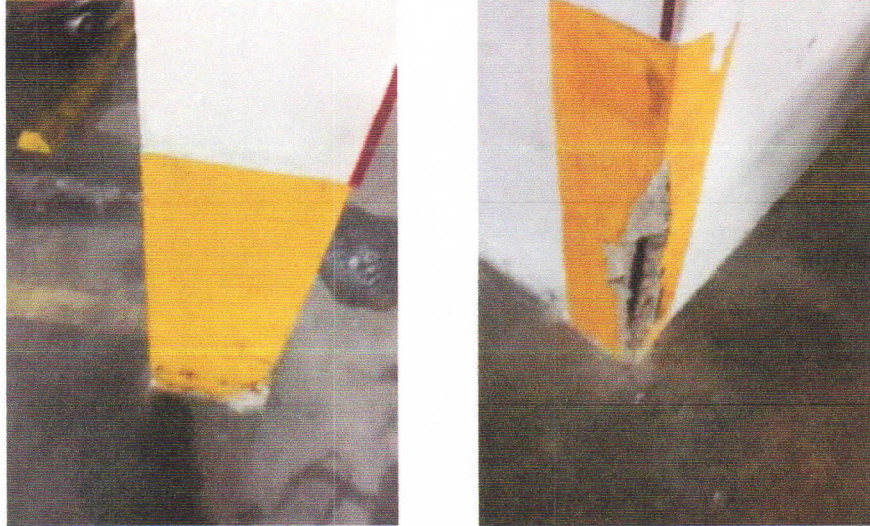
- J. Abundant cracking and spalling of varying degrees was observed in the concrete columns, beams, and walls. Several sizeable spalls were noted in both the topside of the entrance drive ramp and underside of the pool/entrance drive/planter slabs, which included instances with exposed, deteriorating rebar. Though some of this damage is minor, most of the concrete deterioration needs to be repaired in a timely fashion. All cracking and spalling located in the parking garage shall be repaired in accordance with the recommendations of ICRI.

Figure J1: Typical cracking and spalling at parking garage columns

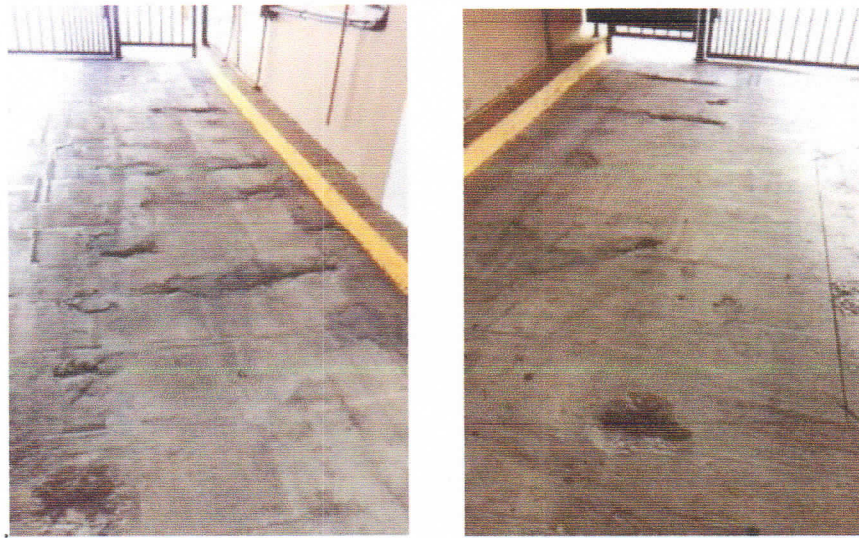
Figure J2: Spalling with exposed steel reinforcement at topside of garage deck.

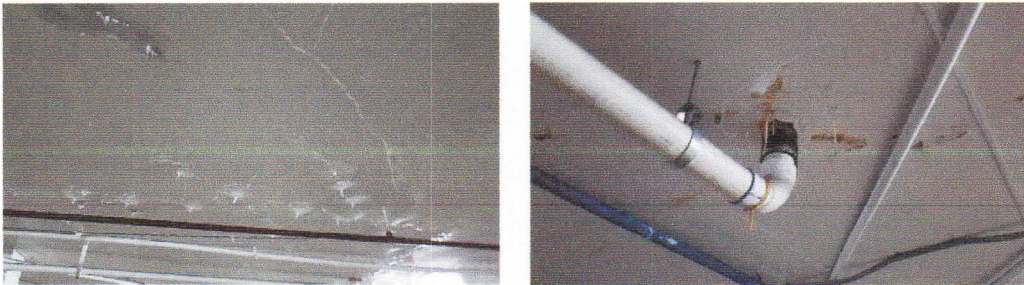
- K. MC visual observations revealed that many of the previous garage concrete repairs are failing resulting in additional concrete cracking, spalling and leaching of calcium carbonate deposits. At the underside of Entrance/Pool deck where the slab had been epoxy-injected, new cracks were radiating from the originally repaired cracks. The installed epoxy is not continuous as observed from the bottom of the slab, which is evidence of poor workmanship performed by the previous contractor. The injection ports were not removed, and the surfaces were not ground smooth at the completion of the injection. Leaching of calcium carbonate deposits in numerous areas has surely caused CTS to pay to repaint numerous cars. This leaching will continue to increase until proper repairs are completed. MC is convinced that the previously installed epoxy injection repairs were ineffective in properly repairing the existing cracked and spalled concrete

Figure K1: Previously installed failed injection repairs with leaching forming

slabs. MC recommends that the Entrance/Pool deck concrete slabs that are showing distress be removed and replaced in their entirety. Unfortunately, all of these failed slab areas are under brick pavers, decorative stamped concrete and planters which require completed waterproofing replacement. All repaired concrete slabs located in the parking garage are to be repaired in accordance with the recommendations of ICRI.

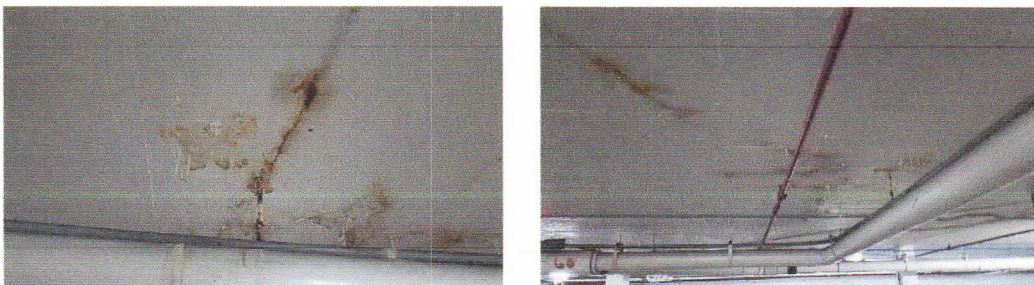
Figure K2: More previously installed failed injection repairs with leaching forming
