MINIMUM INSPECTION PROCEDURAL GUIDELINES FOR BUILDING'S STRUCTURAL RECERTIFICATION

a. **Name on Title:** Champlain Towers South Condominium

b. **Street Address:** 8777 Collins Avenue, Surfside, FL 33154 (Only Bldg on Site)

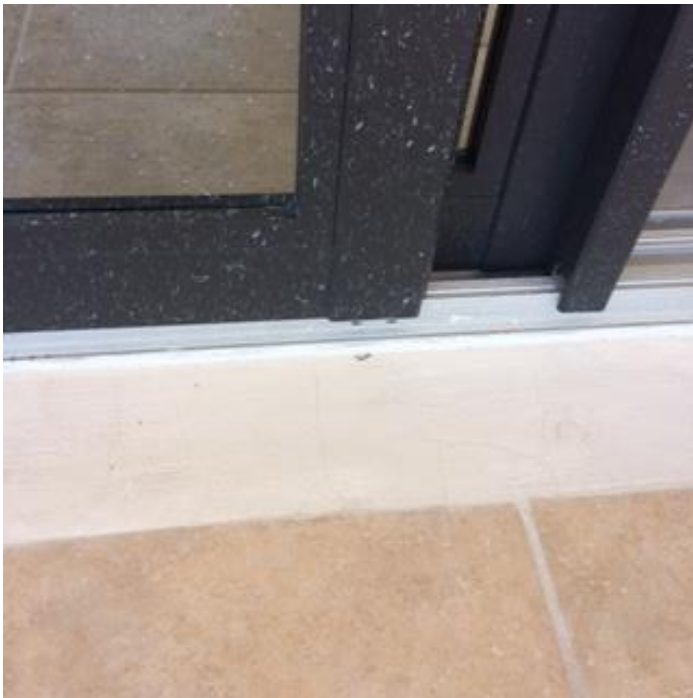
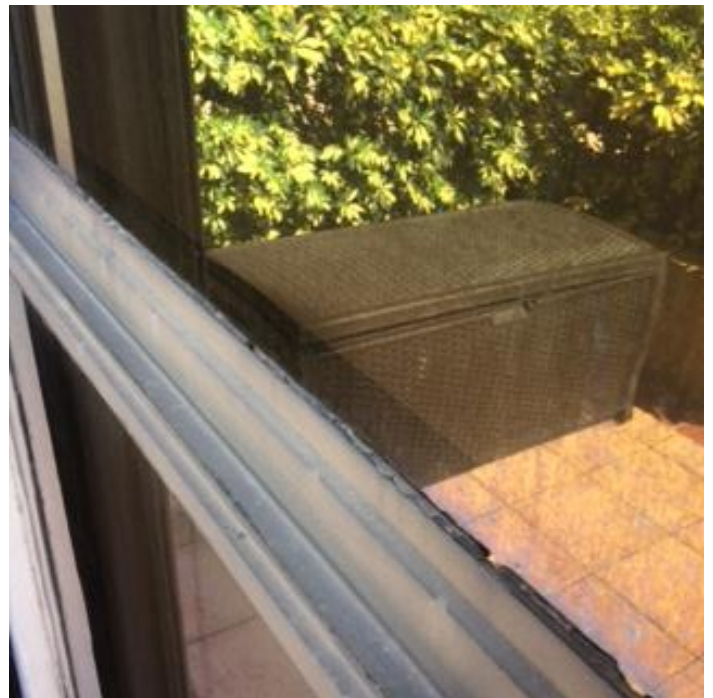
Figure 1: Cracking at balcony floor slab at sliding door threshold

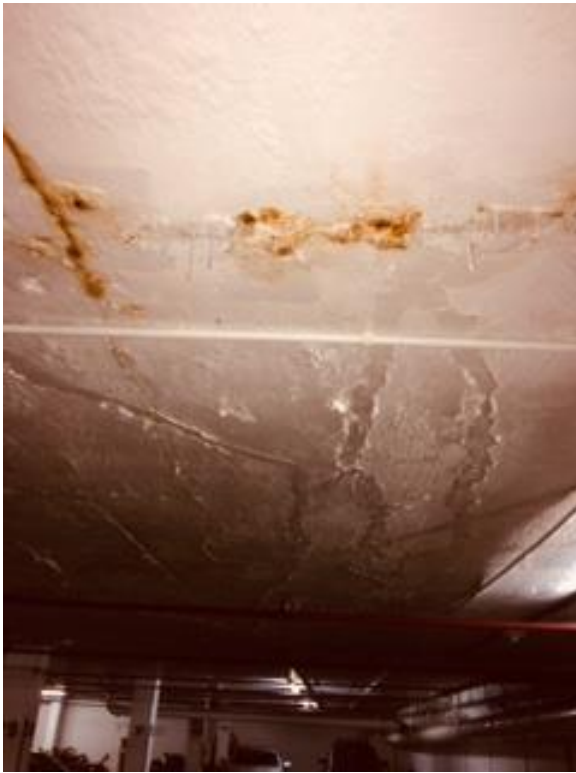
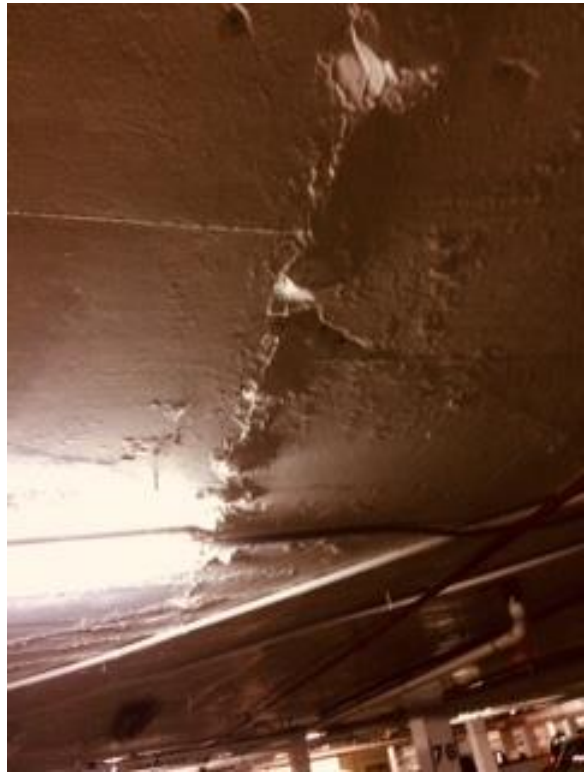
d. Cracks – note location in significant members. Identify crack size as HAIRLINE if barely discernible; FINE if less than 1 mm in width; MEDIUM if between 1 and 2 mm width; WIDE if over 2 mm.
Slabs: the majority of cracking found in the underside of the balcony and plaza/pool concrete slabs was classified as hairline cracks with several instances of fine and medium cracks. Appendix A shows examples of each case.
Columns: The majority of cracking found in the exterior concrete columns was classified as fine or medium cracks with one instance of a wide crack. Appendix A shows examples of each case.
Exterior walls: The majority of stucco wall cracking can be classified as fine.

Figure 2: Hairline cracking at underside of floor slabs in garage

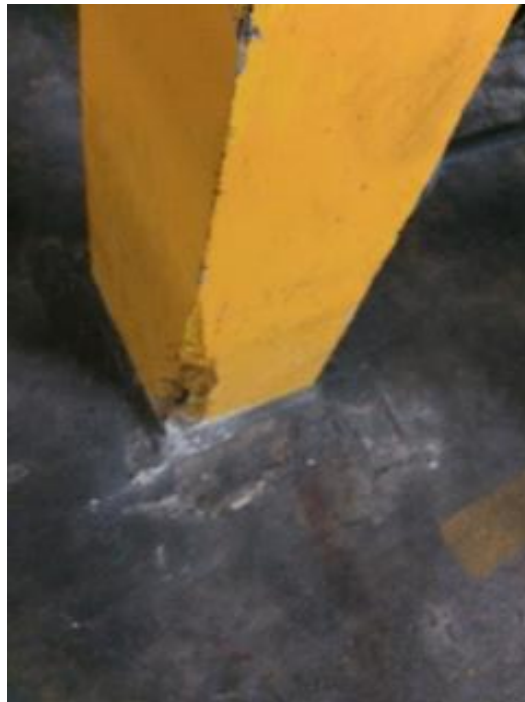
c. Surface conditions – describe general conditions of finishes, noting cracking, spalling, peeling, signs of moisture penetration and stains.
Concrete columns: ~2% of exterior columns have experienced concrete spalling measuring 3 sf or less in each location.
Exterior walls: ~5% of exterior masonry walls have experienced stucco spalling (mostly aligning with the floor elevation) and 2% of the stucco wall has experienced some minor stucco cracking.
Balconies: 90% of the balconies are covered with tile. Only 2% of the balconies have cracked tile and/or cracked mortar joints between the tile units.
Garage/Plaza slab: ~8% of the soffit of these slabs have experienced concrete deterioration with the majority of areas being adjacent to or under the pool and planters. There is also some isolated slab cracks in the soffit of these slabs.
Residential units: ~3% of the units exhibit drywall cracking at partitions, bulkheads, or ceilings and/or cracking in crown molding which are purely cosmetic in nature and are not a structural concern.

Figure 3: Column damage at ground floor

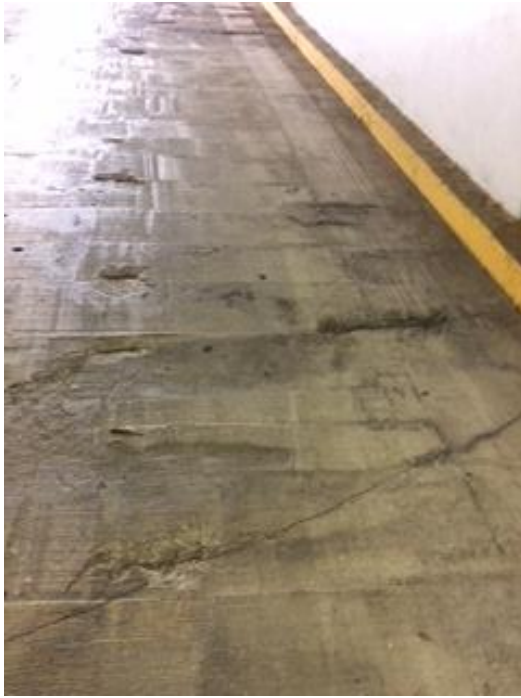
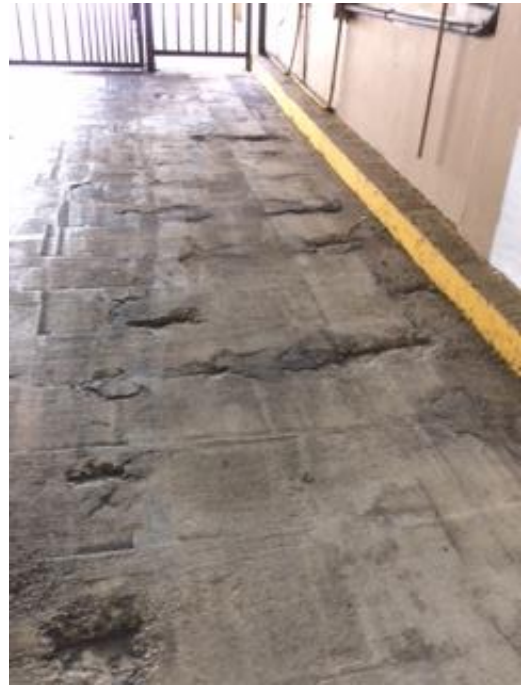
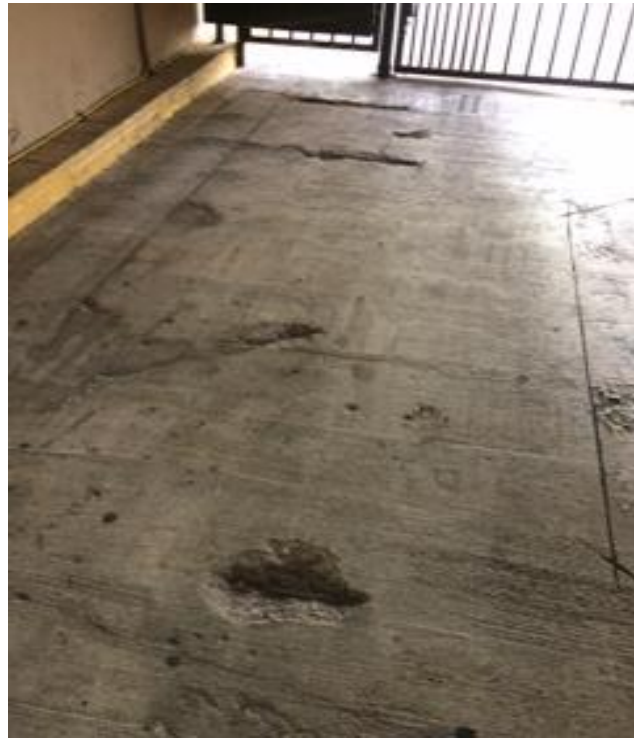
Figure 4: Delaminated concrete garage entrance

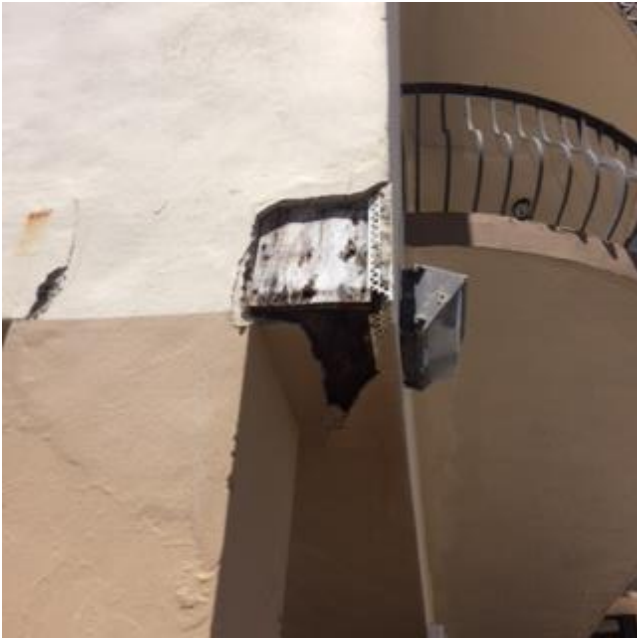
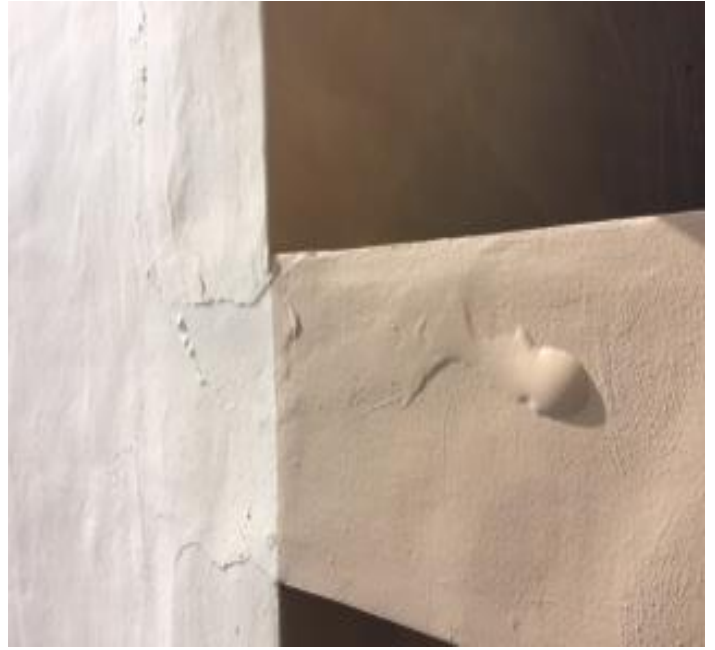
5. Other (describe): Stucco Finish - Satisfactory
i. Cracks
1. Location – note beams, columns, other: Isolated cracking in stucco wall finish
2. Description: Portions of stucco finish on the exterior masonry wall and slab edges are showing spalling/cracking at the floor elevation that is leading to isolated moisture penetration at the interior faces of the wall. It is recommended that the spalled/cracked stucco be repaired; all spalled masonry shall be patched with repair mortars; all cracks be routed out and repointed with type N mortar; and all affected areas painted.

Figure 5: Delaminated stucco

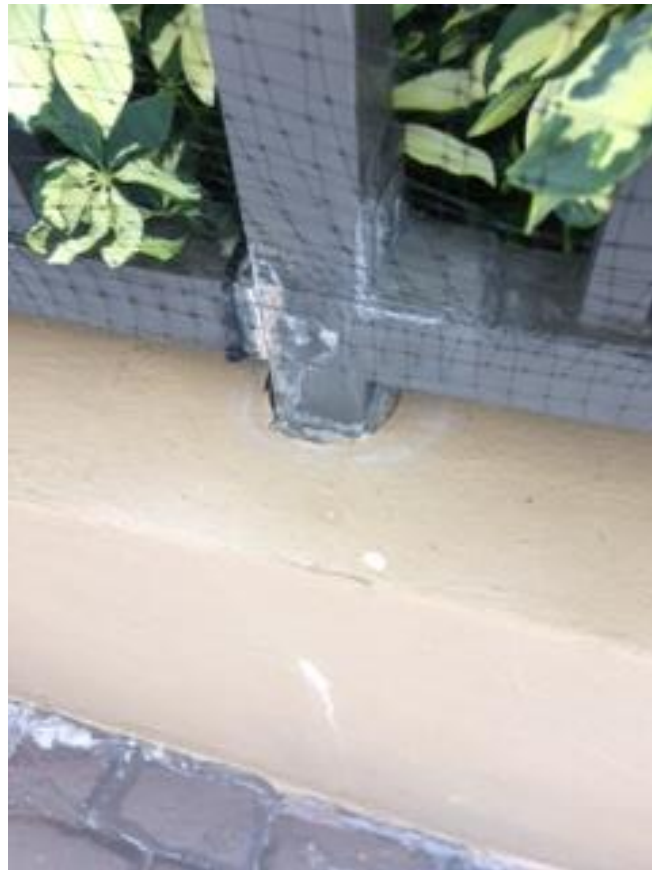
Figure 6: Water intrusion at rail posts

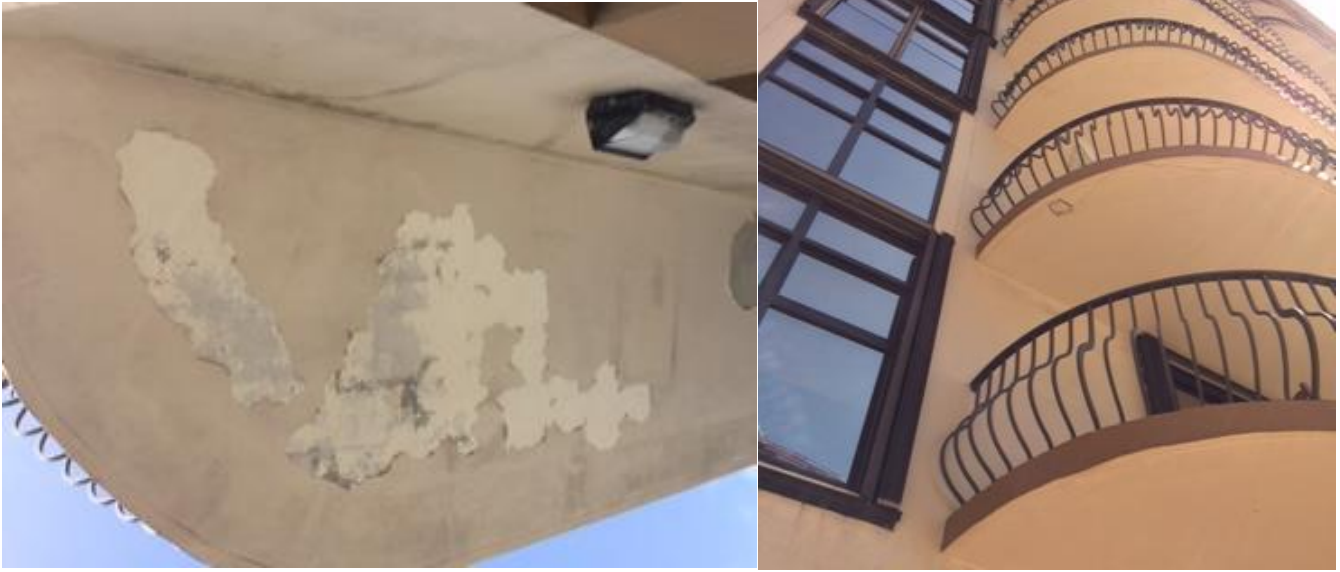
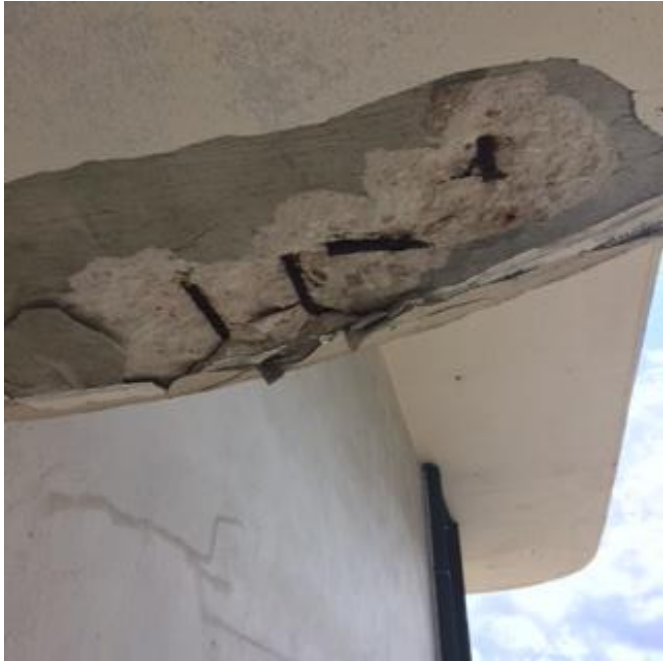
Figure 7: Balcony soffit deterioration

e. Structural repair-note appropriate line:
1. None required
2. Required (describe and indicate acceptance): ✓ Items to be repaired and standard of acceptance listed below:
Balconies: Repair of cracked/spalled exterior concrete columns, soffits, edge slab, loose top rails/pickets.
Exterior Walls: Repair of cracked/spalled masonry stucco wall at floor line and other isolated areas.
Garage/Plaza slab: Repair of cracked/spalled concrete slabs, columns, and walls.
Structural Steel: Exposed structural steel at rooftop cooling towers to be recoated with a galvanizing finish.
Waterproofing: Remove/replace all plaza and planter waterproofing.

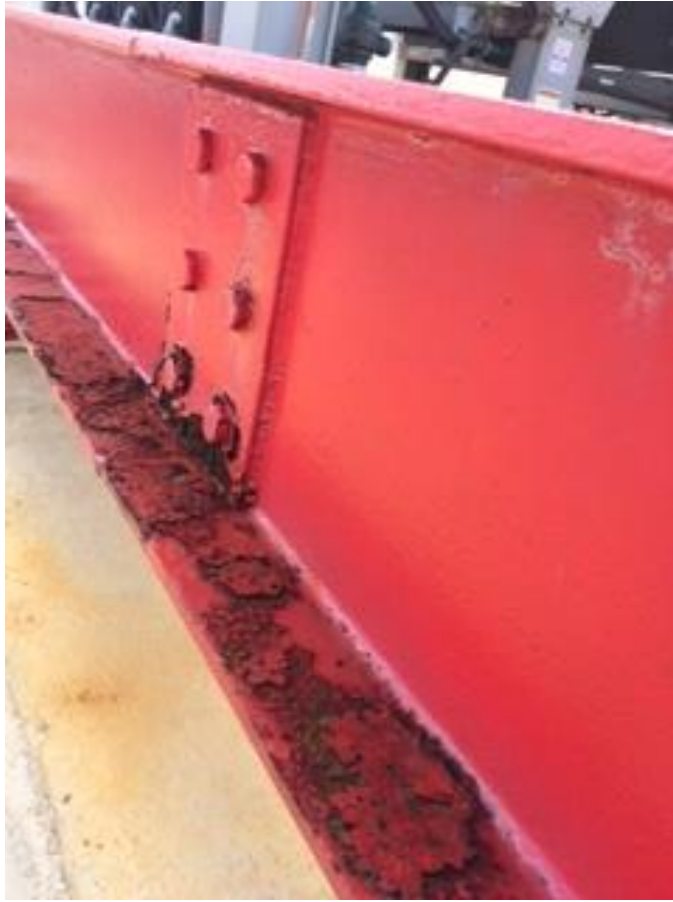
b. Exposed Steel- describe condition of paint and degree of corrosion
Majority of exposed structural steel members and connections are in satisfactory condition with some members experiencing corrosion. It is recommended that the entirety of the steel be recoated with a galvanizing finish.
c. Concrete or other fireproofing – note any cracking or spalling and note where any covering was removed for inspection: N/A
d. Elevator sheave beams and connections, and machine floor beams – note condition: N/A

Figure 8: Rusted steel beam on roof 1

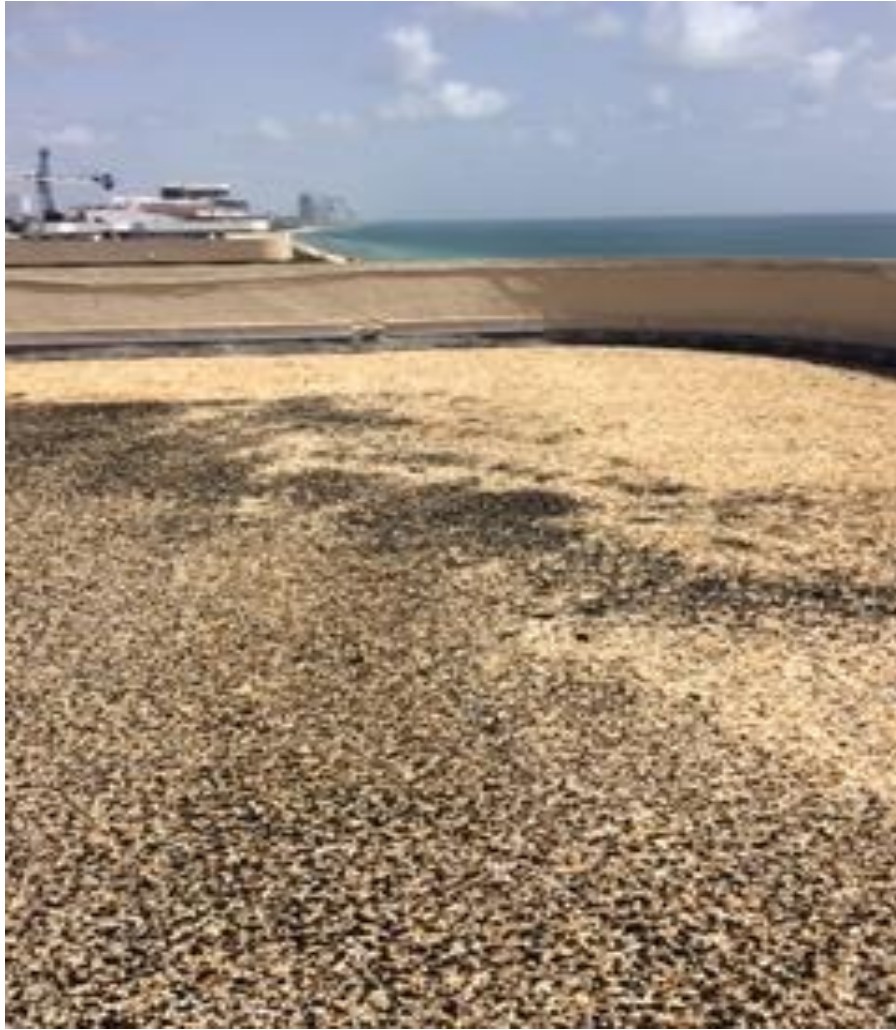
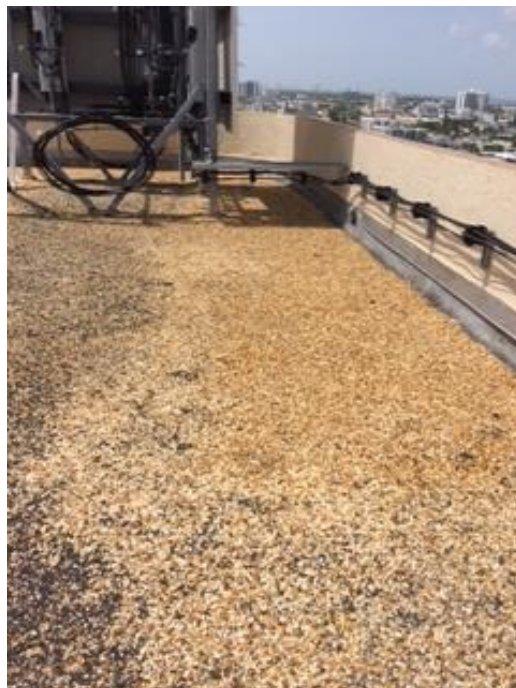
Figure 9: Repaired roof area
