October 5, 2018

Champlain Tower South Condominium
8777 Collins Avenue
Surfside, FL 33154

**Re: Champlain Towers South Condominium
Structural Field Survey Report
MC Job# 18217**

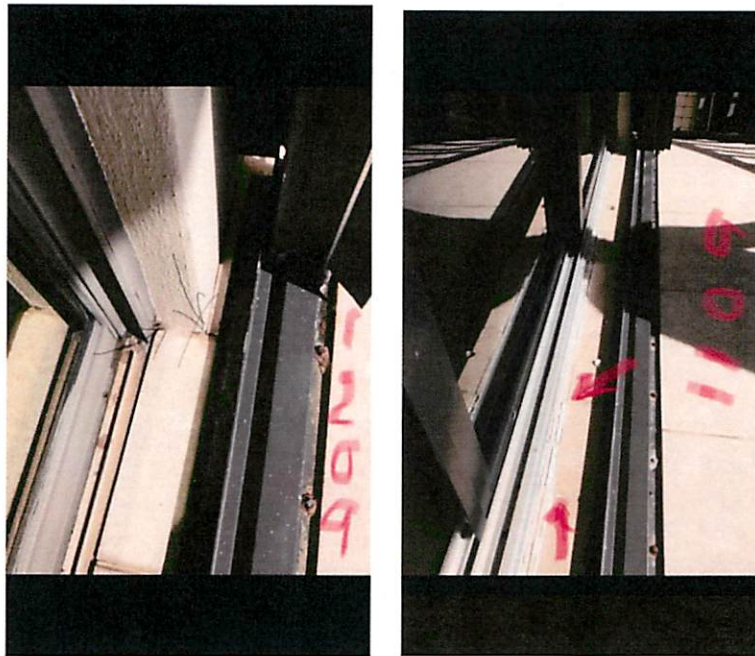
- A. MC understands some unit owners have complained of flooding into the interior space of their unit during a hurricane event. MC has concluded that this infiltration is occurring through the balcony sliding glass doors & windows due to the lack of proper flashing at the sill of these doors & windows and deteriorated exterior perimeter sealant between the window/door frames and masonry/concrete walls. MC recommends that the exterior sealant be removed / replaced at the sliding glass door & window perimeter to assist in providing a water-tight condition. Unfortunately, the new sliding doors in unit 209 and above were not installed properly and were fabricated too tall to allow the base flashing to be properly installed, so these unit owners have no choice but to discard the newly purchased doors and have them completely refabricated.

Figure A1: Exterior sealant past its serviceable lifespan at sealant between the window/door frames and masonry/concrete walls & balcony floors

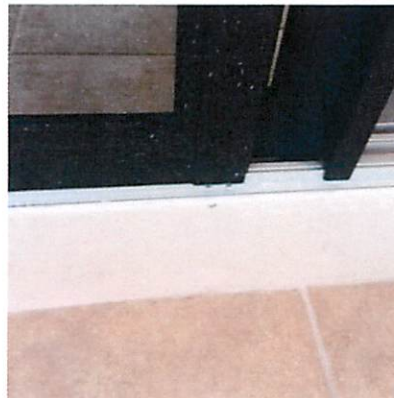
Figure A2: Newly installed sliding door at unit 209 that was not properly flashed

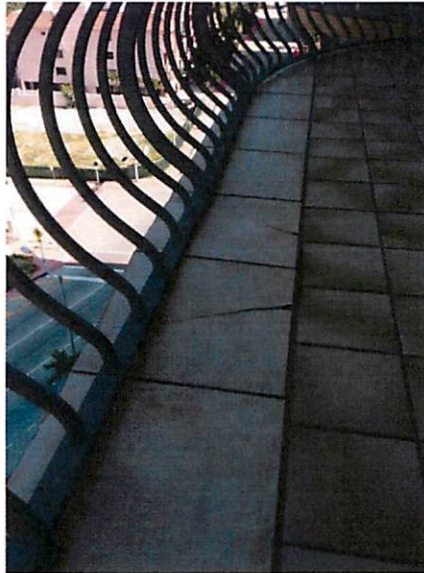
- B. MC observed that the majority of the balconies were furnished with tile or some other floor covering by choice of the tenant, making it impossible to observe the condition of the topside of the balcony slabs. Several instances were noted where balcony tile was damaged, such as in Unit 1008. Based on MC experience, cracked tile usually means structural damage exists to the balcony slab that must be repaired per the requirements of the International Concrete Repair Institute (ICRI) prior to the installation of a pedestrian waterproofing membrane.

Figure B: Damaged balcony tile that must be removed to fix structural damage

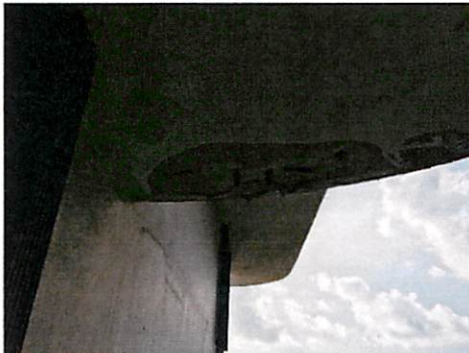
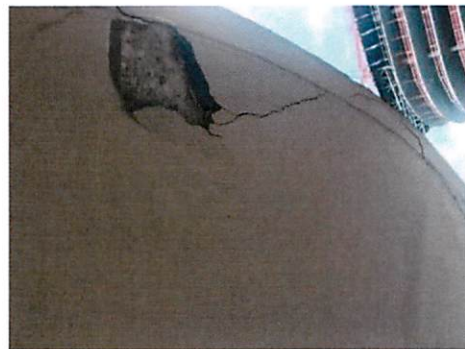
- C. MC found it fairly typical that the concrete slab edges of the balconies are experiencing concrete spalling or cracking. MC sees this as a common source of water infiltration and a main cause of the commonly found, sub-surface deterioration at the exterior soffits under the railings. MC requires that the balcony slab edges be further investigated and repaired in accordance with the recommendations of the ICRI to prevent future water penetration.

Figure C: Concrete spall at balcony slab edge in units 1008 & 211

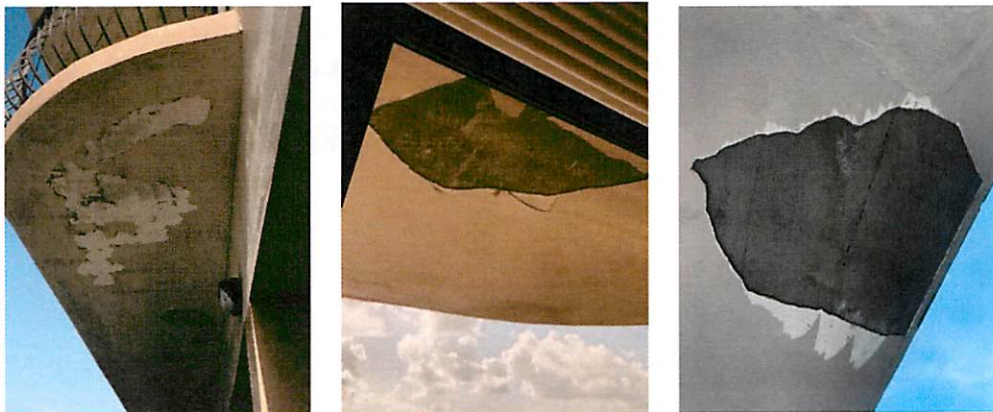
- D. Approximately half of the balcony soffits reviewed by MC show evidence of deterioration under the painted finished surface. These areas were identified by sounding the concrete with a golf club, checking for solidity. In some cases, the paint finish had formed a bubble or pocket that was retaining water, while in other areas the painted soffit was peeled away leaving the concrete surface exposed. The extensive soffit damage is a systemic issue that can only be repaired by removing all of the balcony tile, repairing the damaged concrete surfaces at the top and bottom of the slab and protecting the slab by installing a pedestrian waterproofing membrane on all top-side balcony surfaces. Partial/full depth concrete repairs in these areas shall be performed in accordance with the recommendations of ICRI. It is important to note that installing tile on top of the concrete balcony surfaces results in the railing having inadequate height to meet the minimum guardrail height of 42" required by the Florida Building Code.

Figure D: Balcony Soffit paint spalling in units 208, 703, & 1301.

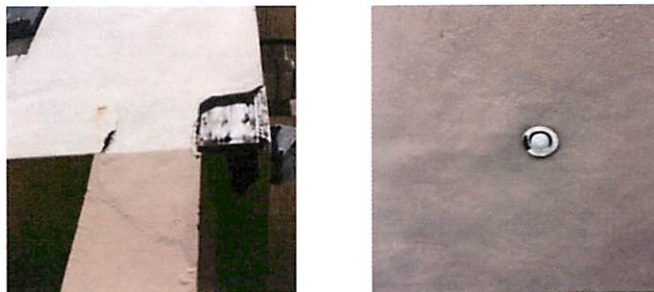
- E. Several areas of the entrance drive soffits under the second floor were observed by MC to have deteriorated black plywood. This condition was also observed at several light fixtures in the entrance soffit. MC could not get access into the soffit areas to observe the extent of the deteriorated soffits and support framing as CTS maintenance was too busy to assist us. MC is concerned that mold exists above these soffit areas and the soffit support framing is deteriorated which will require the complete removal and replacement of the entrance suspended soffit. Further investigation into this area is warranted.

Figure E: Deteriorated plywood soffit above entrance drive.

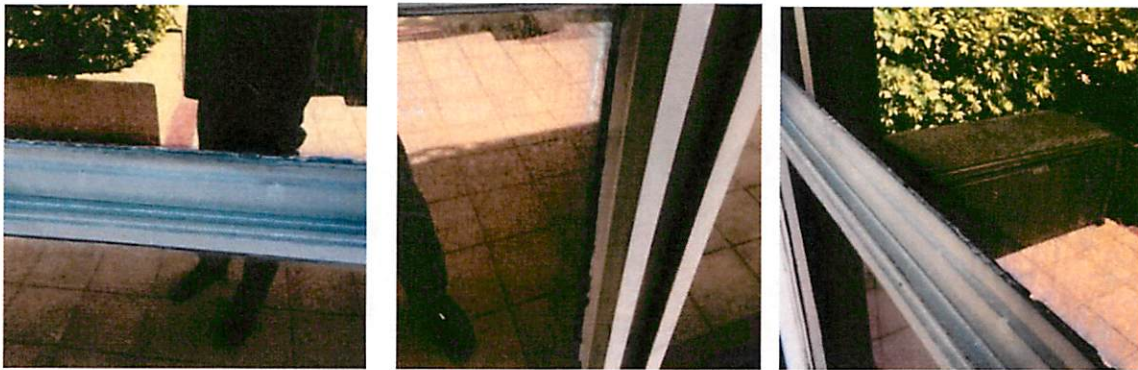
- F. It was brought to MC's attention that several units are experiencing water infiltration through the window frames and glazing as the windows are near the end of their functional lifespan. It is recommended that the window frame glazing (metal to glass), and perimeter sealant (metal to metal or metal to masonry/concrete) be removed and replaced for the entirety of the building to reduce future water penetration and minimize damage during hurricane events. MC recommends that the BOD strongly consider the replacement of all exterior windows and doors with impact resistant units.

Figure F: Exterior sealant at window frame that has aged past its serviceable lifespan

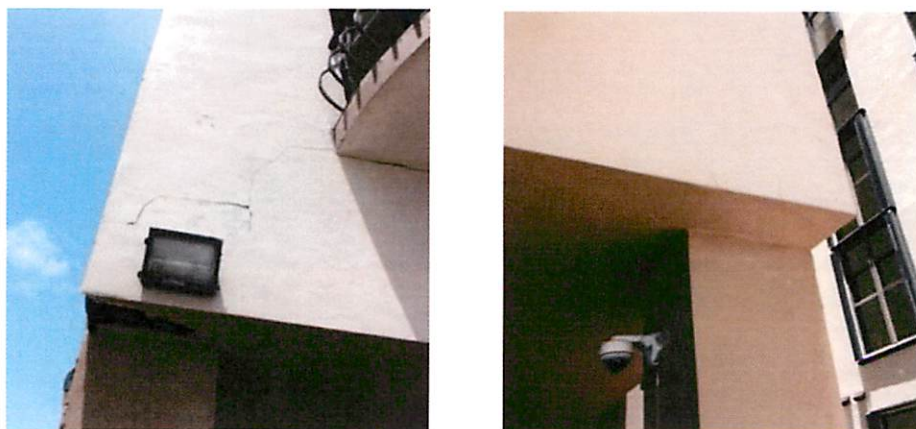
- G. Significant cracking in the stucco exterior façade often occurs at the mortar bed joint between the top of the concrete floor slab and first block masonry course. Although MC does not see this crack as a source of water infiltration into the condominium units, such cracks need to be routed and repointed to prevent future water permeation. All significant façade stucco cracking is to be repaired in accordance with the recommendations of ICRI.

Figure G: Typical cracking in the stucco exterior facade.

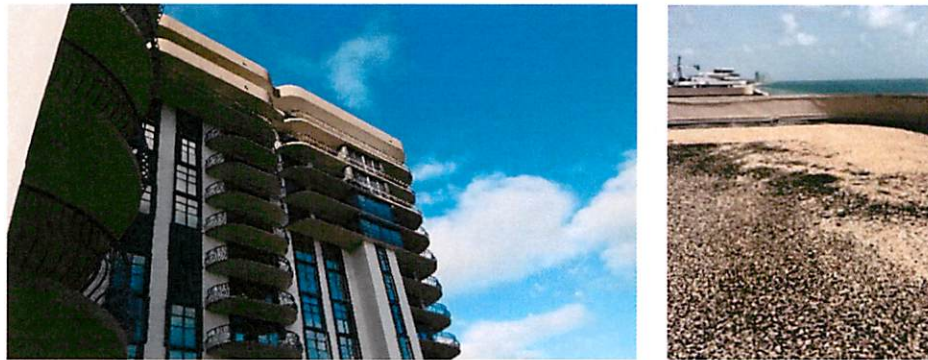
- H. MC observed the non-existence of window washing / suspension hooks that should have been installed face-mounted to the underside of the top-level balconies and spread throughout the roof of this building structure. This failure to have suspension hooks is a violation of the present-day **Occupational Safety and Health Administration (OSHA) Rules and Regulations 29 CFR Part 1910 "Walking-Working Surfaces and Personal Protective Equipment (Fall Protection systems)"** requirements and **ANSI/IWCA I-14.1-2001 "Window Cleaning Safety Standard"**. MC recommends that new hooks be installed and waterproofed on the roof structural slab and underside of the top-level balcony slabs that meet the requirements of **OSHA 29 CFR Part 1926.502 "Fall Protection Systems Criteria and Practices"** and **ANSI/IWCA 1-14.1** prior to the commencement of façade and balcony restoration. Furthermore, MC recommends that our office meet with the contractor who is to perform the façade restoration work and the present window washing contractor so that the new fall protection system anchor quantity and location can be agreed upon to assure adequate anchor coverage for all future contractors who will be suspended on the exterior of the Champlain Towers South Condominium.

Figure H: No suspension hooks at the underside of the balconies and on the roof.

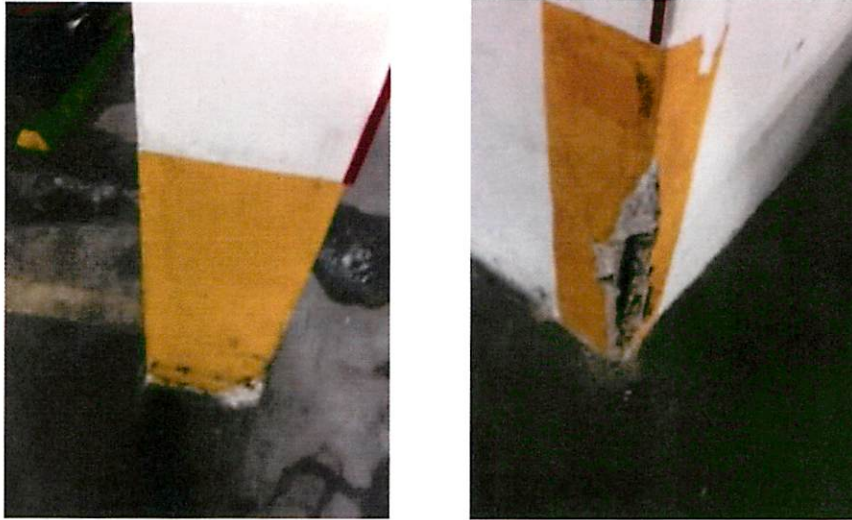
- J. Abundant cracking and spalling of varying degrees was observed in the concrete columns, beams, and walls. Several sizeable spalls were noted in both the topside of the entrance drive ramp and underside of the pool/entrance drive/planter slabs, which included instances with exposed, deteriorating rebar. Though some of this damage is minor, most of the concrete deterioration needs to be repaired in a timely fashion. All cracking and spalling located in the parking garage shall be repaired in accordance with the recommendations of ICRI.

Figure J1: Typical cracking and spalling at parking garage columns

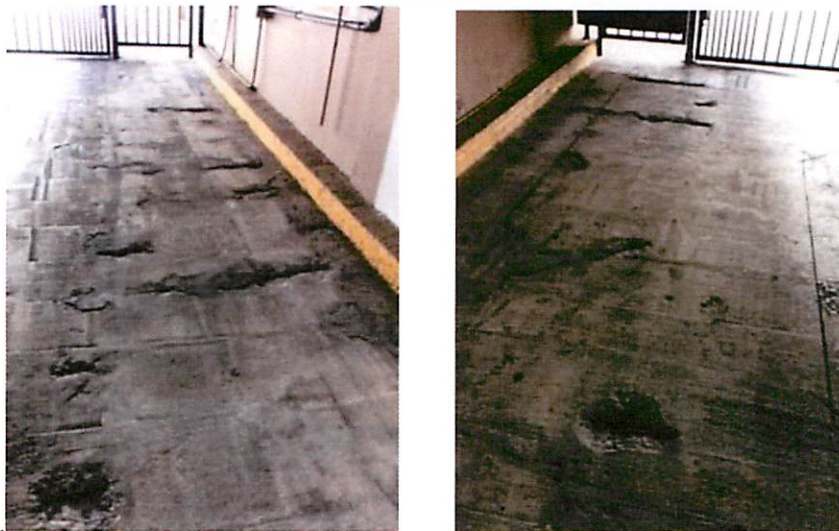
Figure J2: Spalling with exposed steel reinforcement at top of garage deck.

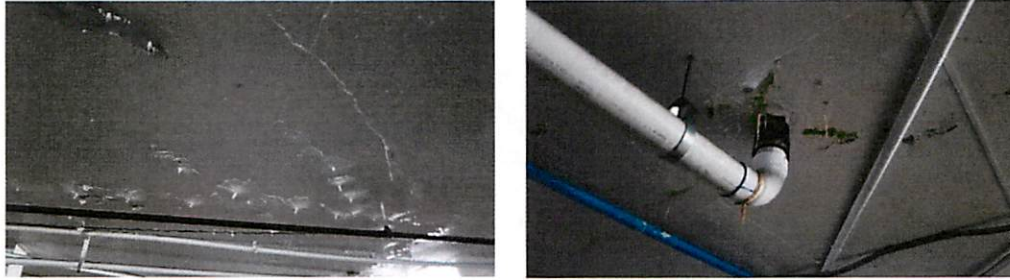
- K. MC visual observations revealed that many of the previous garage concrete repairs are failing resulting in additional concrete cracking, spalling and leaching of calcium carbonate deposits. At the underside of Entrance/Pool deck where the slab had been epoxy-injected, new cracks were radiating from the originally repaired cracks. The installed epoxy is not continuous as observed from the bottom of the slab, which is evidence of poor workmanship performed by the previous contractor. The injection ports were not removed, and the surfaces were not ground smooth at the completion of the injection. Leaching of calcium carbonate deposits in numerous areas has surely caused CTS to pay to repaint numerous cars. This leaching will continue to increase until proper repairs are completed. MC is convinced that the previously installed epoxy injection repairs were ineffective in properly repairing the existing cracked and spalled concrete

Figure K1: Previously installed failed injection repairs with leaching forming

slabs. MC recommends that the Entrance/Pool deck concrete slabs that are showing distress be removed and replaced in their entirety. Unfortunately, all of these failed slab areas are under brick pavers, decorative stamped concrete and planters which require completed waterproofing replacement. All repaired concrete slabs located in the parking garage are to be repaired in accordance with the recommendations of ICRI.

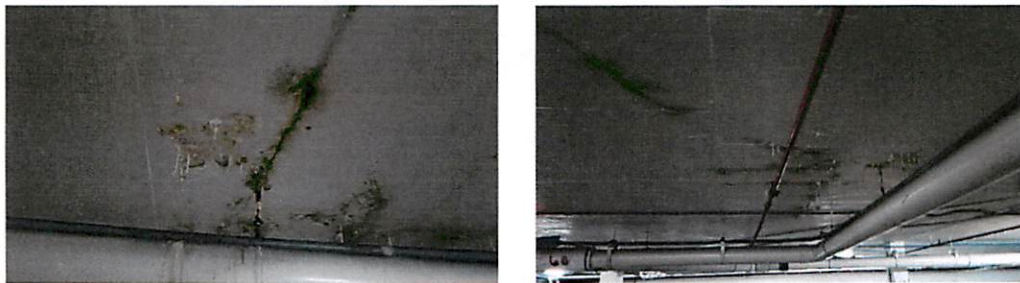
Figure K2: More previously installed failed injection repairs with leaching forming
