**Project Title: Bulkhead Grant Application and Construction Application (CGA Project No.: 12-4952)**

This report summarizes an inspection performed on municipally owned bulkheads in the Town of Surfside and makes recommendations for their repair or replacement.

Bulkhead 1, Carlyle Ave & 88<sup>th</sup> St.

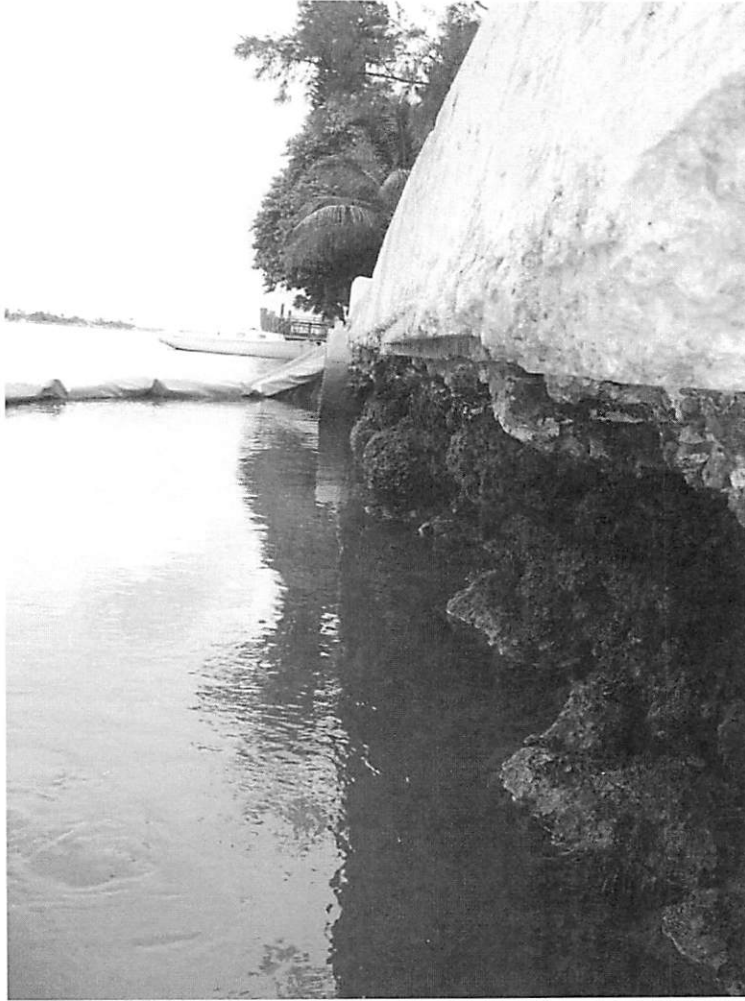
This native-stone bulkhead is failing. The bulkhead is comprised of large, porous native stone and mortar with a concrete cap (*See Photo 1.1*). The bulkhead contains a 36" concrete culvert near its midpoint, and the cap above the culvert is cracked (*See Photo 1.2*). The remainder of the cap appears to be in reasonably good condition. There is a plastic conduit line penetrating the bulkhead toward its west end.

*Photo 1.1: Native Stone Wall*

It is recommended that this bulkhead be replaced entirely. Replacing the wall with a different material will have to take into consideration the joints with neighboring native stone bulkheads.

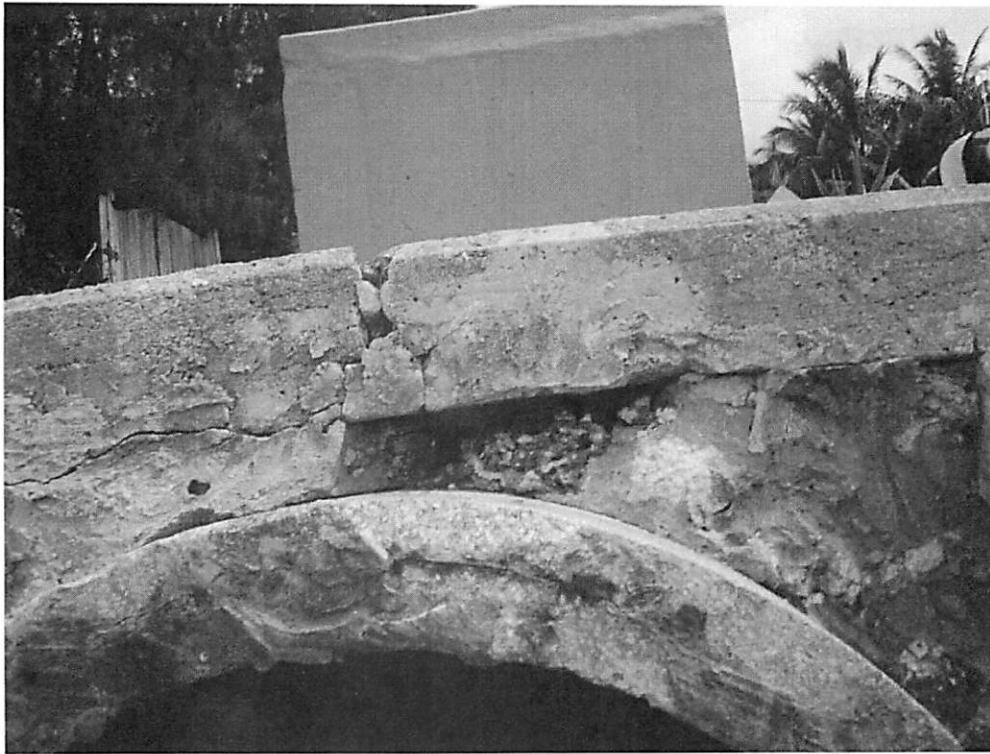
*Photo 1.2: Crack above Concrete Outfall*

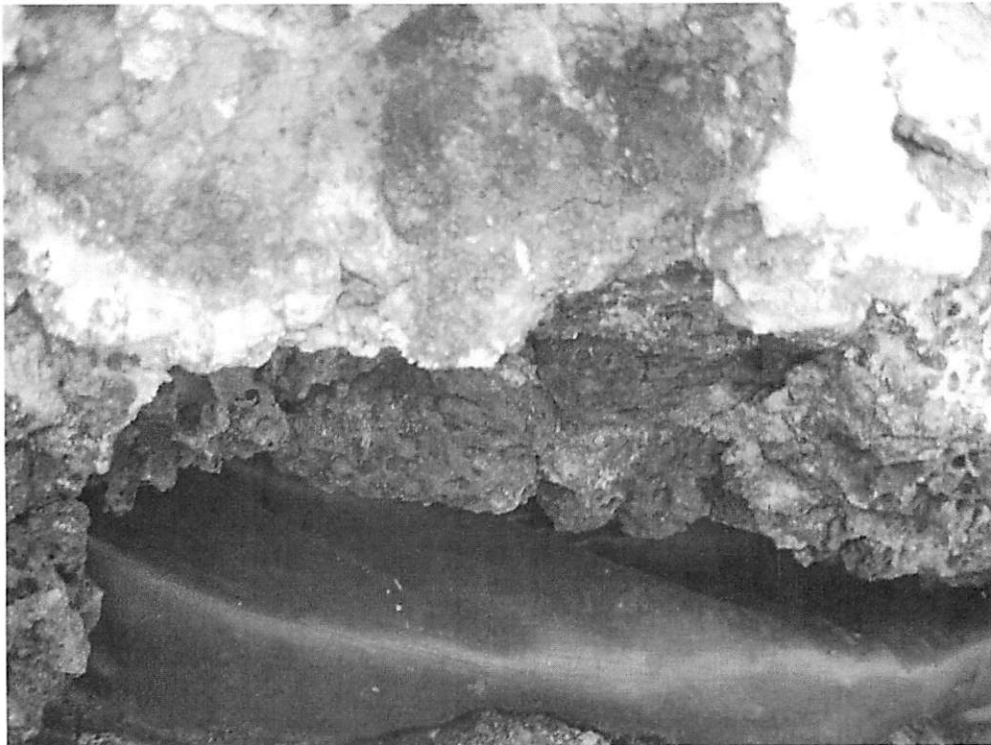
Many of the stones and mortar in the bulkhead have broken away with time. In no place is this more apparent than on the eastern portion of the bulkhead where a 3 foot wide section of geofabric may be seen through a hole in the bulkhead where the stones have fallen away (*See Photo 1.3*). The geofabric appears to be in good condition, and may have been part of a previous repair to reduce erosion through the bulkhead.

*Photo 1.3: Geofabric Witnessed Through Wall*

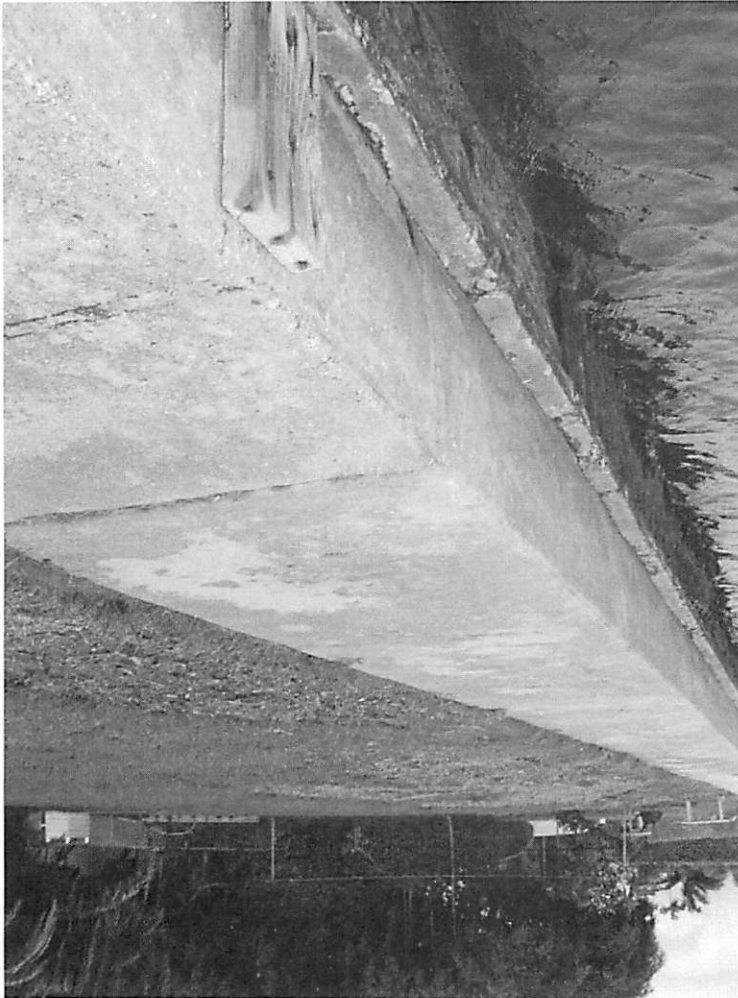
This concrete bulkhead was formed with two monolithic pours, separated by a cold joint toward the bulkhead's east end (*See Photo 2.1*). There are a number of cracks throughout the top of the bulkhead. At some point after the initial construction, asbestos-concrete sheet piles were driven immediately in front of the concrete bulkhead, and topped with a small concrete cap (*See Photo 2.2*). As a result, it is difficult to see the face of the bulkhead to inspect for cracking or other areas of water infiltration. These asbestos-concrete sheets and small concrete cap are very brittle and may be broken with little force.

*Photo 2.1: Concrete Bulkhead with Asbestos-Concrete-Sheets*

It is recommended that the bulkhead be repaired to prevent soils from washing through the bulkhead, or that the bulkhead be replaced entirely. This bulkhead may be repaired by adding a geofabric layer behind the bulkhead and backfilling to inhibit the migration of soils through the bulkhead with seepage.

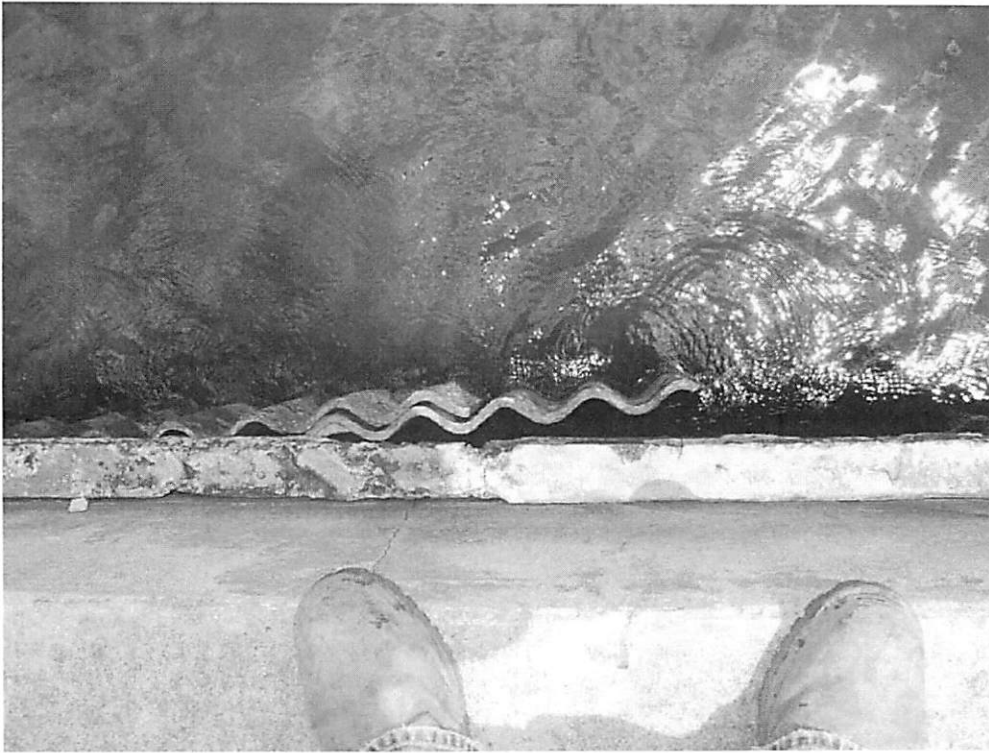
Being as they are of no apparent structural benefit, it is assumed that the asbestos-concrete sheet piles were placed in front of the larger concrete bulkhead to curtail the seepage of soils from behind the bulkhead. The ground behind the bulkhead is very soft and irregularly eroded. Only recently before the field observation was conducted, a large amount of fill was added above the sod in some low lying areas in an apparent effort to replace the eroded soils (*See Photo 2.3*). All of these observations indicate that the soil behind the bulkhead is seeping through cracks in the bulkhead.

Photo 2.2: Asbestos-Concrete Sheet Piles In Front of Wall

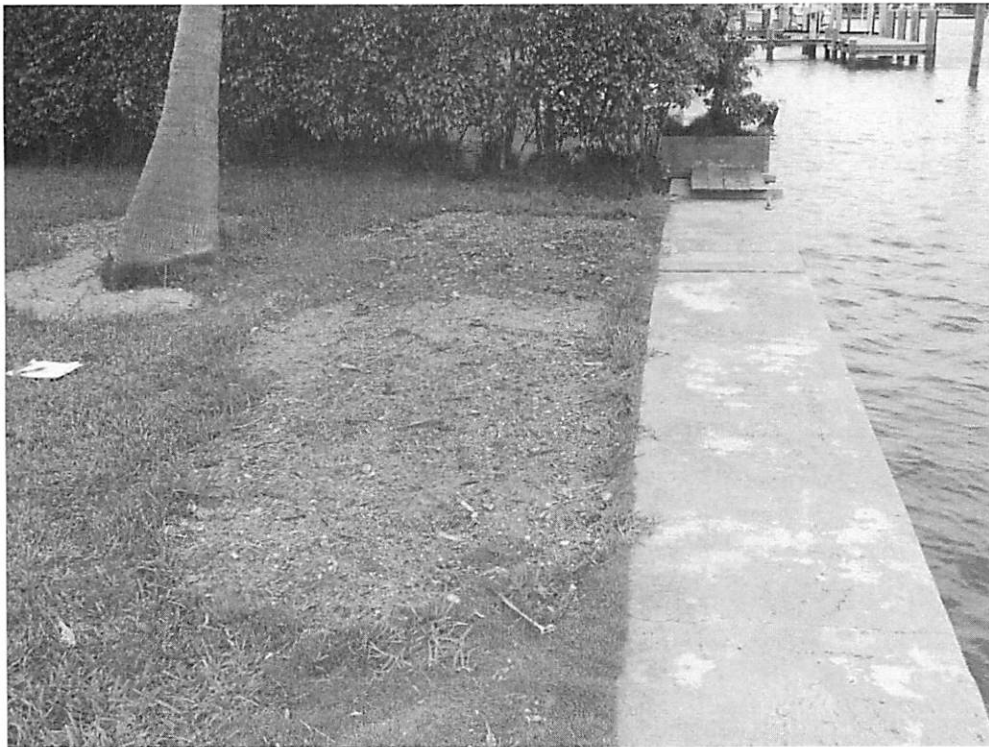
*Photo 2.2: Recently Placed Imported Fill*

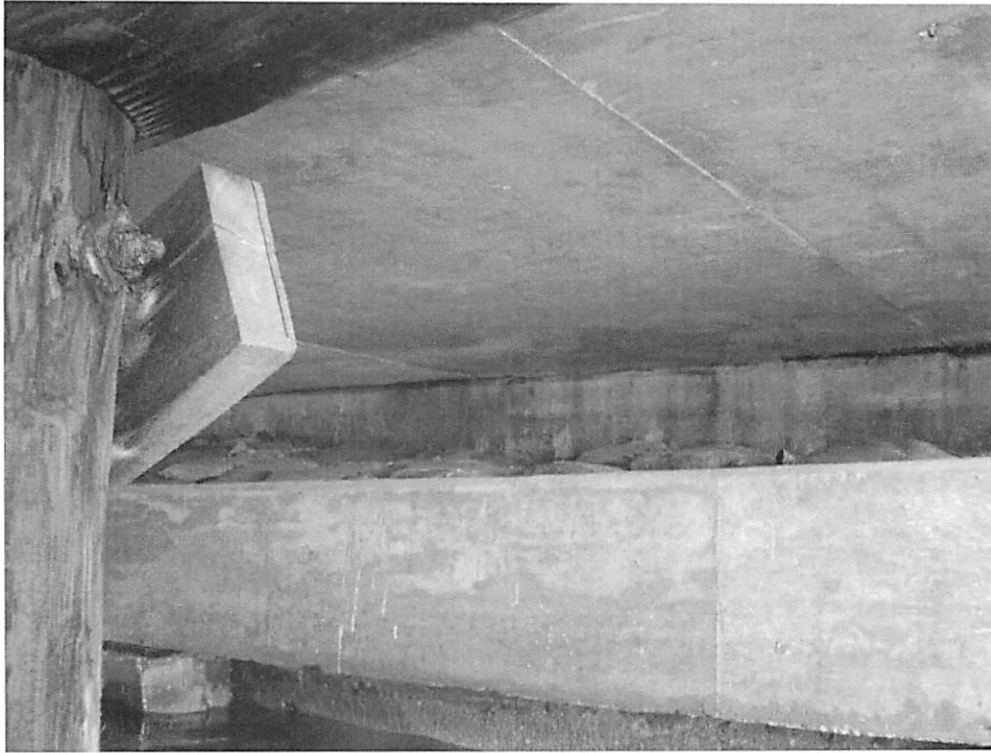
The caps on the bulkheads under the bridge appear to be relatively new, and there is minimal cracking on the concrete sheets. However, in three locations behind the concrete bulkheads (one on the east side, two on the west side), there are deep depressions in the backfill area (*See Photo 4.1*). At each of these locations, on the bottom of the bulkhead sheets near the mudline, there is a rectangular hole with approximate dimensions of 2' wide by 1' tall. It is unknown whether these holes are directly correlated to the depressions in backfill witnessed behind them.

*Photo 3.1: Concrete Cap In Front of Abutment with Backfill*

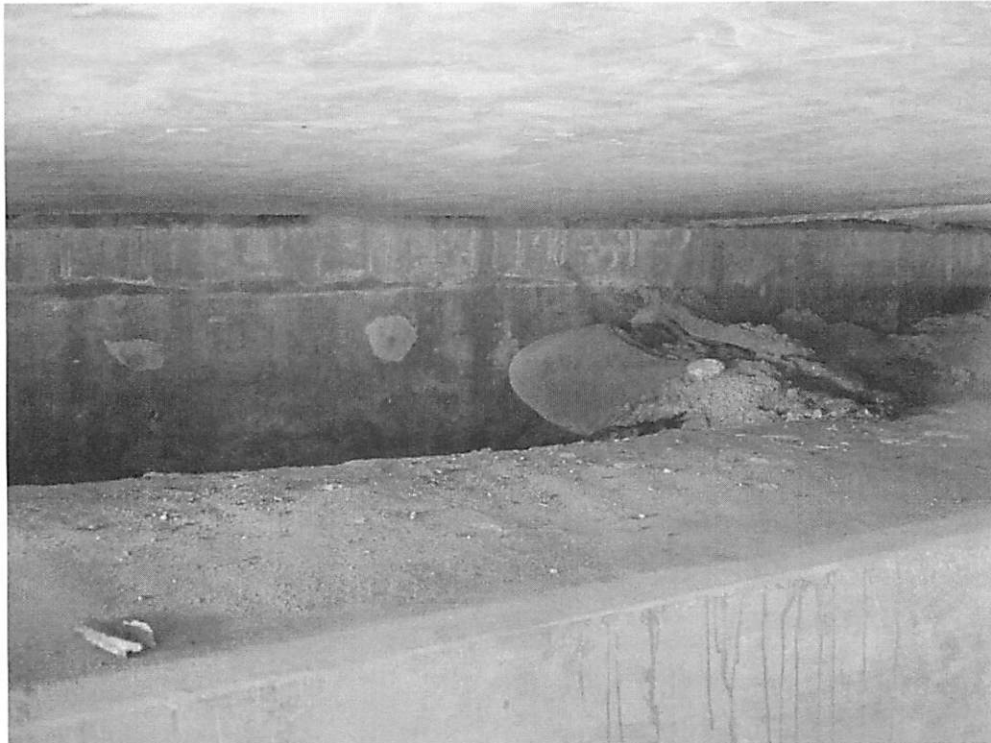
The abutments themselves have weep holes which are used to convey stormwater from behind the abutments or other areas to the backfilled area. It is possible that this stormwater from the bridge deck and/or tidal water infiltrating the bulkhead are liquefying the backfill and allowing it to escape through the aforementioned holes. It could also be that settling by the bridge caused these backfilled soils to shift.

*Photo 4.1: Sunken Area between Concrete Bulkhead and Bridge Abutment*

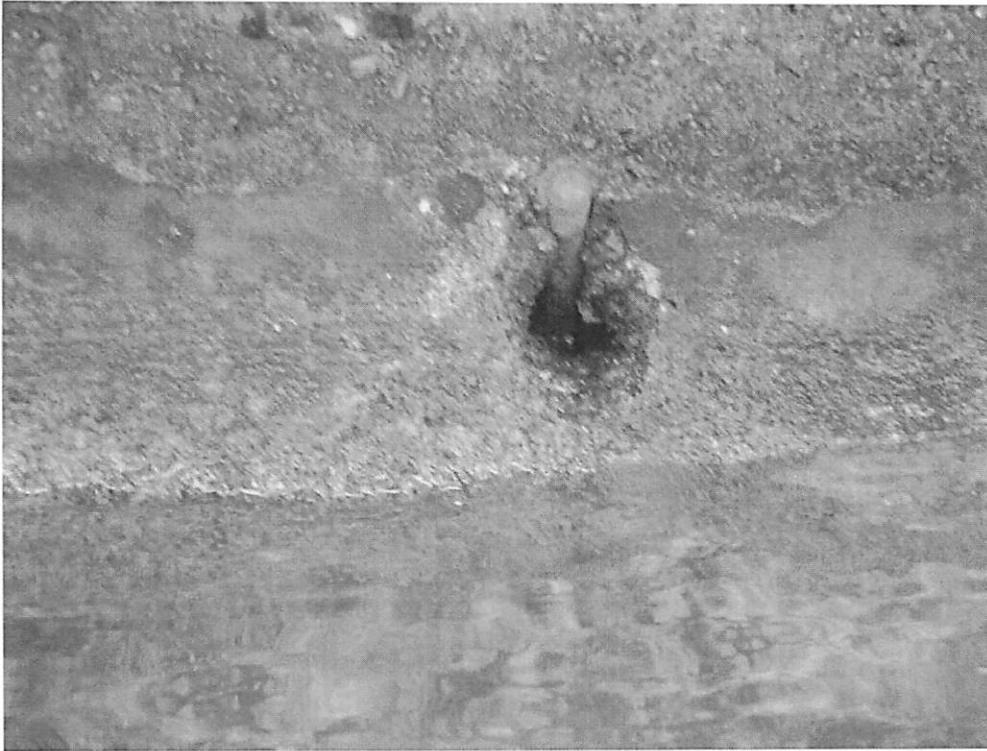
*Photo 5.1: Tie Rod Pulled Through Sheet Pile*

It is recommended that this bulkhead be replaced.

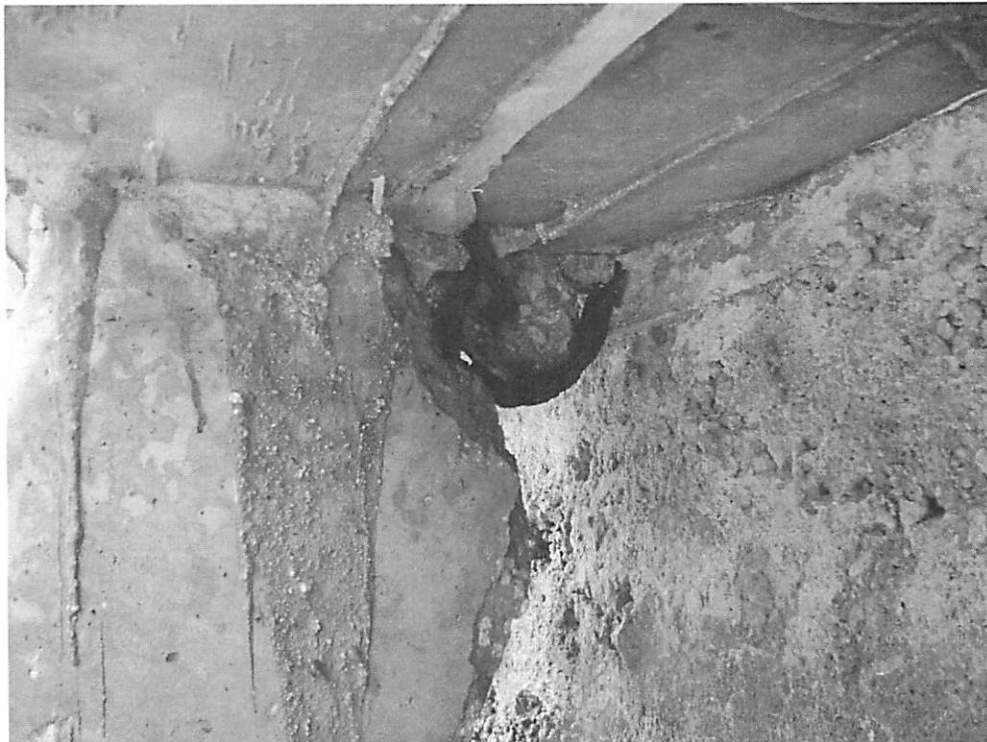
At the other end of the same bulkhead, the joint at which the easternmost batter pile connects with the cap has corroded to such a point that the steel is entirely exposed and rusted and the concrete that should be surrounding it is absent (*See Photo 5.2*). This batter pile is not likely providing optimal support to the bulkhead.

*Photo 5.2: Exposed Steel Reinforcement in Batter Pile*

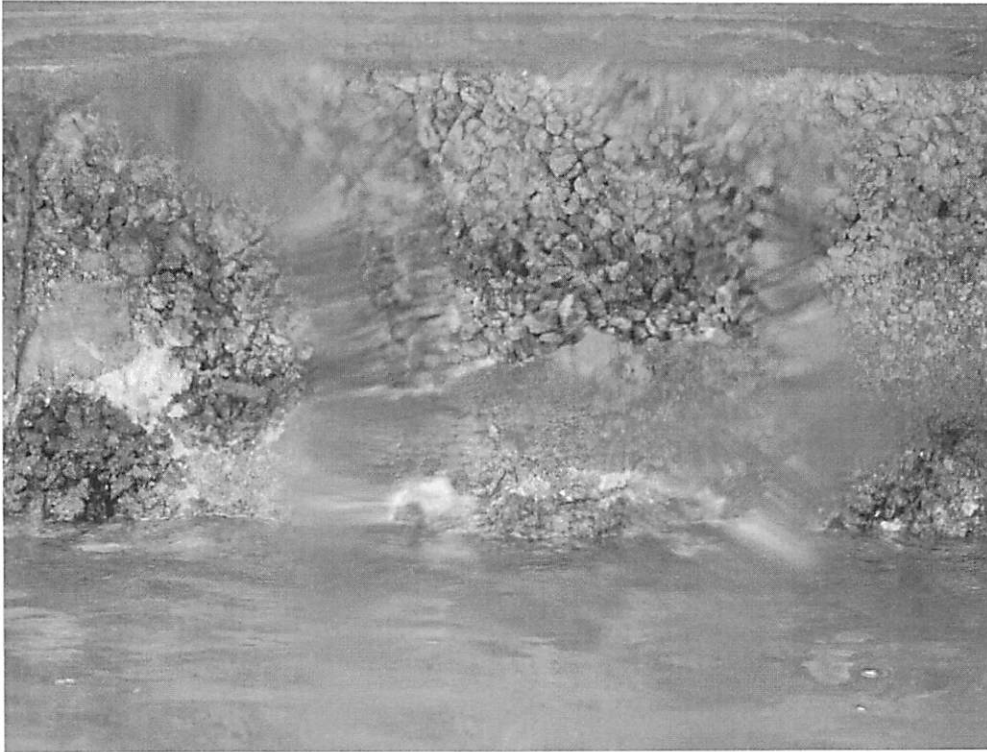
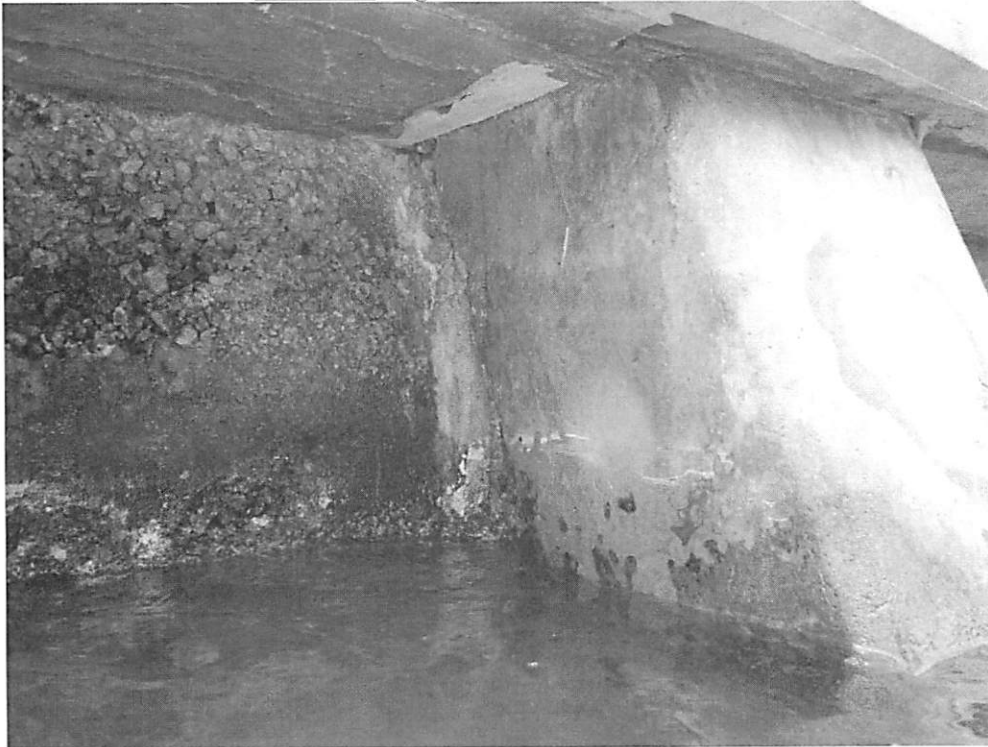
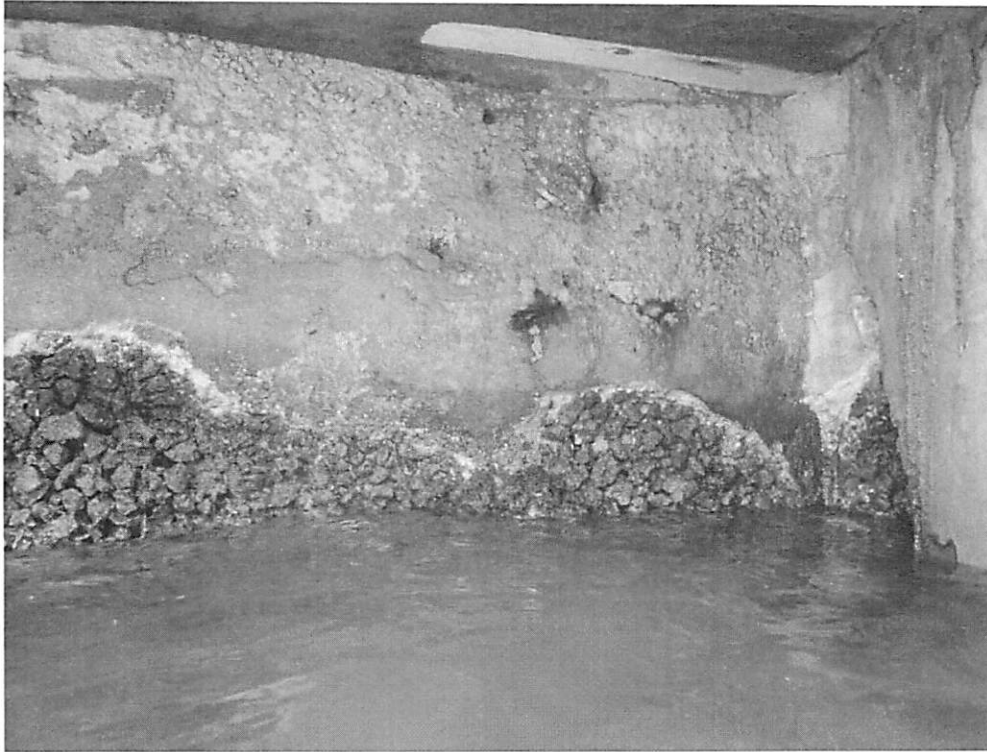
Presently, the concrete sheets themselves are highly weathered, (*See Photos 5.3, 5.4, 5.5*). The concrete binder in the sheets has eroded away, showing loose aggregate in the concrete sheets where the bulkhead is exposed to tidal fluctuations. There is a 12" metal water pipe that enters the wall at its midpoint, so any repair would have to make considerations for it.

*Photo 5.3: Degraded Concrete Sheet Piles*

*Photo 5.4: Degraded Concrete Sheet Piles*

*Photo 5.5: Degraded Concrete Sheet Piles*

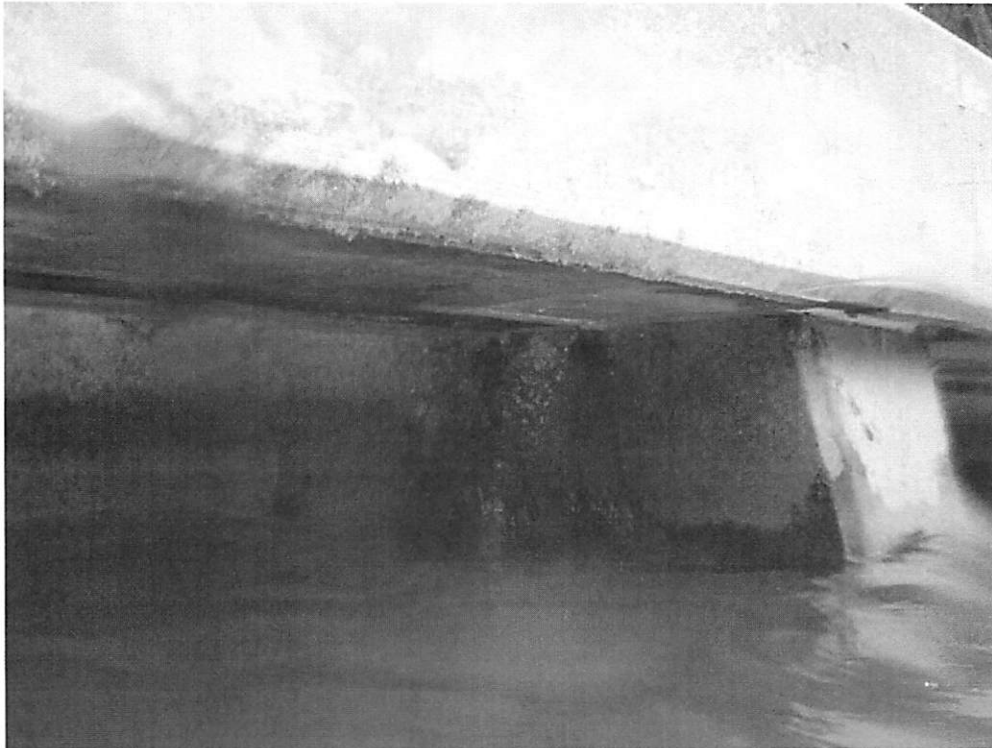
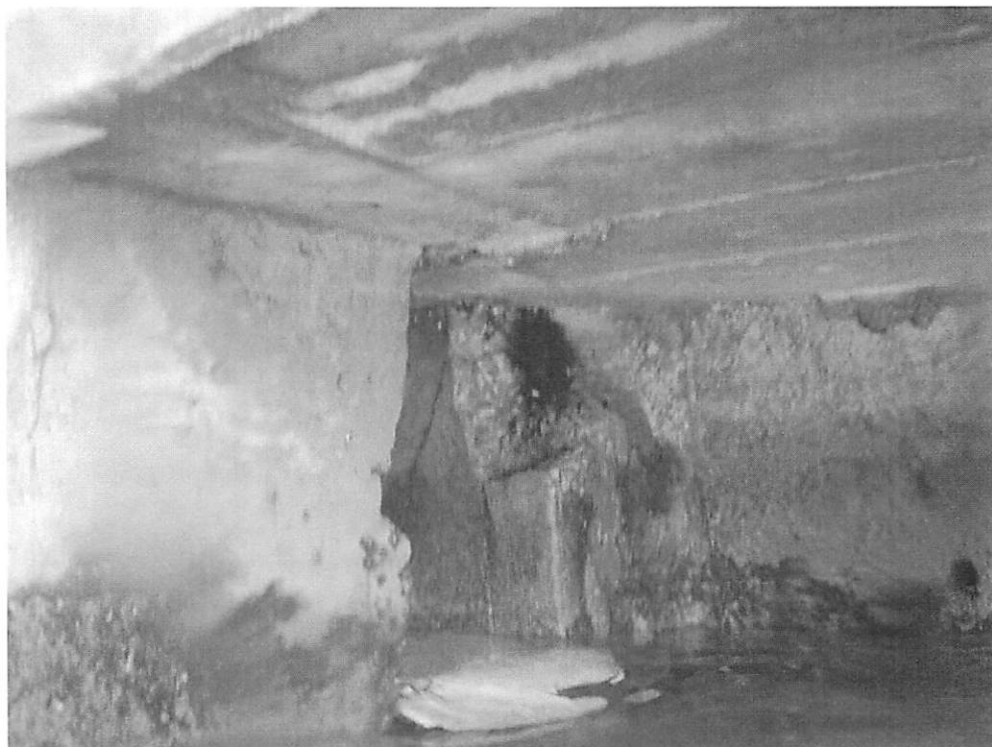
Unlike the previously mentioned bulkhead, the sheets themselves appear to be in good condition and the tieback systems show no signs of failure. There is some rust bleeding through the concrete that should be repaired with an epoxy grout and monitored for future degradation. In two other locations, some of the supporting concrete has broken away and exposed the underlying steel. These locations will need to be patched to prevent further corrosion (*See Photos 6.1, 6.2*). Some minor soil subsidence can be seen behind the wall.

*Photo 6.1: Exposed Steel Reinforcement*

*Photo 6.2: Exposed Steel Reinforcement*

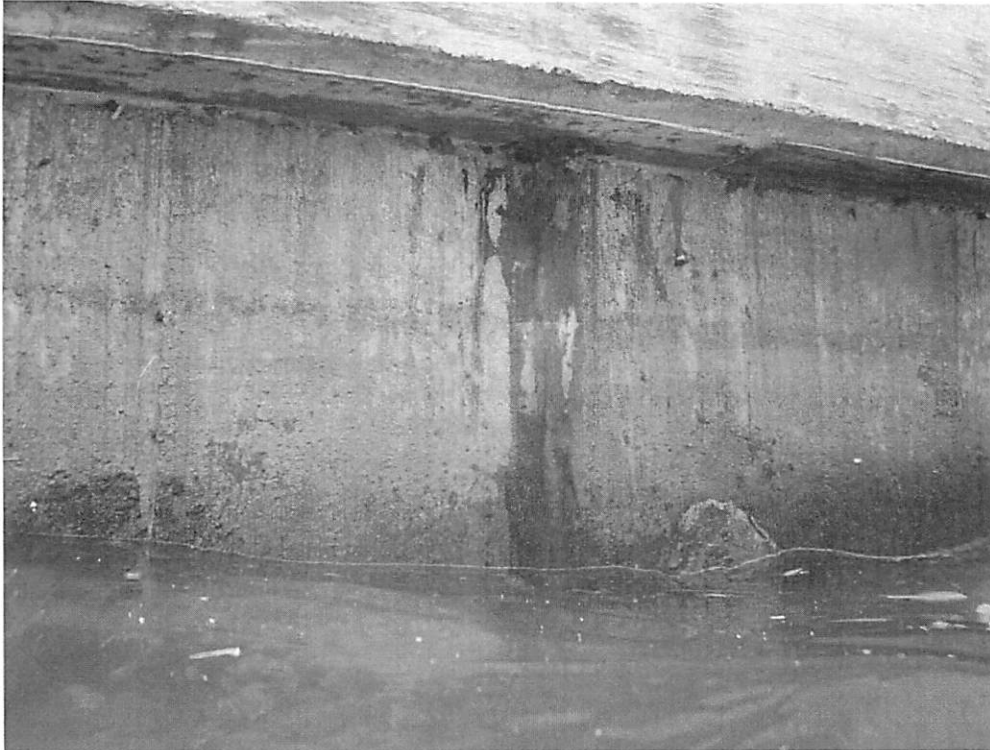
This bulkhead is comprised of interlocking concrete sheets piles. The sheets themselves are not connected by any H-piles or batter piles but as interlocking sheets sealed with hydraulic cement (*See Photo 7.1*). The sheets appear to be in good condition. The area behind the bulkhead is exhibiting sunken areas indicative of seepage between the joints, though no such cracks between the joints could be located. The sheets themselves fit together somewhat angularly; they are not aligned in parallel as a bulkhead face. It is possible that they have twisted over time under lateral stresses, that they became contorted when the new cap was installed, or that they were installed as described. The cap appears to be in good condition. There is riprap at the base of the sheets which helps to prevent scour along the toe of the bulkhead.

*Photo 7.1: Joint between Concrete Sheet Piles*

Although the wall does not appear to be in need of immediate repair, the twisted sheet piles along with the washouts are a matter of concern and the Town may wish to include this wall in a comprehensive repair/replacement plan.

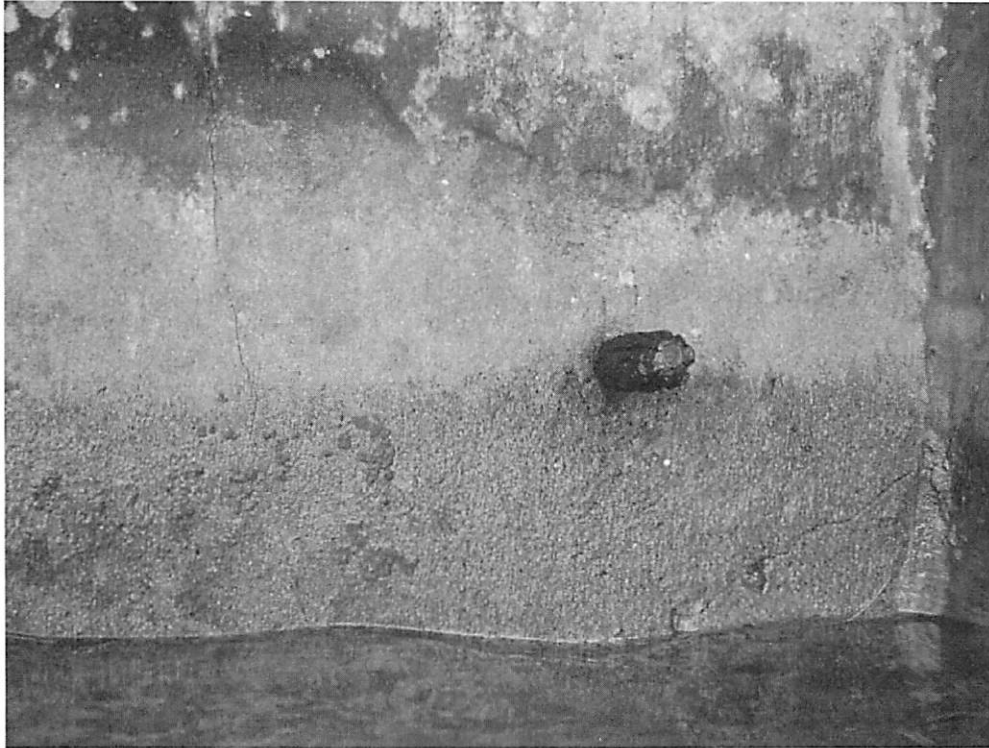
There are some existing tie back rods that are rusting and exposed to tidal fluctuations (*See Photo 8.1*). It is recommended that these areas and others that are exhibiting rusting be patched with an epoxy grout to prolong the useful life of the wall. Additional repairs should be made to some cracking that can be seen in the supporting H-piles (*See Photo 8.2*).

*Photo 8.1: Rusted Tie-back Rod End*

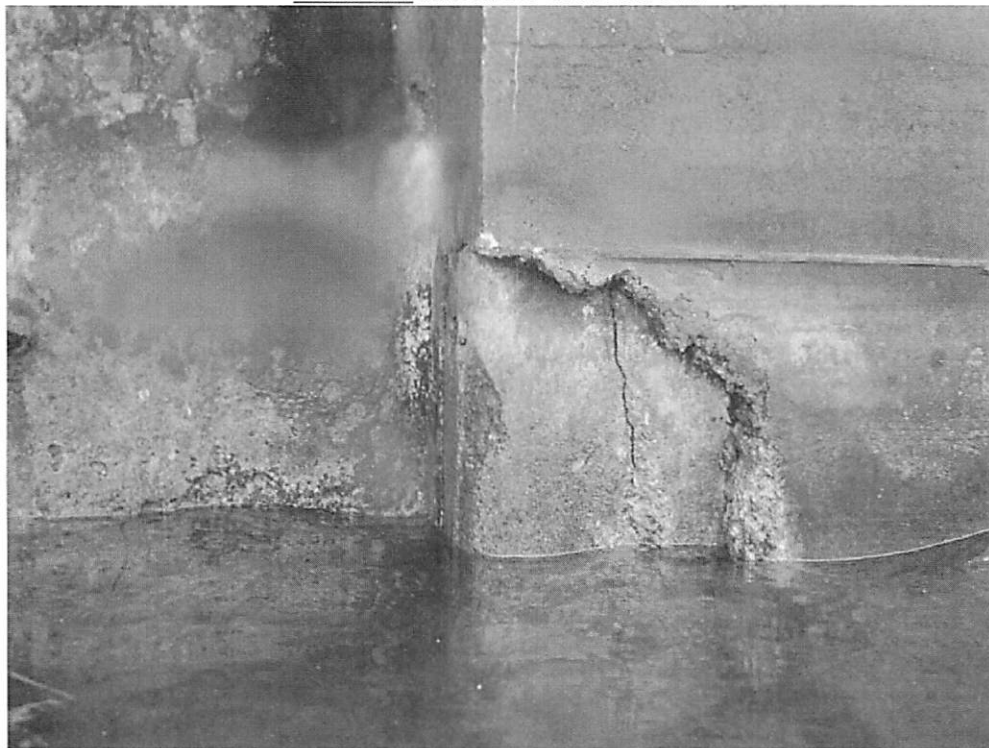
*Photo 8.2: Cracks Observed in H-piles*

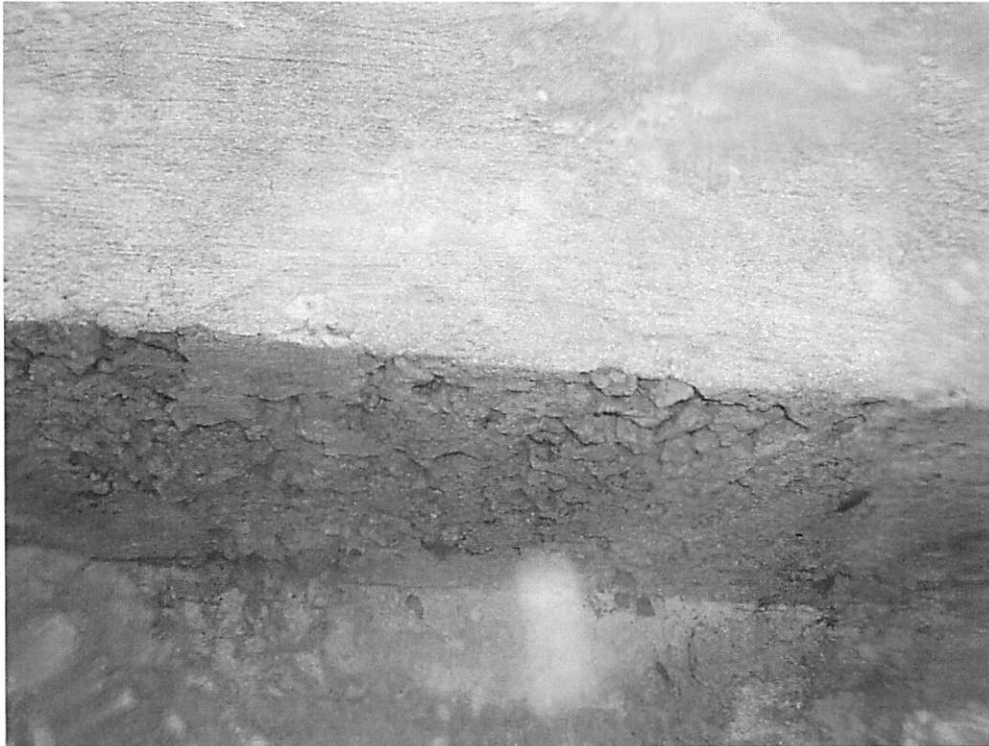
This bulkhead is comprised of concrete sheet piles with H-piles supporting them. Like the previous bulkhead, the sheets are in good condition. The cap is relatively new, but displays “honeycombing” on its underside (*See Photo 9.1*), indicating that it was not properly vibrated to allow the voids to be filled before the concrete was allowed to cure. The tieback rods that pass through the H-piles have been covered with mortar to prevent corrosion. Some of this mortar has chipped away, and may require replacement.

*Photo 9.1: Honeycombing in Concrete Cap*

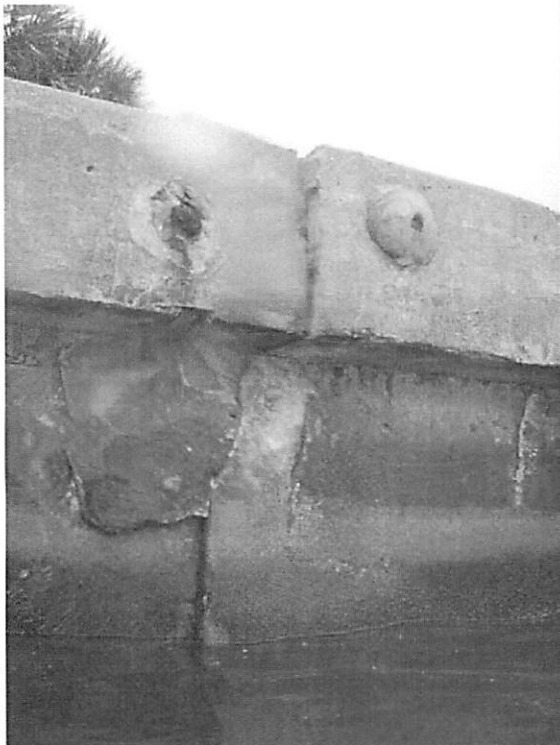
Of greater consequence to the structural integrity of the overall bulkhead is the presence of a very large vertical shear crack running from the top of the cap to at least the mudline at the bulkhead’s center (*See Photos 9.2, 9.3*). The bulkhead has split via shearing, and the sections are offset from one another by a couple of inches. Two tieback rods were installed in the cap, one on each side of the crack, as a means of repairing the crack, but the crack provides an avenue for soils to wash away from behind the bulkhead.

Though there are no buildings or other significant sources of dead loading in the vicinity of the crack, it was likely caused by temporary overloading, possibly a vehicle driven close to the bulkhead edge. In any case, the crack should either be sealed from both sides or the bulkhead may need to be replaced.

*Photo 9.2: Vertical Shear Crack in Wall Face and Cap*

*Photo 9.3: Vertical Shear Crack*

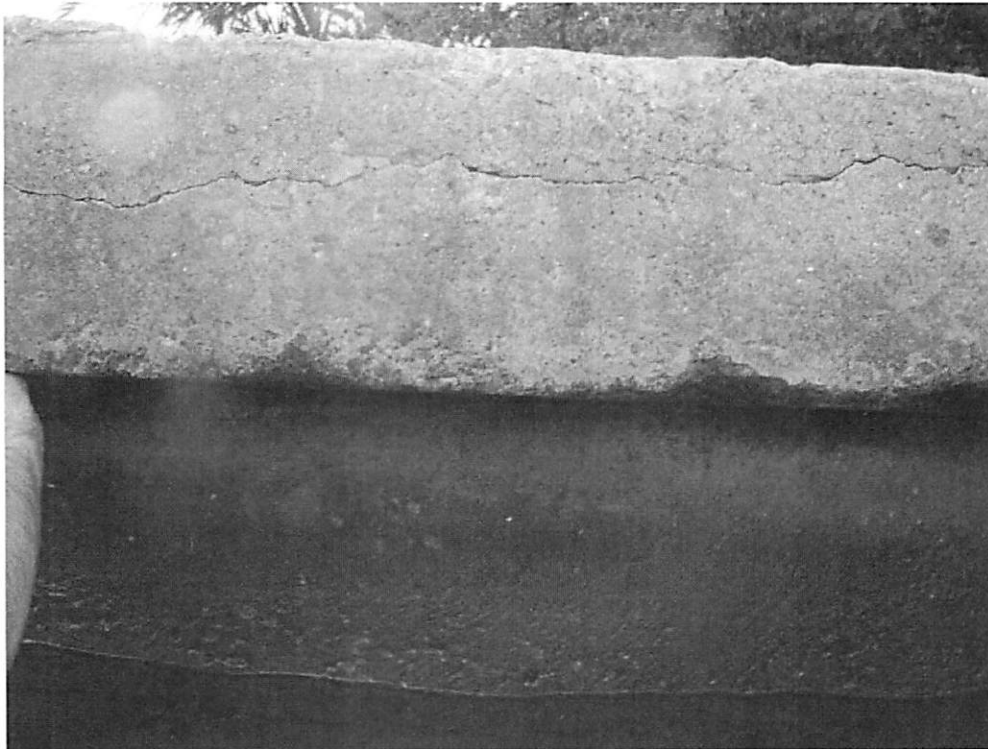
This bulkhead has concrete sheet piles with an older concrete cap and H-piles. There is a drainage outfall in the center of the bulkhead that is overgrown with mollusks. There doesn't appear to have been any repairs conducted on this bulkhead and the soil behind it is badly washed away. There is some longitudinal cracking along the cap (*See Photo 10.1*), but there is almost no seepage of rust from the reinforcement, so the cracks may be fairly new.

*Photo 10.1: Longitudinal Cracking Along Cap*

This bulkhead is a candidate for repair, rather than replacement. An epoxy-grout may be used to seal some of the cracks that have appeared in the cap and prolong the bulkhead's useful life.

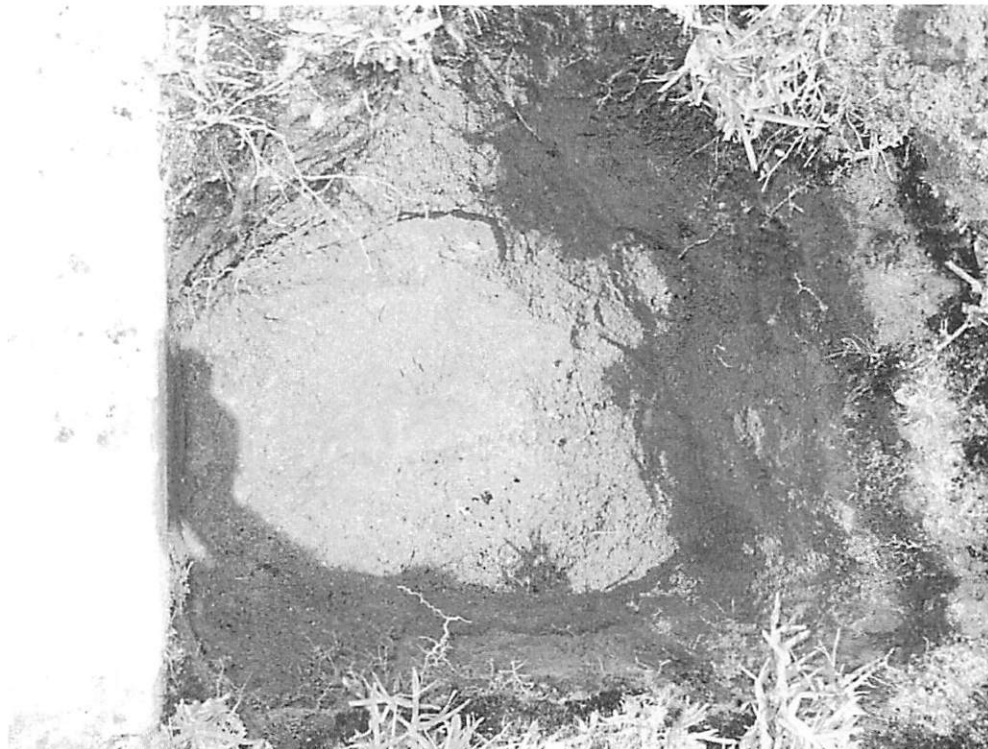
Efforts were made to excavate a tie rod for inspection. The rod was found to be encased in a thick layer of concrete (*See Photo 10.2*). It is assumed that this was part of the bulkhead's plans as a means of protecting the tie rod from corrosion.

*Photo 10.2: Concrete-Encased Tieback Rod*

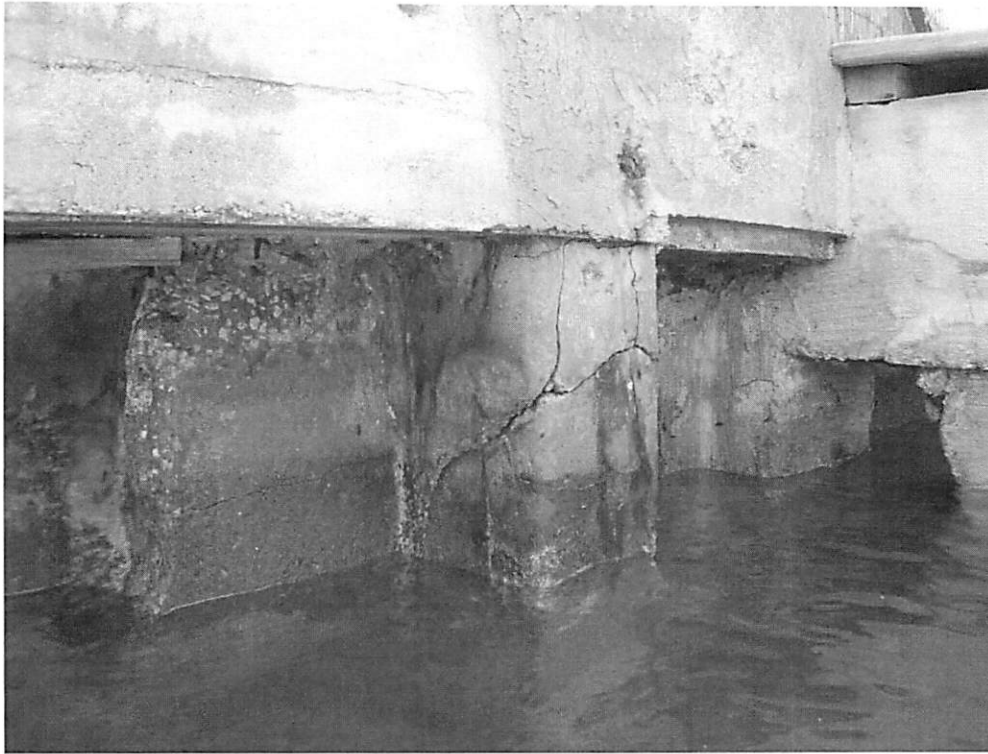
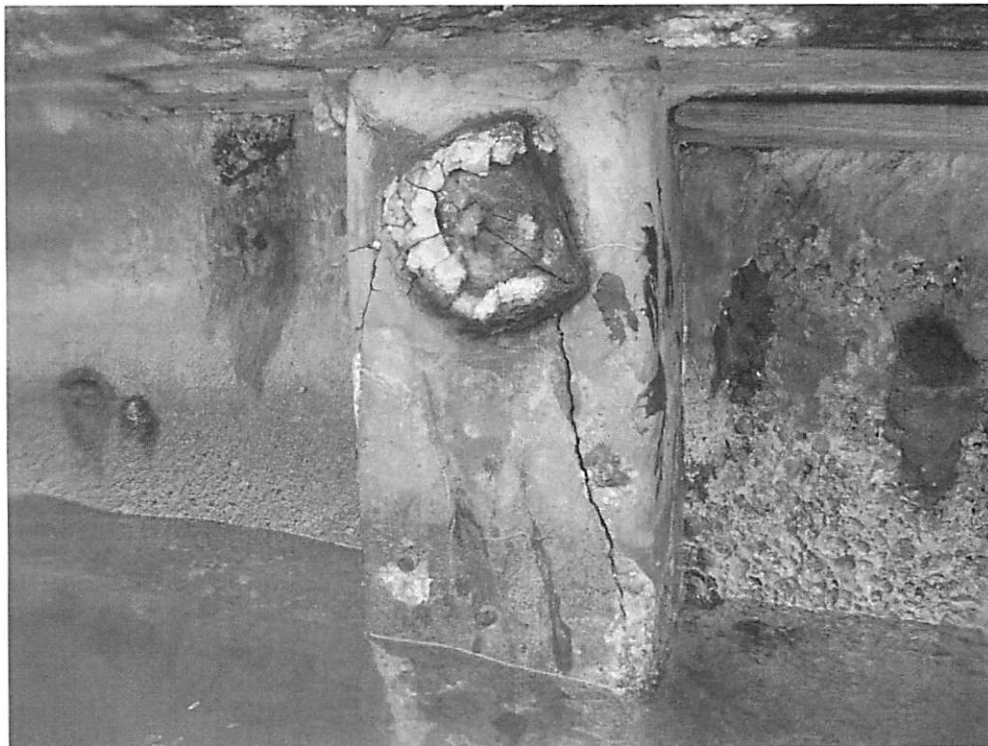
This bulkhead contains king piles supporting concrete sheet piles. Many of the king piles are severely cracked (*See Photos 11.1, 11.2*) around the tiebacks to the extent of sacrificing structural viability. Much of the steel reinforcement contained within all parts of the bulkhead is corroded with rust exiting through cracks in the bulkhead (*See Photos 11.1-11.6*).

*Photo 11.1: Cracking in King Pile*

*Photo 11.2: Cracking in King Pile, Spalling Cap*

This bulkhead is highly deteriorated and should be replaced.

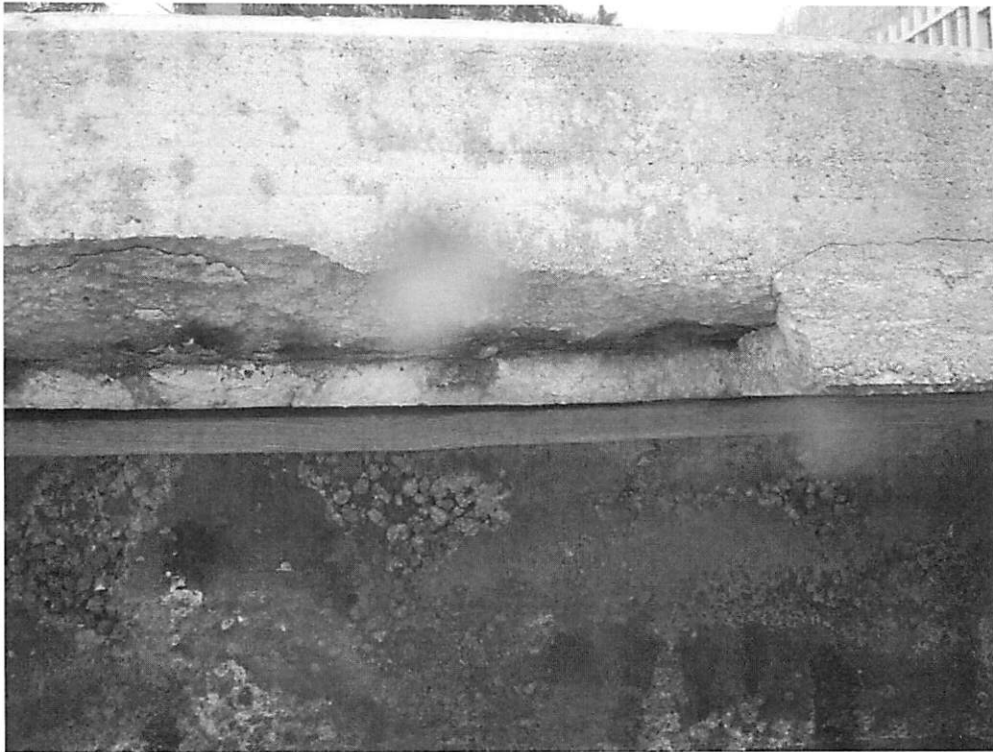
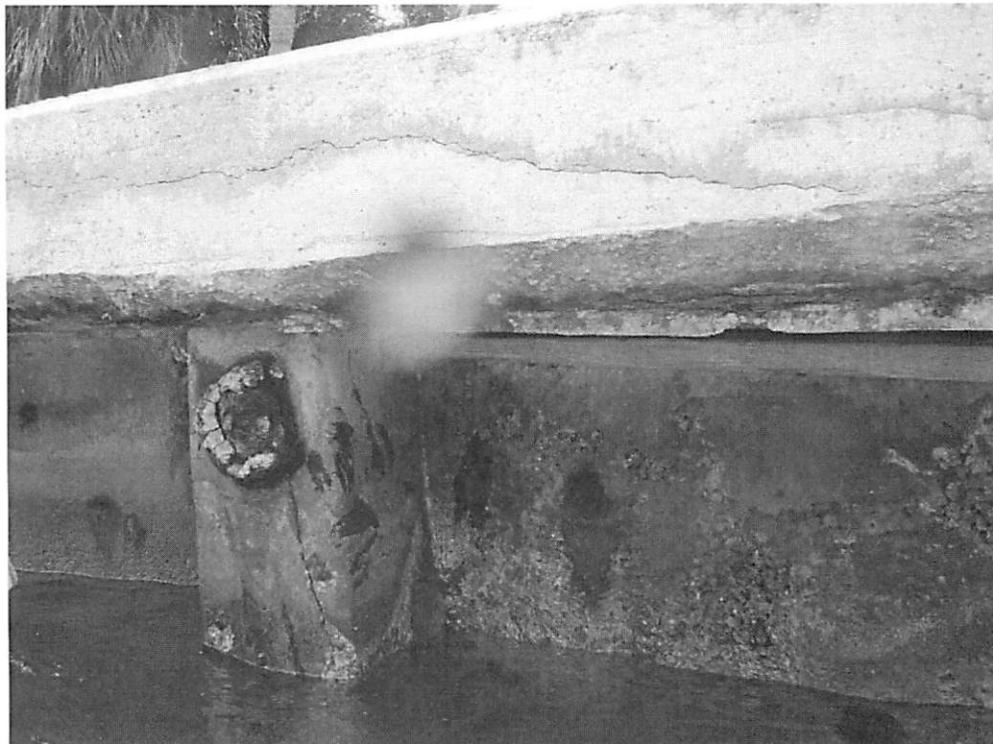
In some areas, the binder has eroded away from the sheets piles, exposing the aggregate (*See Photos 11.3, 11.4*). A newer cap was added at some point, but the bottom of the cap has broken away due to spalling, exposing the lower layer of steel reinforcement and subjecting it to further corrosion (*See Photos 11.3, 11.4*). Though the cap appears to be younger than the king piles and sheet piles, there are cracks in the cap that run perpendicular to the face and pass all the way through the cap.

*Photo 11.3: Degraded Sheet Piles, Spalling Cap*

*Photo 11.4: Cracking in King Pile & Cap, Degraded Sheet Piles*
