**Project Title: Bulkhead Grant Application and Construction Application (CGA Project No.: 12-4952)**

This report summarizes an inspection performed on municipally owned bulkheads in the Town of Surfside and makes recommendations for their repair or replacement.

Bulkhead 1, Carlyle Ave & 88<sup>th</sup> St.

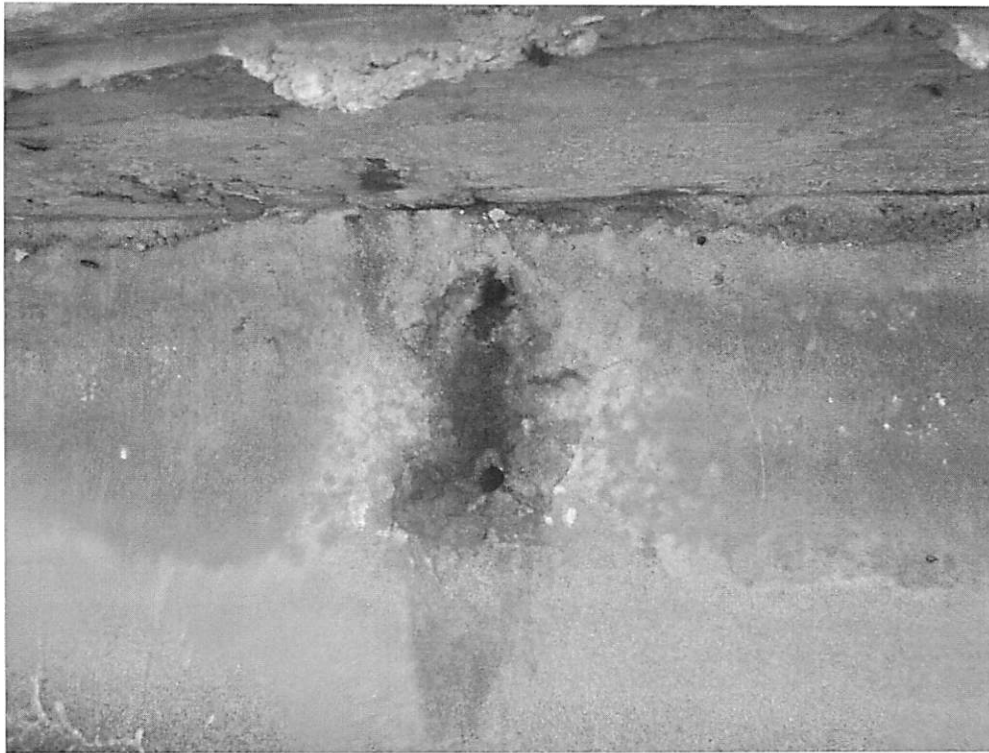
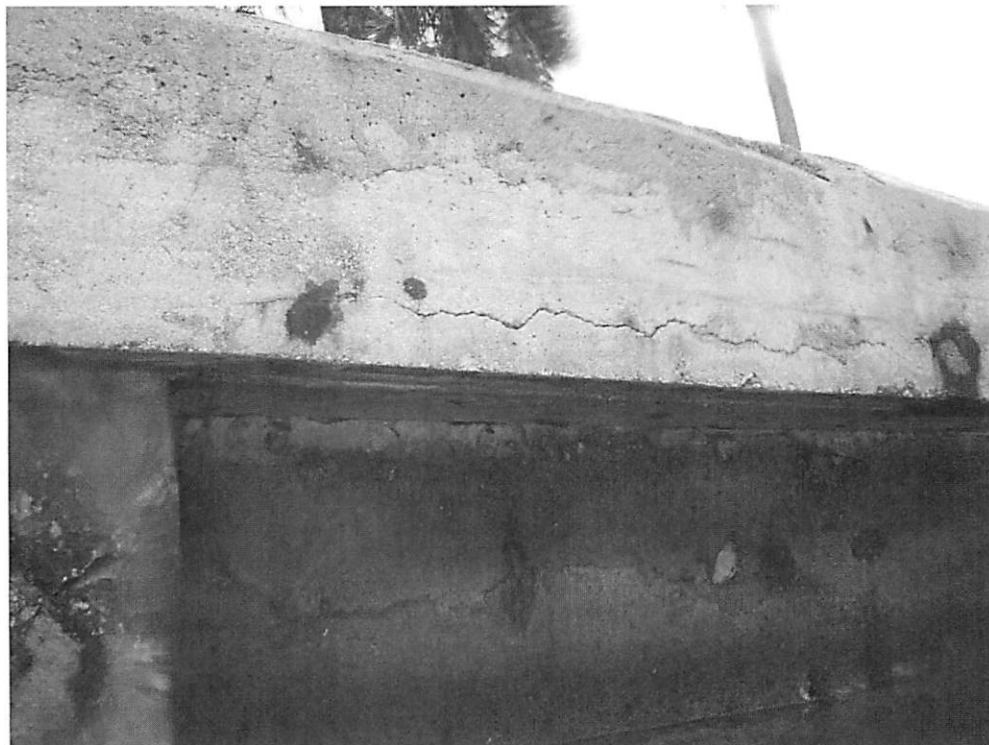
This bulkhead contains king piles supporting concrete sheet piles. Many of the king piles are severely cracked (*See Photos 11.1, 11.2*) around the tiebacks to the extent of sacrificing structural viability. Much of the steel reinforcement contained within all parts of the bulkhead is corroded with rust exiting through cracks in the bulkhead (*See Photos 11.1-11.6*).

*Photo 11.5: Rusted Steel Reinforcement Leaking Through Wall*

*Photo 11.6: Spall Cracking in Cap, Rusted Reinforcement*

This bulkhead is highly deteriorated and should be replaced.

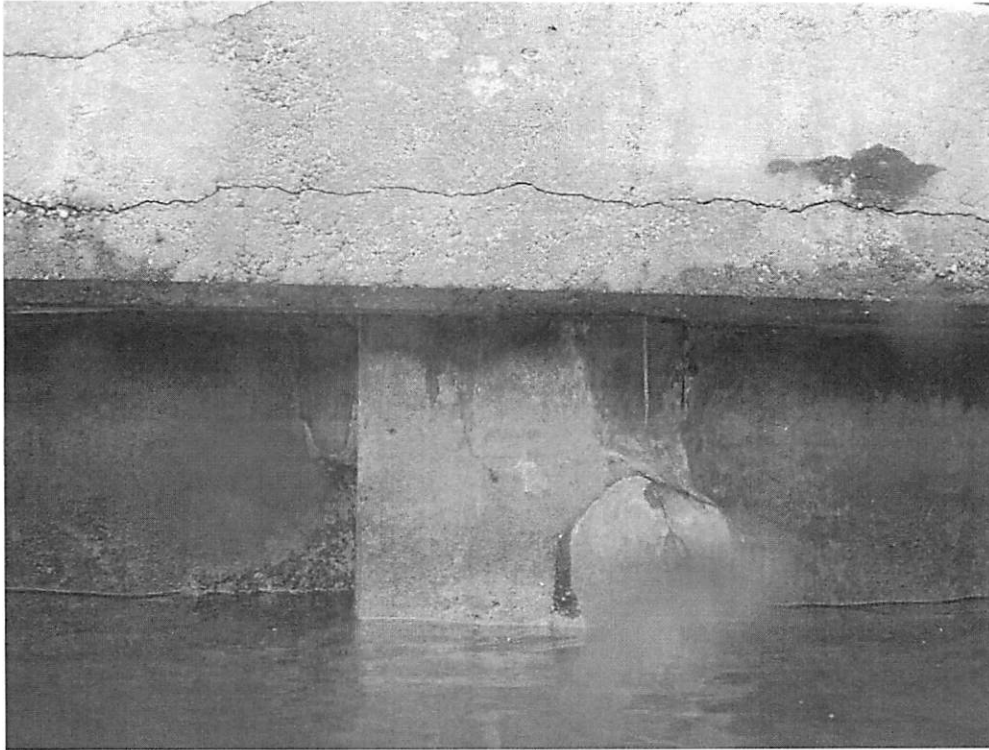
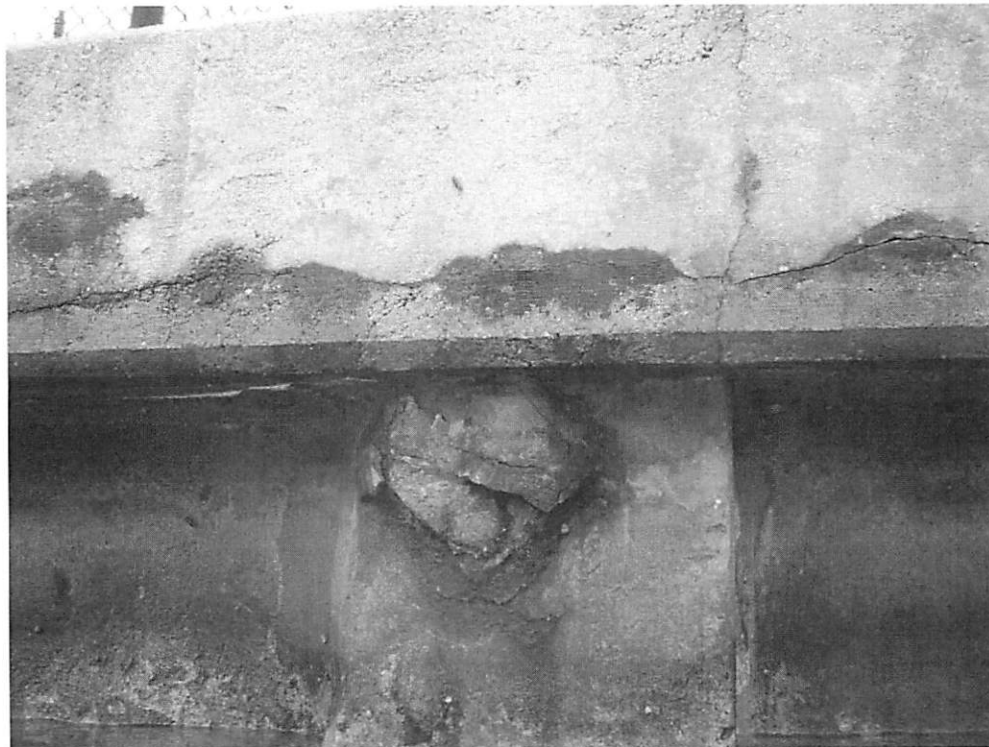
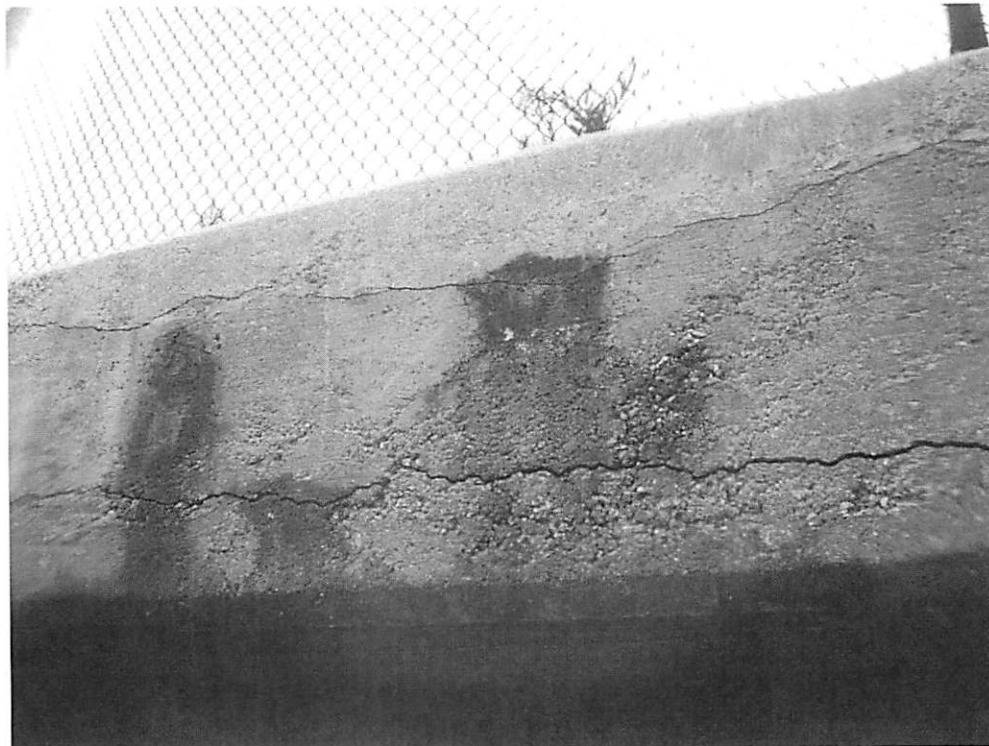
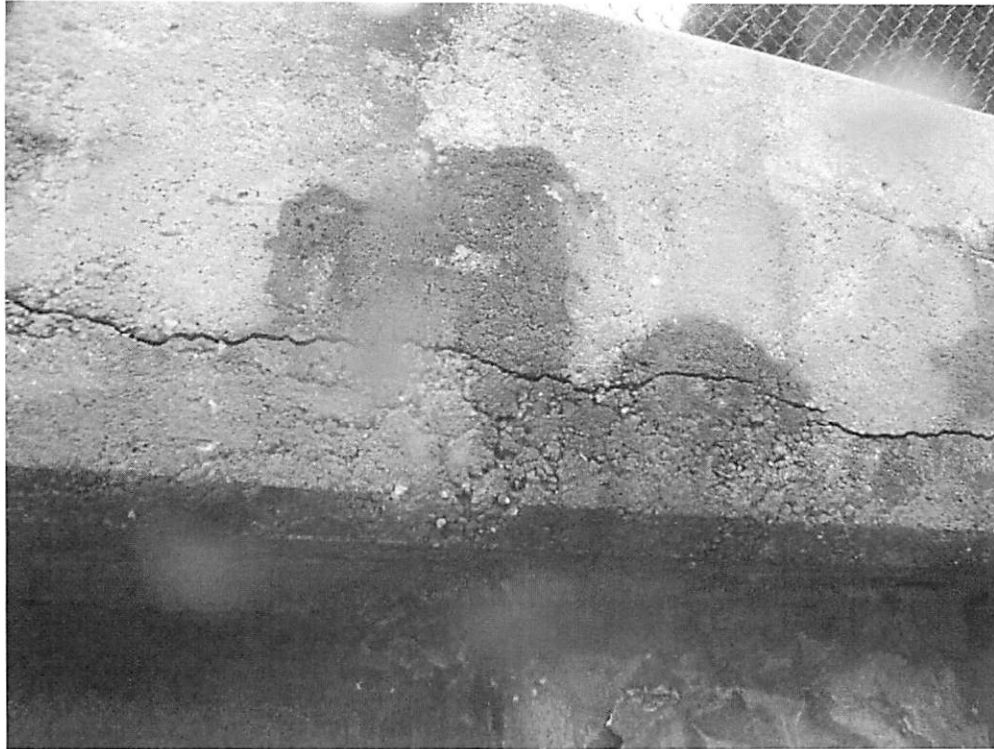
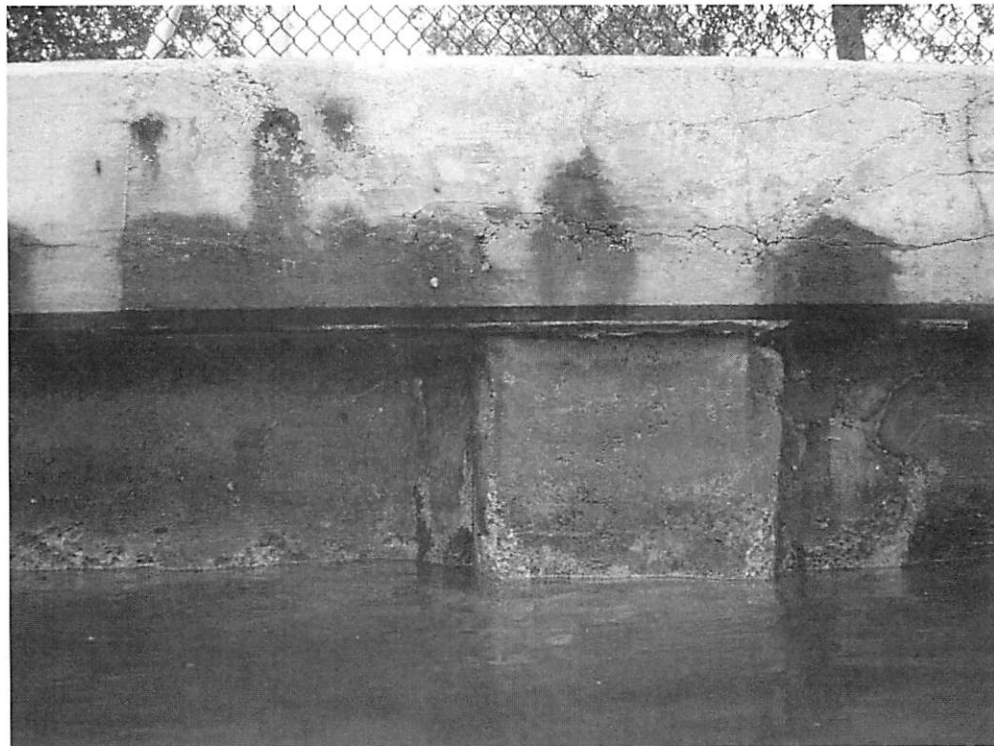
Another apparent failure existing in the bulkhead is a longitudinal crack beneath the central axis of the cap that runs nearly the entire length of the bulkhead (*See Photos 12.1, 12.2, 12.4-12.6*). This crack is likely due to improper coverage of concrete over the steel reinforcement. As with other areas discussed in this report, cracks like this allow rain and saltwater to enter the concrete cap. When this water reaches the steel reinforcement, it causes it to swell and rust. This rust is present on nearly the entire length of the crack.

*Photo 12.1: Longitudinal Spall Cracking in Cap, Rusted Reinforcement, Tieback Not Centered*

*Photo 12.2: Longitudinal Spall Cracking in Cap, Rusted Reinforcement*

*Photo 12.4: Longitudinal Spall Cracking in Cap, Rusted Reinforcement*

*Photo 12.5: Longitudinal Spall Cracking in Cap, Rusted Reinforcement*

*Photo 12.6: Longitudinal Spall Cracking in Cap, Rusted Reinforcement*

At a minimum, the concrete should be broken away from the steel where the longitudinal crack is present and the cap should be cast to provide adequate coverage to the steel reinforcement. This should help to prevent saltwater and freshwater intrusion. It should also be noted that there are areas of spalling beneath the Kane Concourse/96<sup>th</sup> St. Bridge which adjoins Surfside Park bulkhead to the north (*See Photo 12.7*). Some of the concrete has been broken away so much that the entire steel reinforcement cage may be seen. It is assumed that the portion of the bulkhead belongs to FDOT and is not the immediate responsibility of the Town of Surfside.

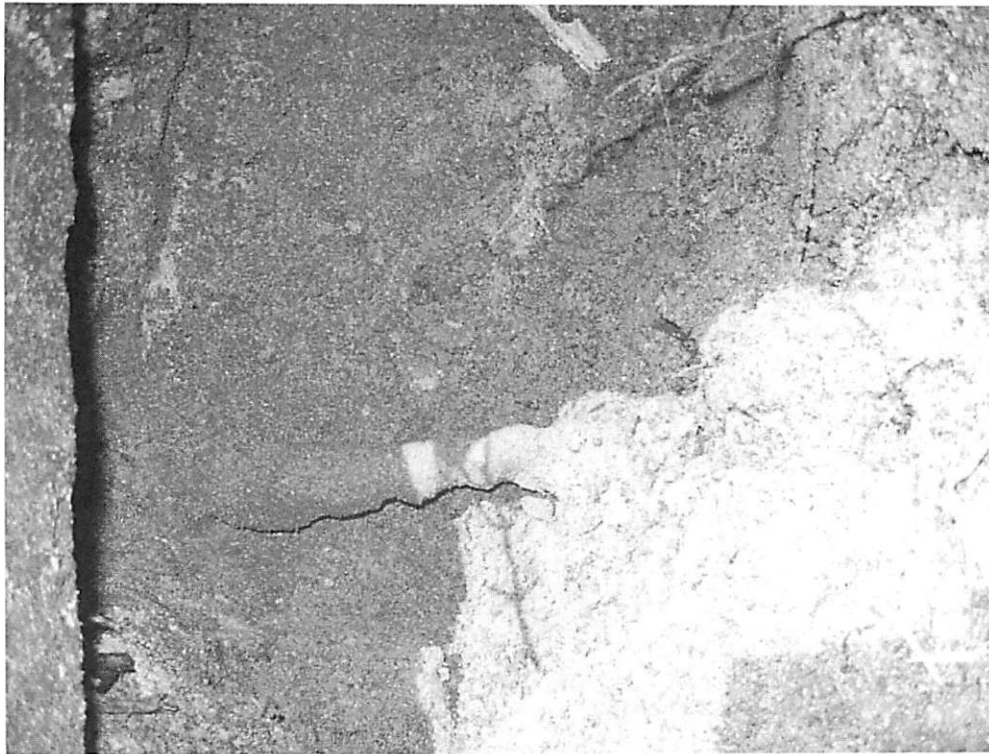
The section of bulkhead running along Surfside Park is made up of concrete H-piles and concrete sheet piles. The bulkhead is in fair condition with some cracking and rusting present in the sheet piles and around the tiebacks. Some patchwork exists throughout the bulkhead. Many of the tieback rods pass through the bulkhead at abnormal locations (*See Photo 12.1*), rather than through the conventional center of the H-pile supports. Most of the tieback ends have been covered with mortar that is now chipping away (*See Photos 12.1, 12.2*). This mortar may need to be chipped away and replaced. One tieback rod was dug up, and appeared to be in good condition, though the area around it had washed away considerably (*See Photo 12.3*).

*Photo 12.3: Excavated Tieback Rod in Good Condition*

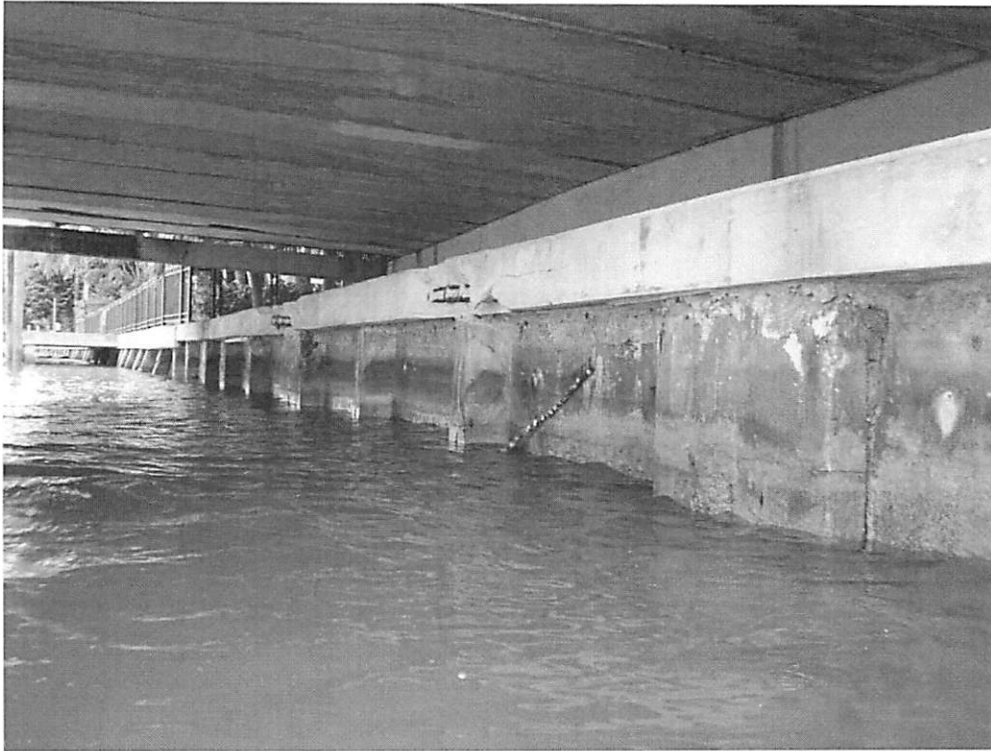
*Photo 12.7: Longitudinal Spall Cracking in Cap beneath FDOT Bridge*
