Subject: **Town of Surfside – Emergency Operations Center Adaption Plan
Feasibility Report**

Town of Surfside - Emergency Operations Center Adaption Plan Feasibility Report

Kimley»Horn

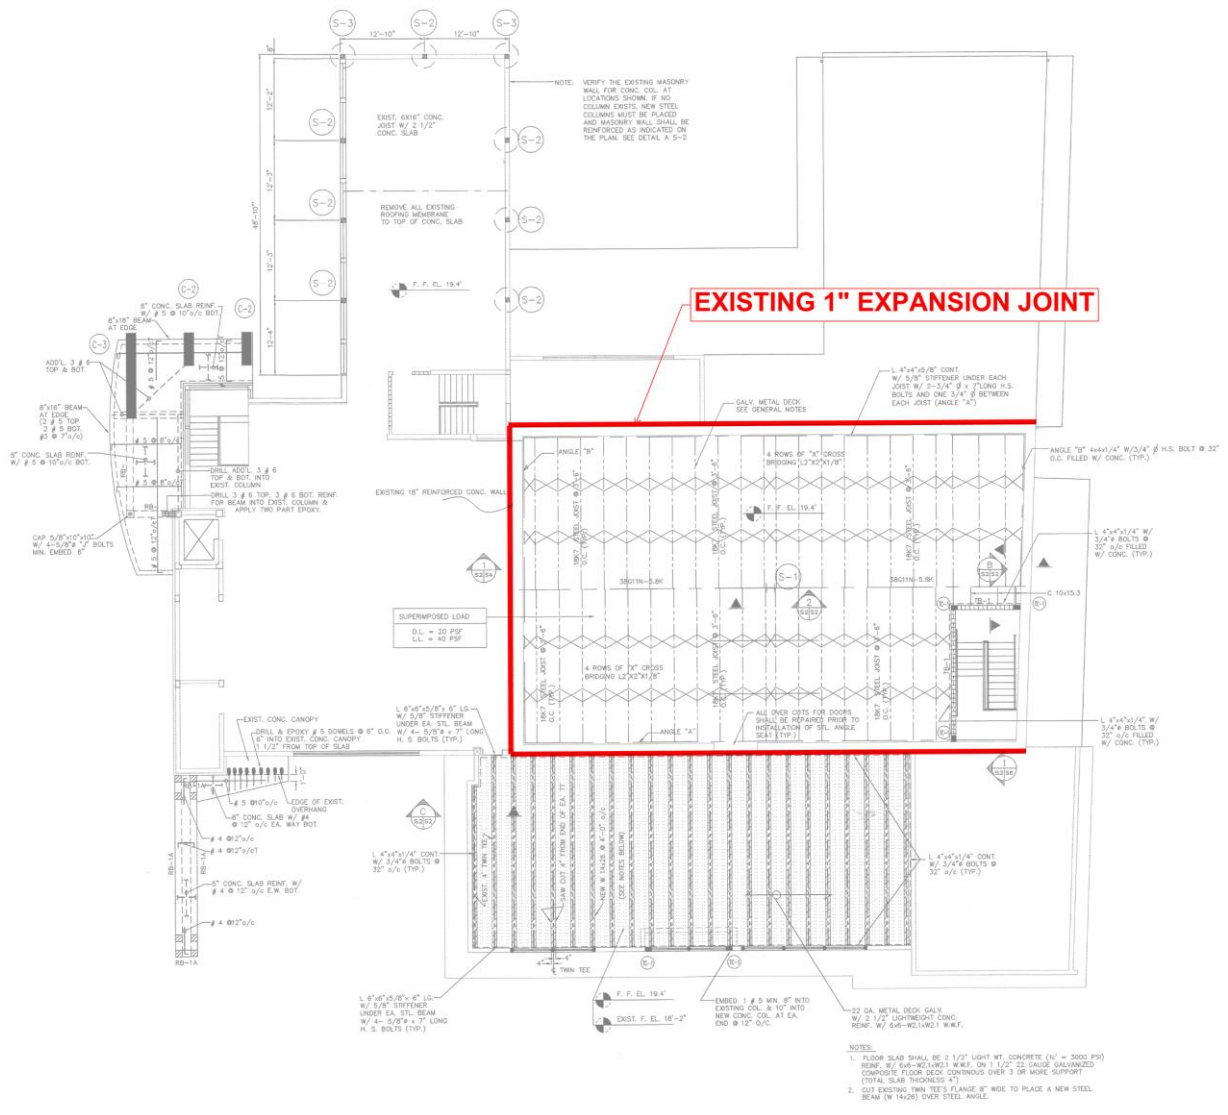
FIGURE 2: LOCATION OF 1" EXPANSION JOINT FROM ORIGINAL CONSTRUCTION IN 1957

- **Expansion Joints:** Refer Figure 2 for location of 1" expansion joint between concrete walls for water tank and building structure for town hall from original construction in 1957.

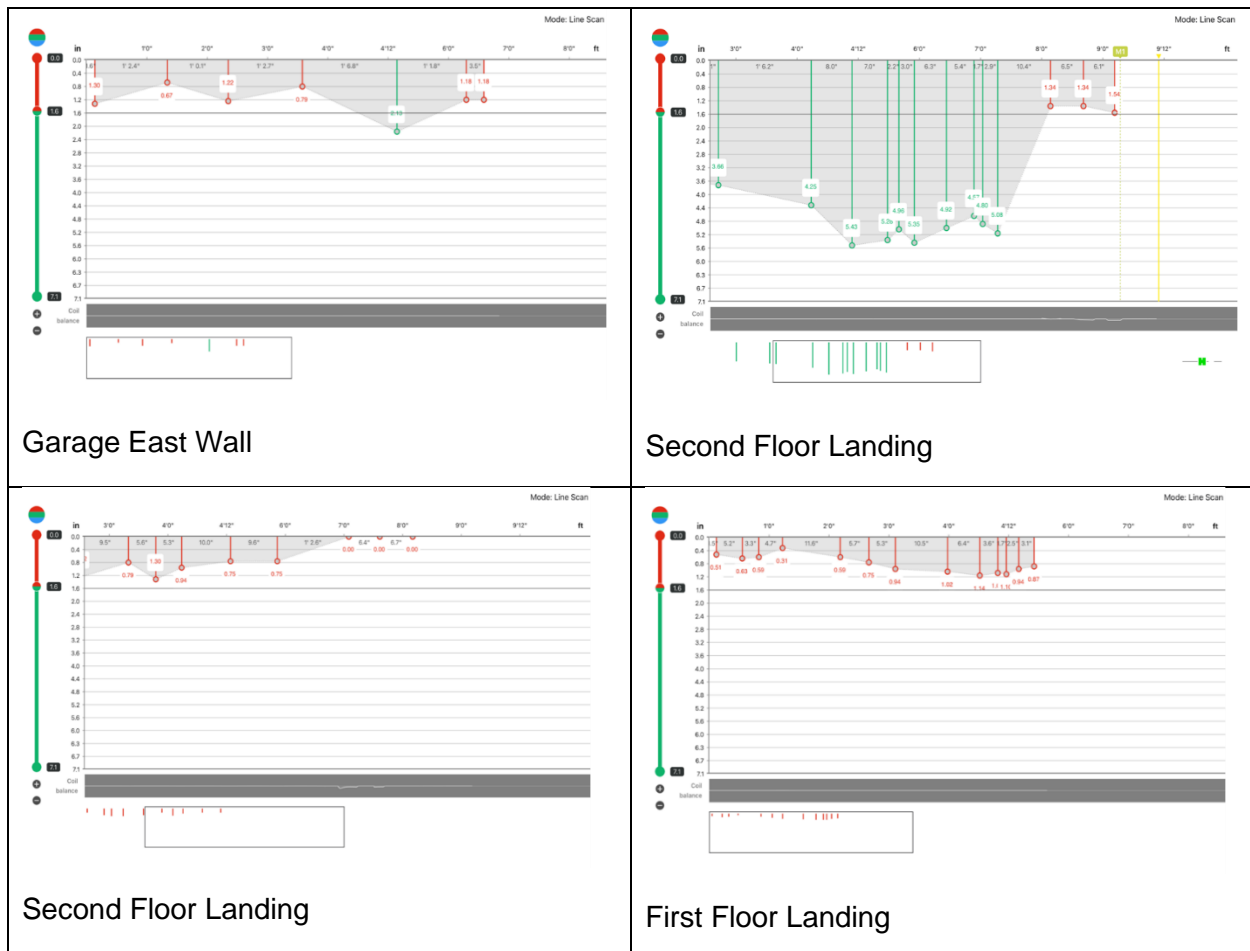
FIGURE 11: SCANS OF FERRO SCANNER TESTS

The results from the ferro scanner confirmed the location and spacing of reinforcement in existing concrete walls. However, the existing size and grade of reinforcement could not be verified due to limitations of the equipment. One potential reason for this inconsistency is the thick layer of stucco on the wall surfaces, which likely interfered with the scanner's ability to obtain accurate measurements. One of the more reliable measurements was taken at the ground floor garage east wall, as shown in Figure 11. The reinforcement was detected at 12-inch intervals, with varying cover depths between 0.79 inches and 1.3 inches.

All other measurements, including two from each floor of the south stairwell, showed inconsistent readings, making it difficult to identify the spacing and diameter of the reinforcement. The observations are recorded in Figure 11 below.

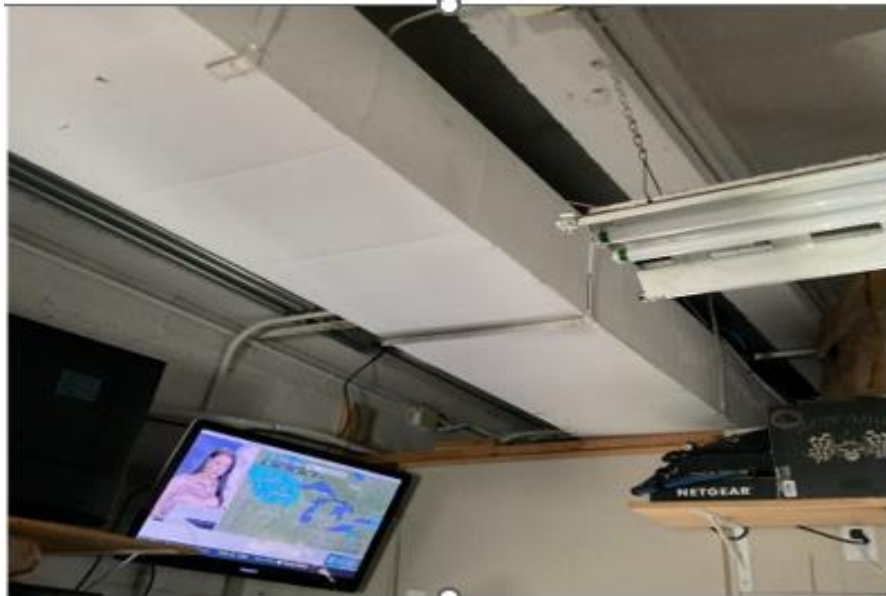
Cast-in-place beams are in good condition, no sign of distress was observed on the few exposed elevated beams.

TYPICAL ELEVATED CONCRETE BEAM IN GOOD CONDITION

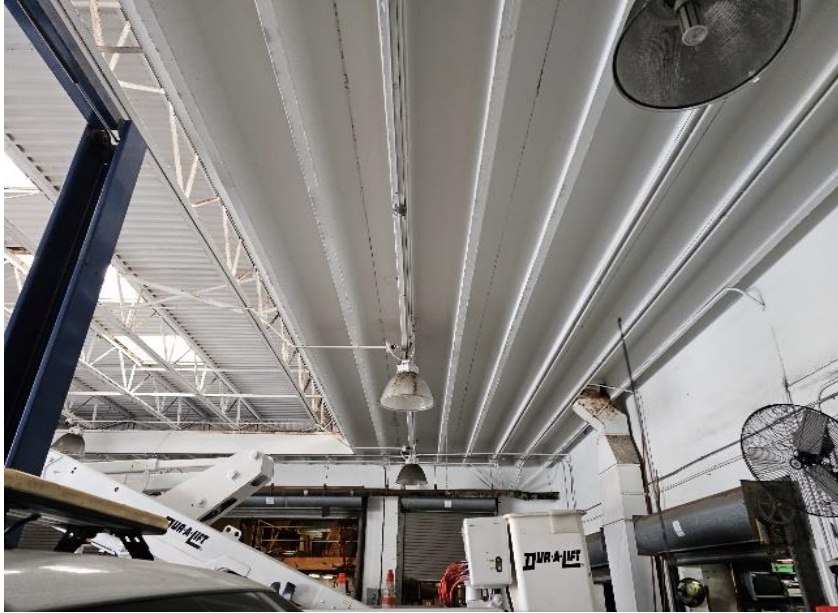
Roof framing system (Double Tees and Joists) were observed in good condition. Connections of Tee's and joints were not accessible and were not observed.

ROOF DOUBLE TEES AT INTERIOR YARD IN GOOD CONDITION

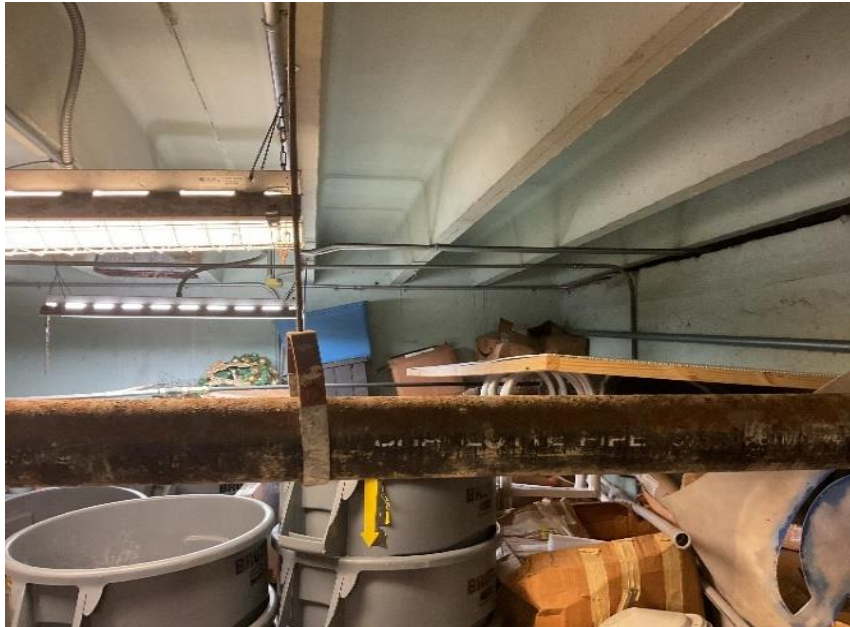
FLOOR DOUBLE TEES IN GOOD CONDITION

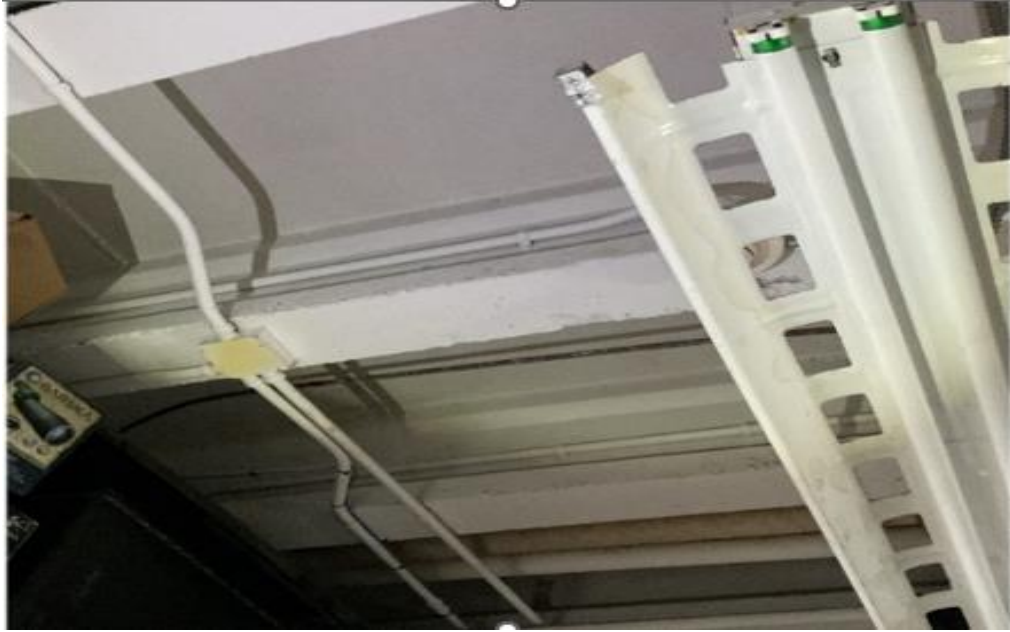
INTERIOR FLOOR PRECAST JOISTS IN GOOD CONDITION

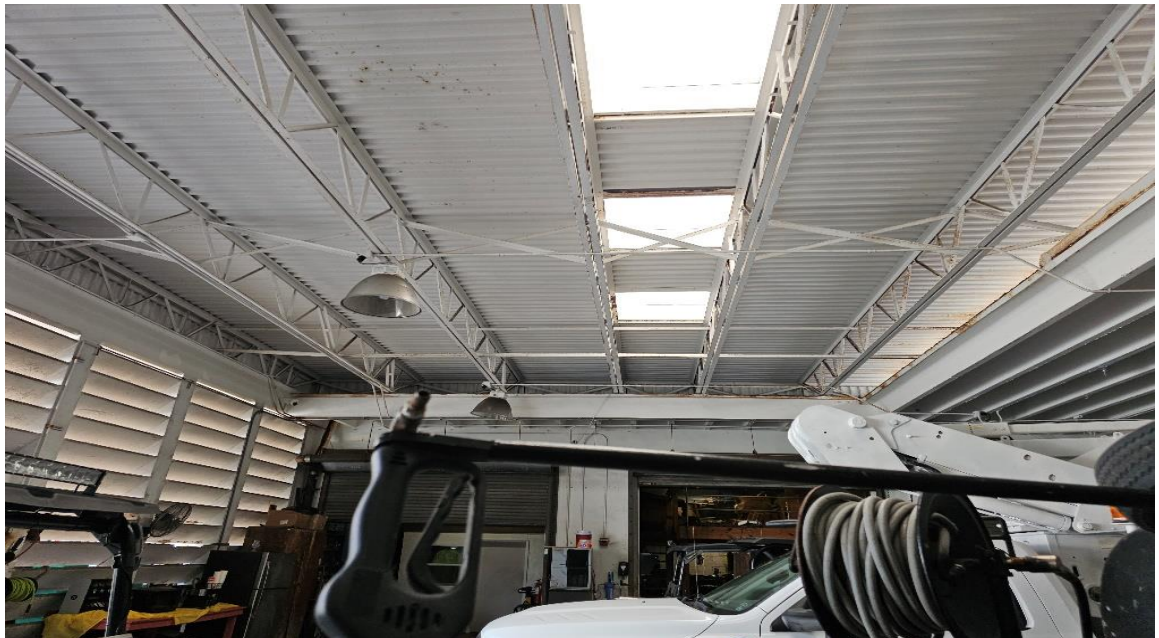
Roof and floor steel joists systems were found to be in good condition. All of the joist bearing locations were in good condition too.

ROOF JOISTS AT INTERIOR YARD IN GOOD CONDITION

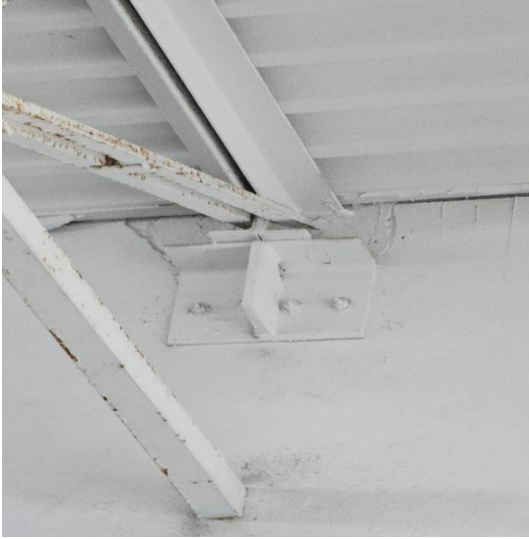
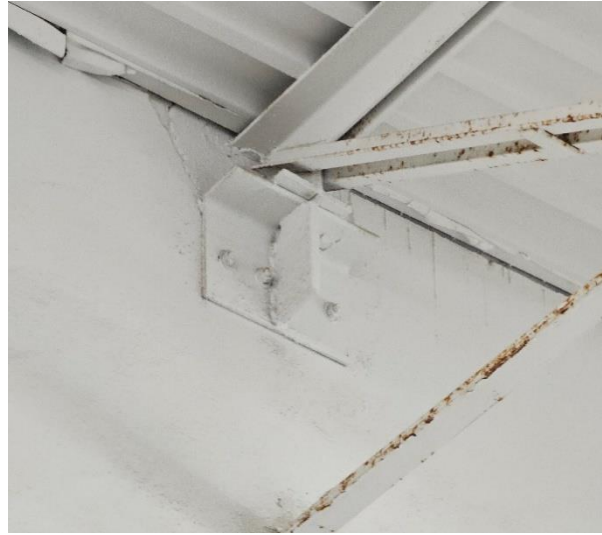
STEEL JOISTS CONNECTION IN GOOD CONDITION

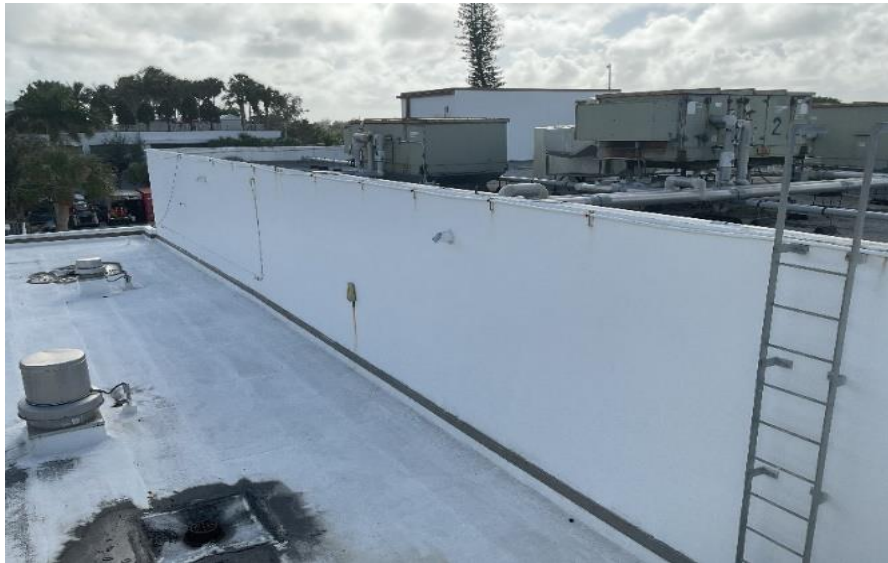
EAST FAÇADE SECOND FLOOR WALL IN GOOD CONDITION

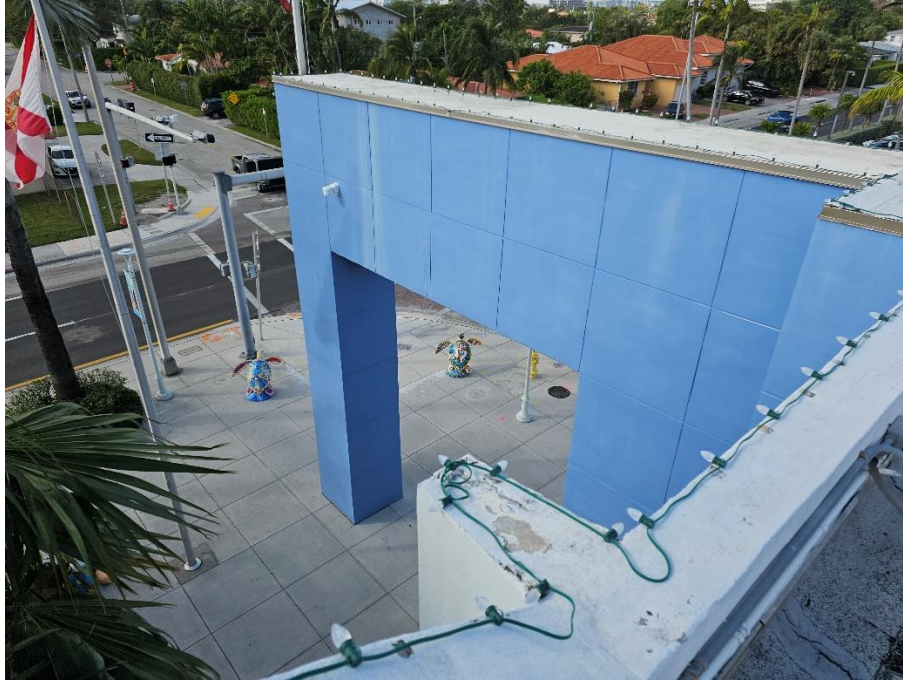
Masonry walls were on fair conditions. No major cracks were detected, but some bulging and stucco delamination was observed.

ENTRANCE WALL AT WEST FACADE IN FAIR CONDITION

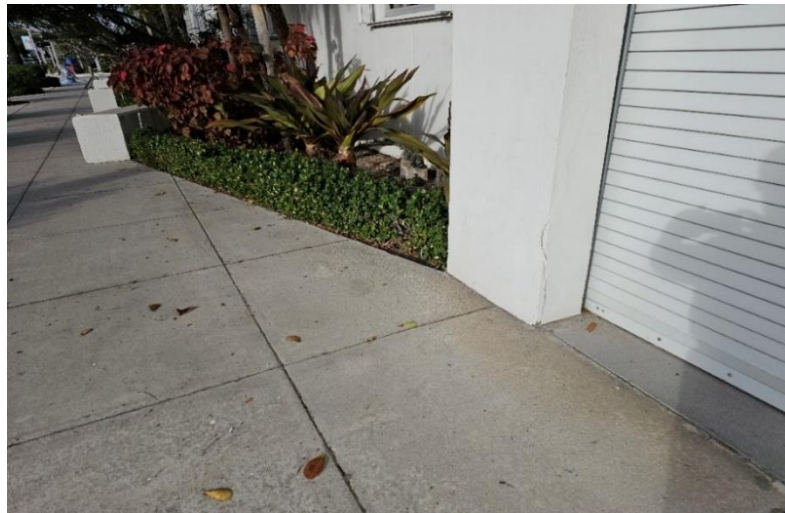
CRACKS OBSERVED AT DOOR JAMB

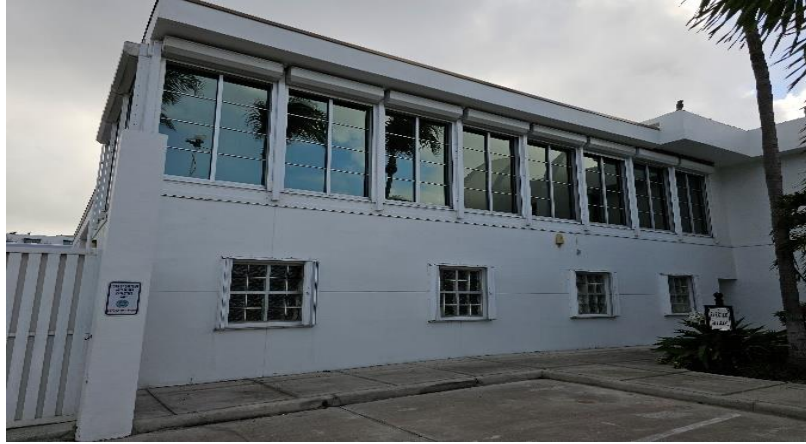
EAST FAÇADE WINDOWS IN GOOD CONDITION

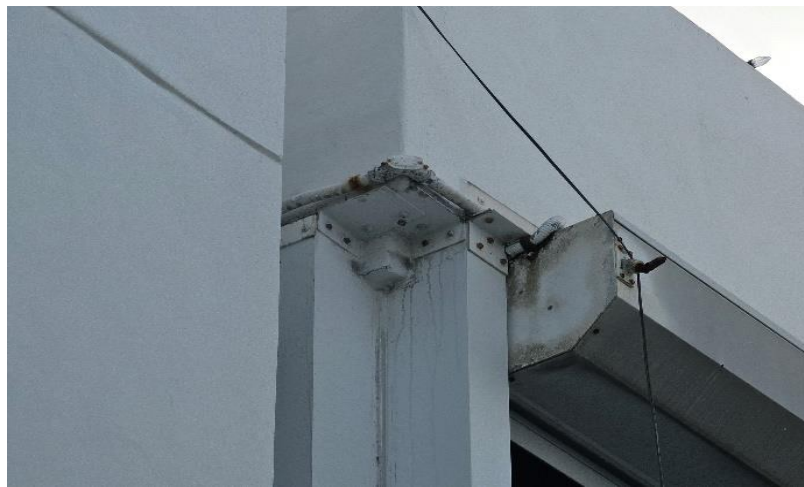
RUST OBSERVED ON EAST ENTRANCE STOREFRONT FRAMING

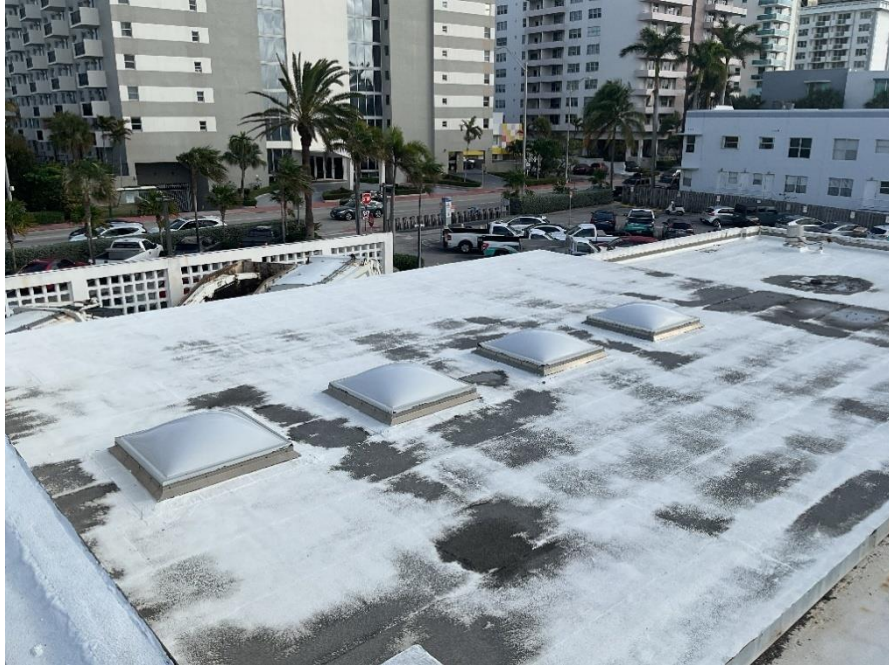
Several areas of bubbling were observed throughout the roof. Roofing also showing signs of cracking, water damage and general deterioration.

EAST LOWER ROOFING SYSTEM SHOWS BUBBLING AND SIGNS OF DETERIORATION

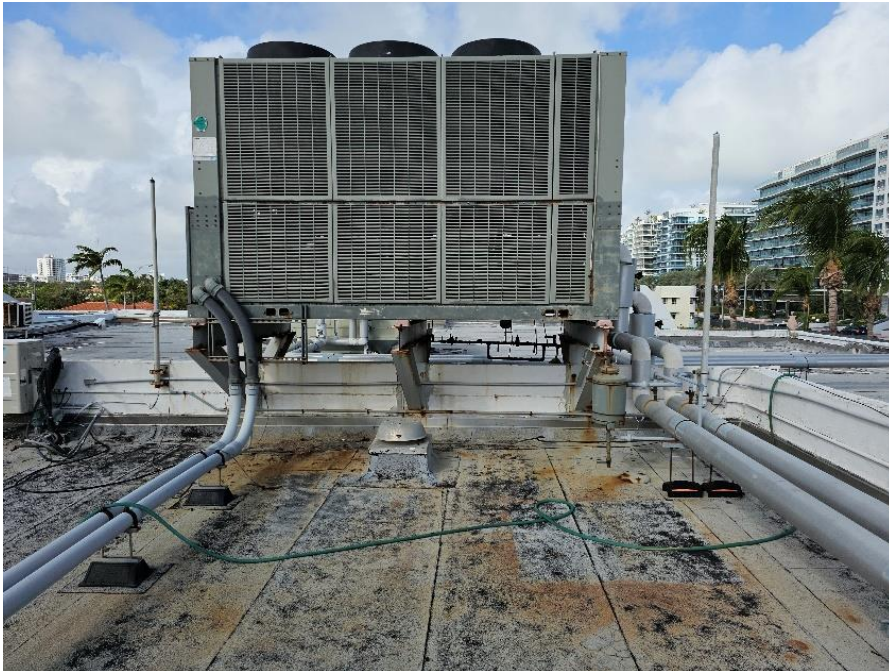
LOSS OF MEMBRANE AND CRACKING WAS OBSERVED IN THE ROOFING SYSTEM

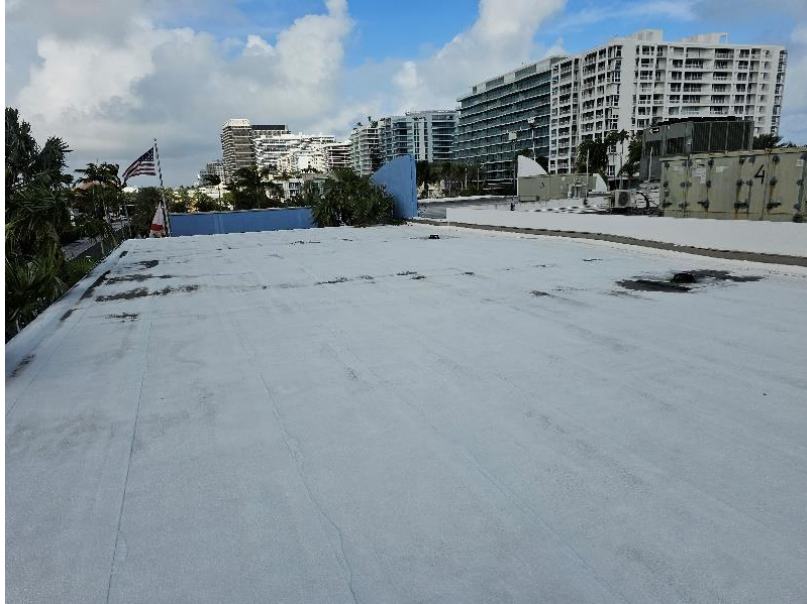
WEST ROOFING SYSTEM IN FAIR CONDITION

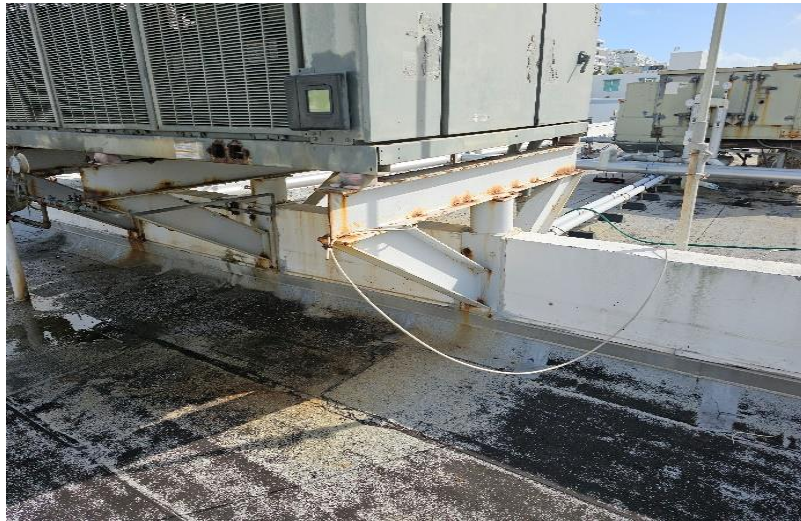
RUST WAS OBSERVED ON THE CHILLERS SUPPORT PLATFORM

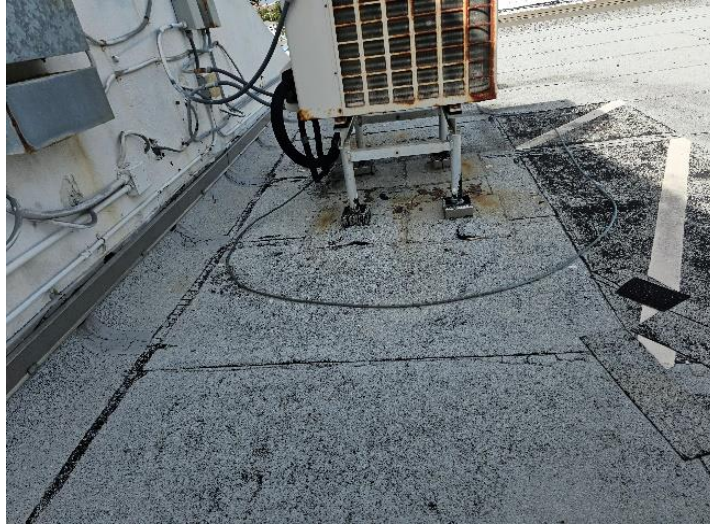
RUST OBSERVED AT RTU BASE CONNECTION

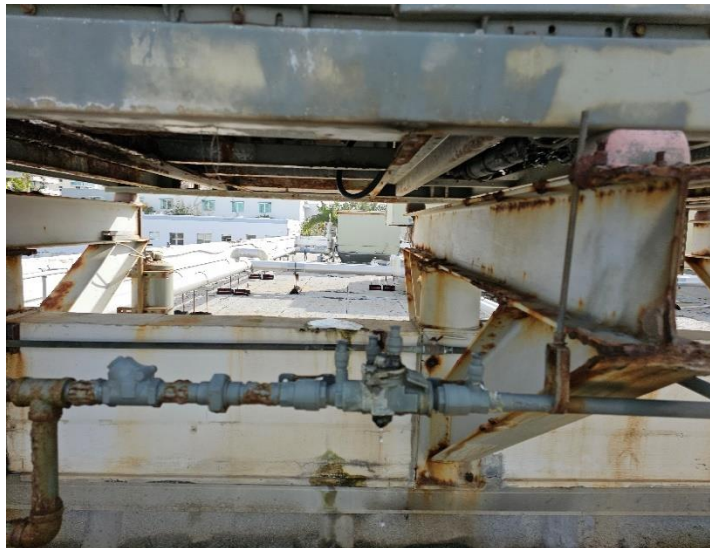
RUST OBSERVED ON THE CHILLERS SUPPORT PLATFORM BEAMS

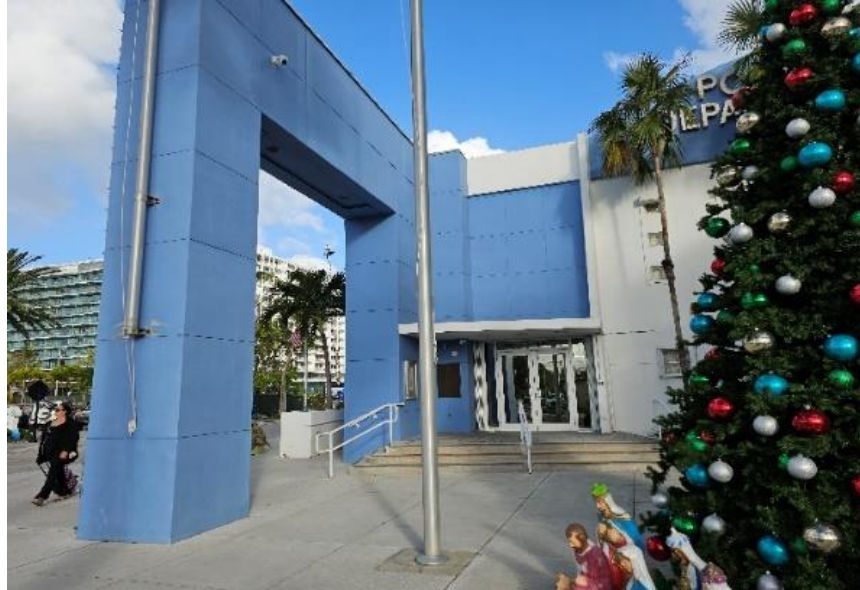
BUILDING WEST ENTRANCE WALL IN GOOD CONDITION

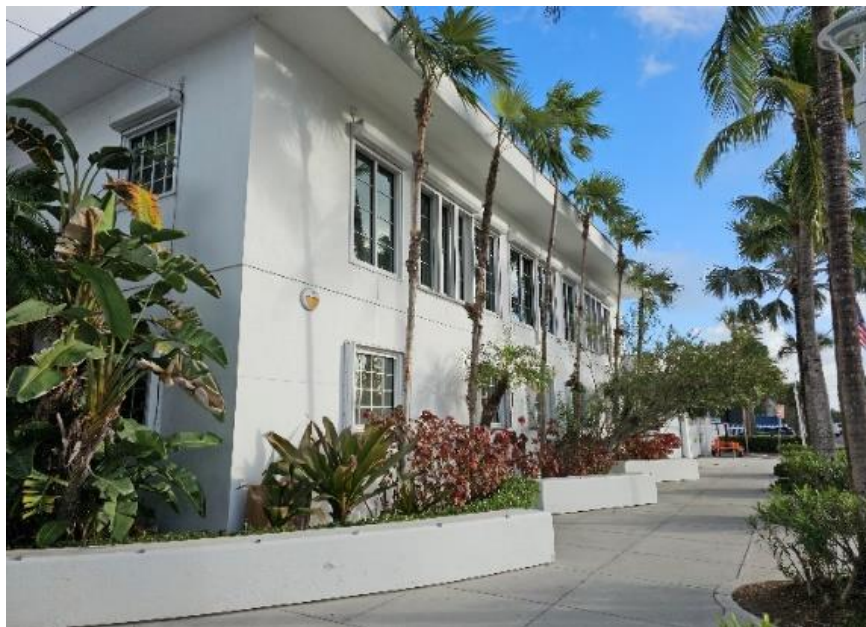
BUILDING WEST FAÇADE IN GOOD CONDITION

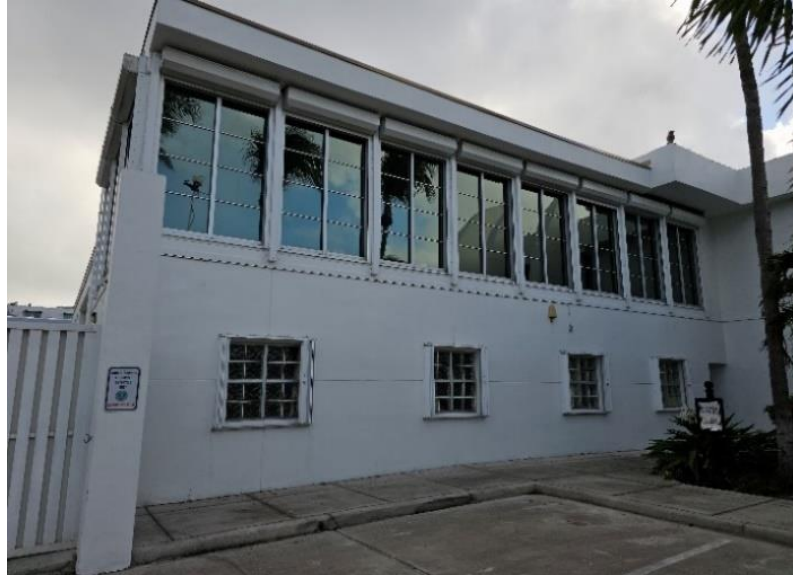
Fine cracks and stucco deterioration in exterior wall finishes, were observed. Paint chipping in certain locations of roof.

BUILDING EAST FAÇADE IN FAIR CONDITION

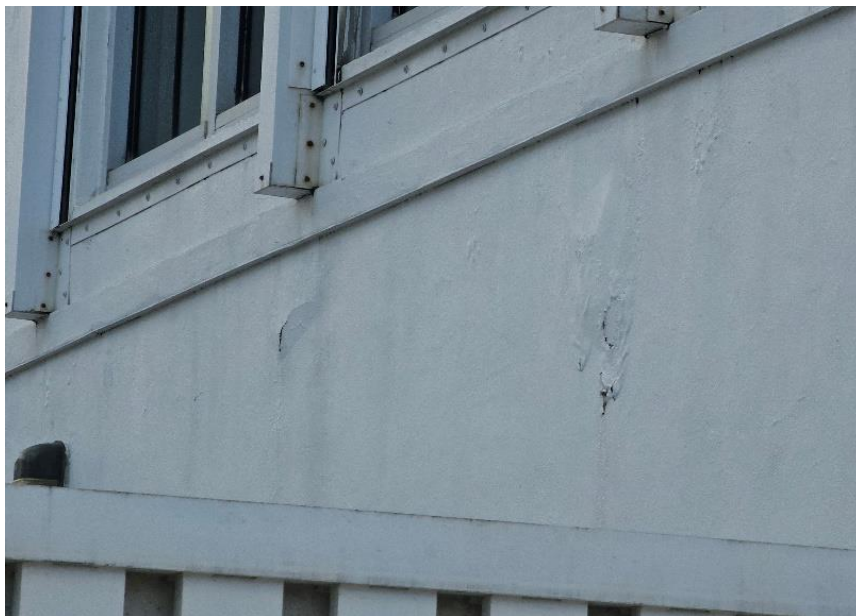
EAST FAÇADE SHOWS SIGN OF STUCCO PEELING AND DETERIORATION
