# Town of Surfside - Emergency Operations Center Adaption Plan

Town of Surfside  
9293 Harding Avenue  
Surfside, Florida 33154

Kimley-Horn and Associates, Inc.  
2 Alhambra Plaza, Suite 500  
Coral Gables, FL 33134

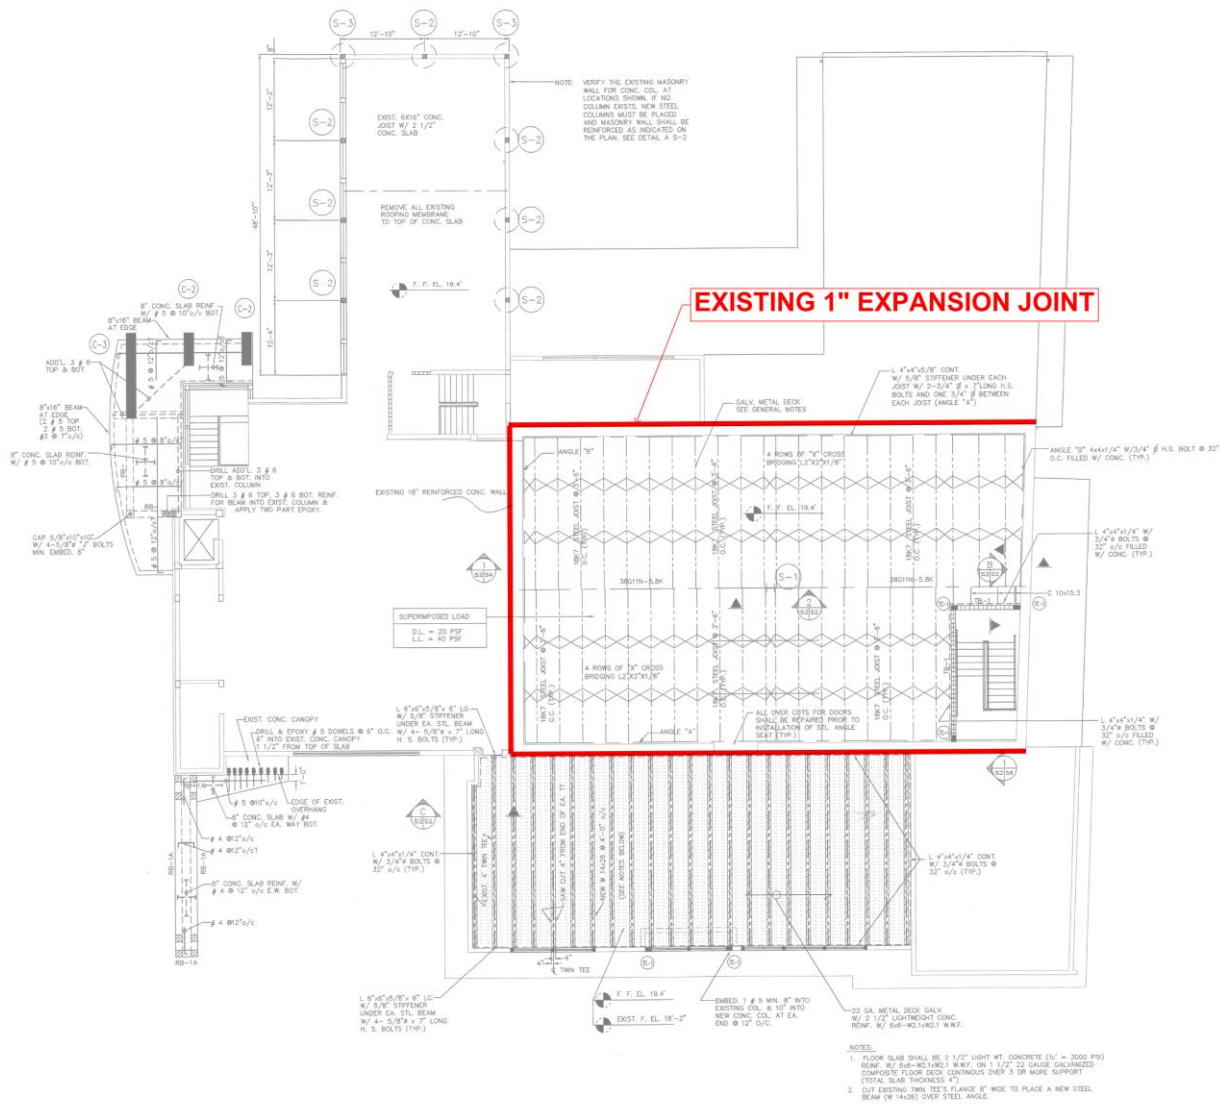
- **Expansion Joints:** Refer Figure 2 for location of 1" expansion joint between concrete walls for water tank and building structure for town hall from original construction in 1957.

**FIGURE 2: LOCATION OF 1" EXPANSION JOINT FROM ORIGINAL CONSTRUCTION IN 1957**

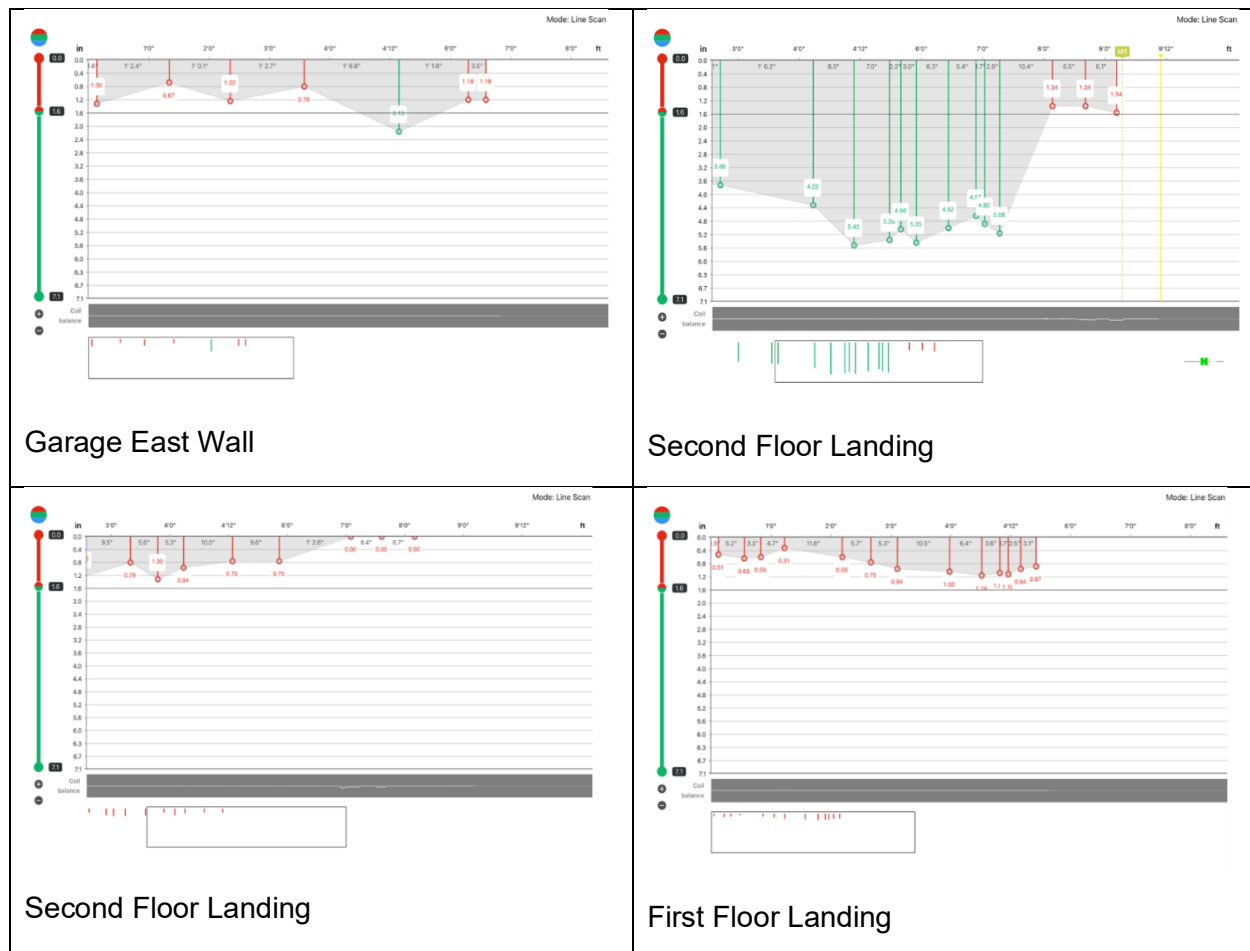
The results from the ferro scanner confirmed the location and spacing of reinforcement in existing concrete walls. However, the existing size and grade of reinforcement could not be verified due to limitations of the equipment. One potential reason for this inconsistency is the thick layer of stucco on the wall surfaces, which likely interfered with the scanner's ability to obtain accurate measurements. One of the more reliable measurements was taken at the ground floor garage east wall, as shown in Figure 11. The reinforcement was detected at 12-inch intervals, with varying cover depths between 0.79 inches and 1.3 inches.

All other measurements, including two from each floor of the south stairwell, showed inconsistent readings, making it difficult to identify the spacing and diameter of the reinforcement. The observations are recorded in Figure 11 below.

FIGURE 11: SCANS OF FERRO SCANNER TESTS

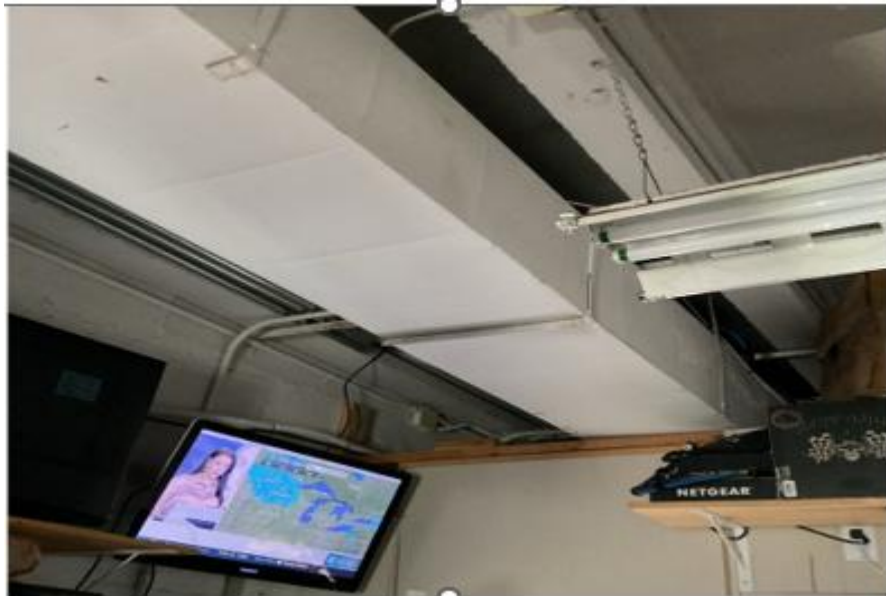
Cast-in-place beams are in good condition, no sign of distress was observed on the few exposed elevated beams.

**TYPICAL ELEVATED CONCRETE BEAM IN GOOD CONDITION**

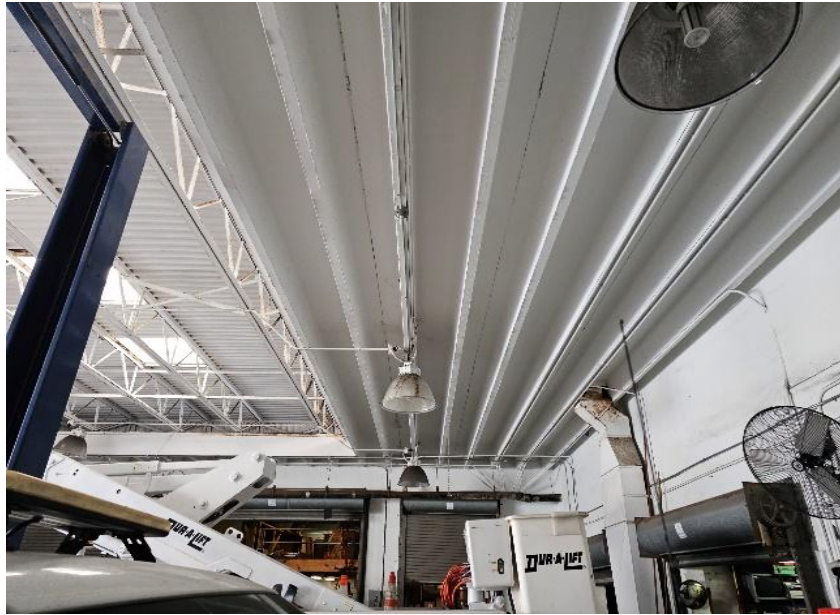
Roof framing system (Double Tees and Joists) were observed in good condition. Connections of Tee's and joints were not accessible and were not observed.

**ROOF DOUBLE TEES AT INTERIOR YARD IN GOOD CONDITION**

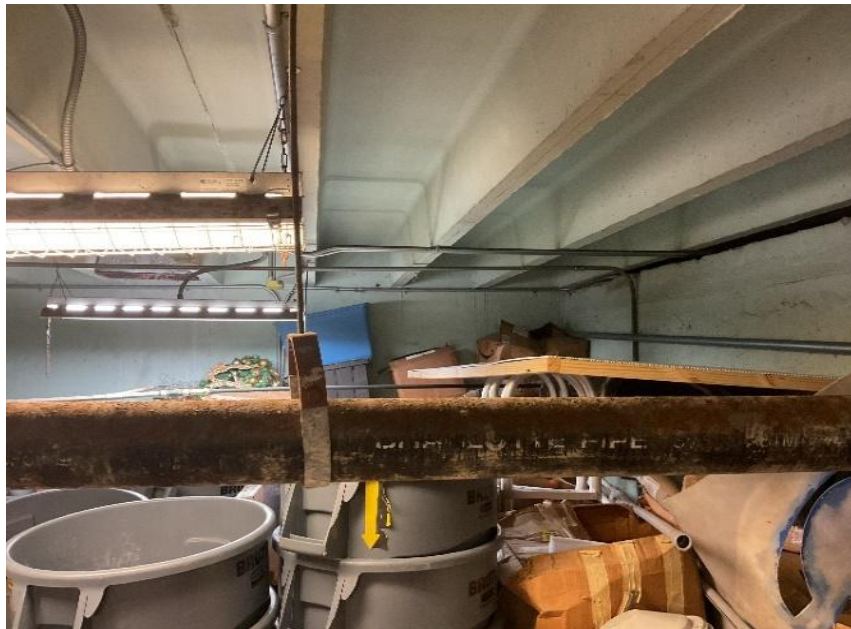
**FLOOR DOUBLE TEES IN GOOD CONDITION**

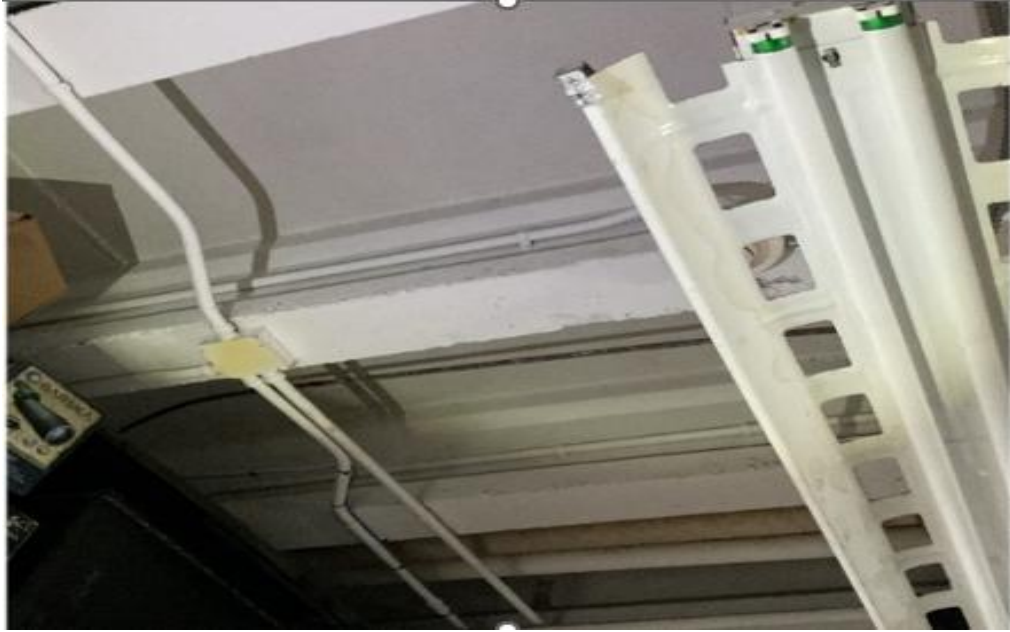
*INTERIOR FLOOR PRECAST JOISTS IN GOOD CONDITION*

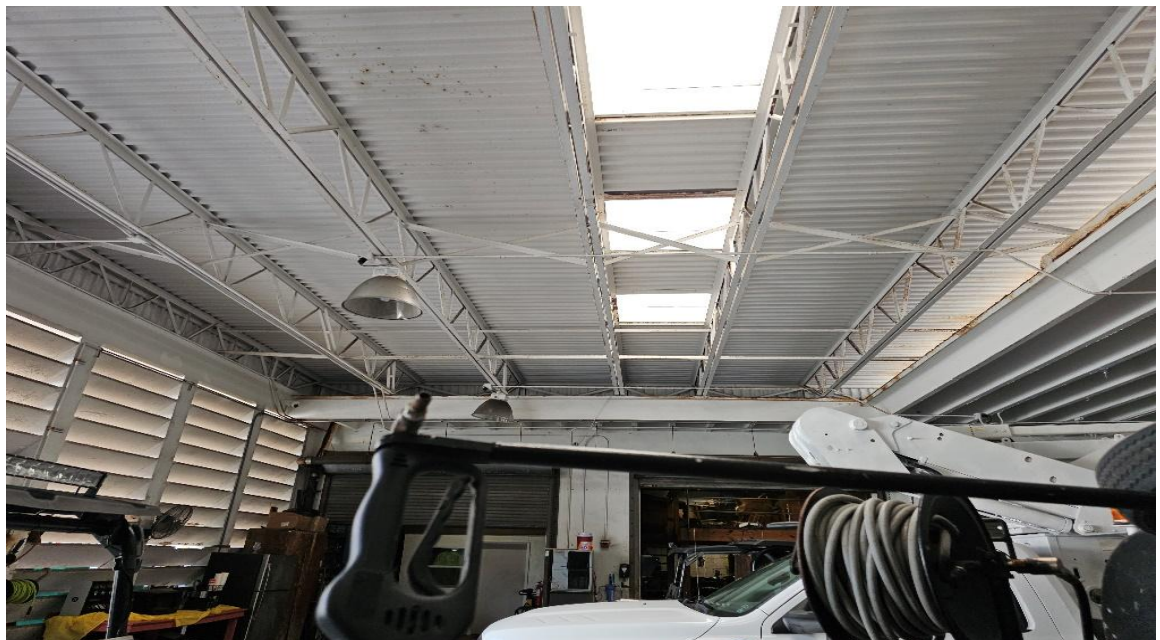
Roof and floor steel joists systems were found to be in good condition. All of the joist bearing locations were in good condition too.

*ROOF JOISTS AT INTERIOR YARD IN GOOD CONDITION*

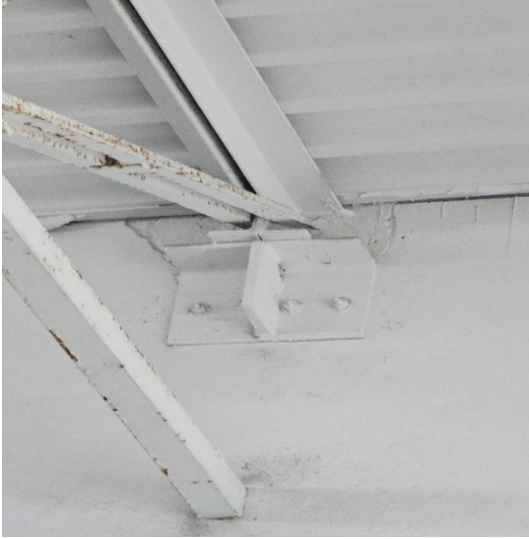
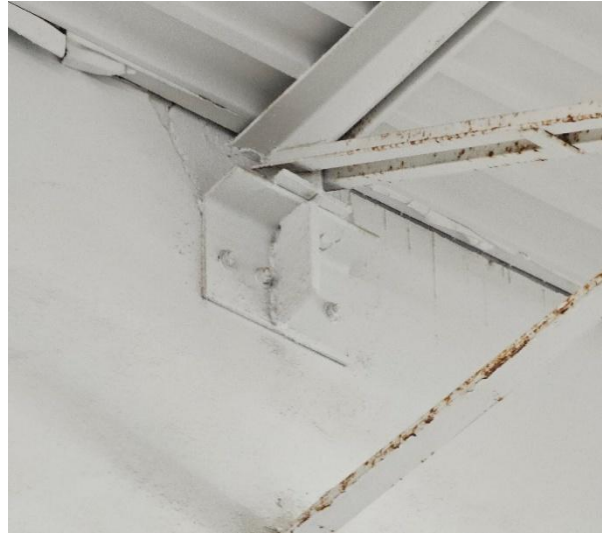
*STEEL JOISTS CONNECTION IN GOOD CONDITION*

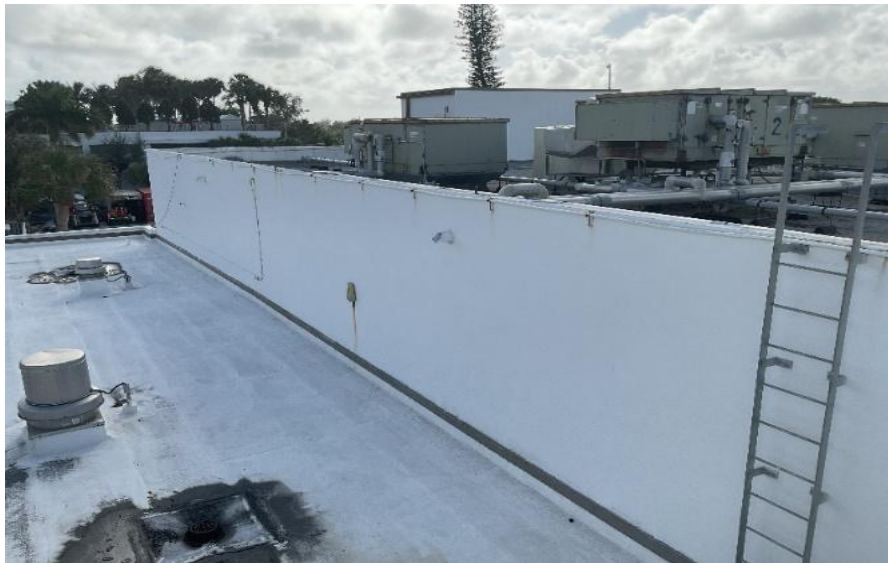
*EAST FAÇADE SECOND FLOOR WALL IN GOOD CONDITION*

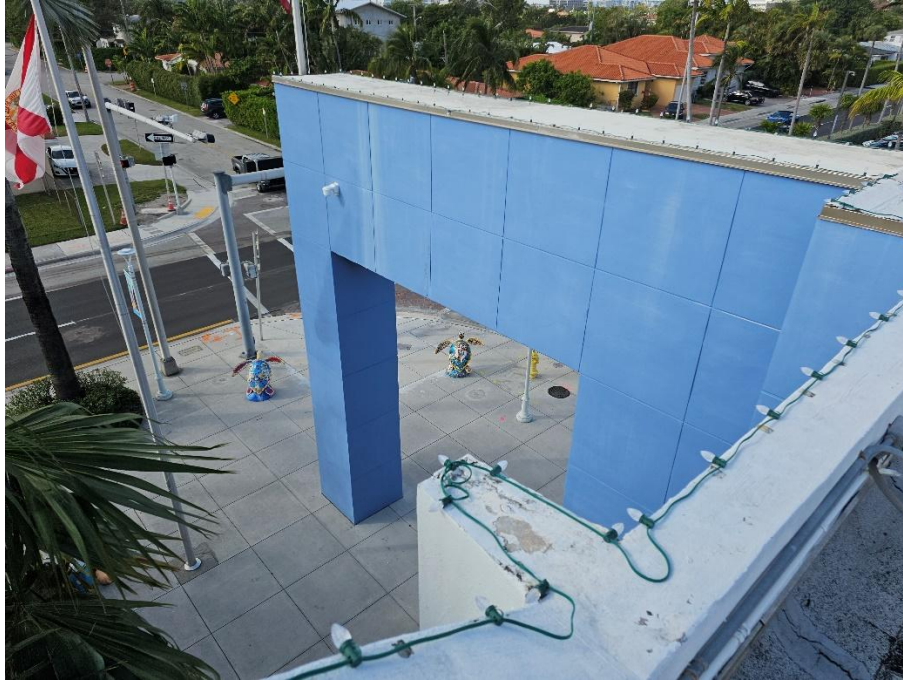
Masonry walls were on fair conditions. No major cracks were detected, but some bulging and stucco delamination was observed.

*ENTRANCE WALL AT WEST FACADE IN FAIR CONDITION*

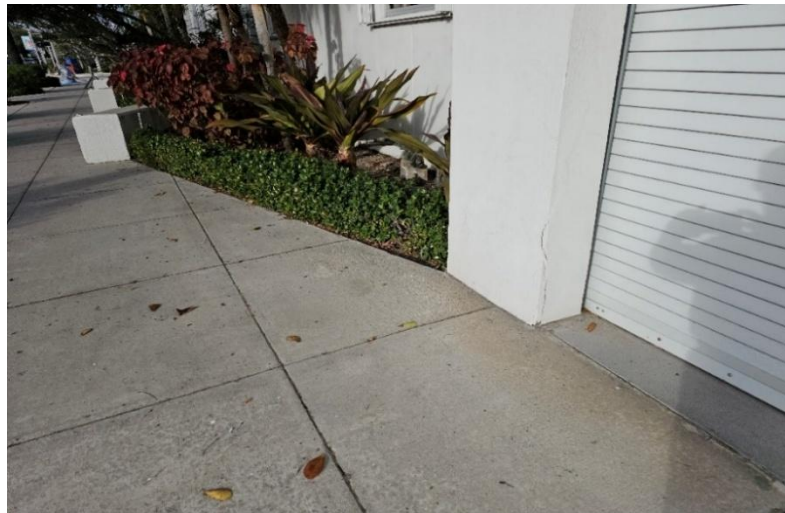
*CRACKS OBSERVED AT DOOR JAMB*

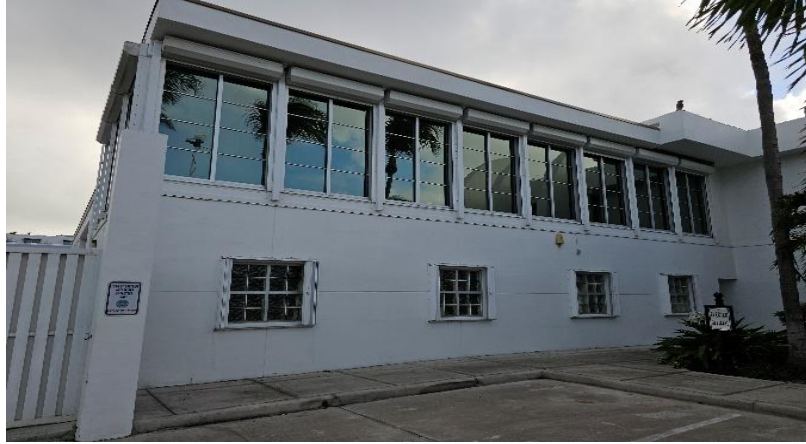
*EAST FAÇADE WINDOWS IN GOOD CONDITION*

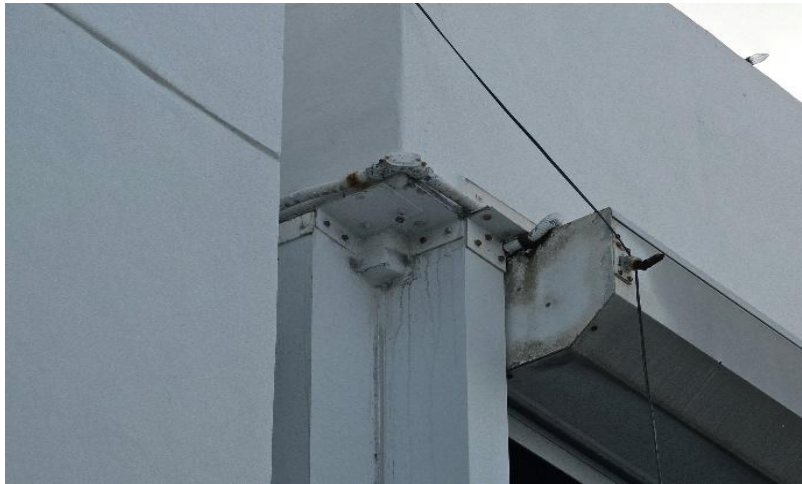
*RUST OBSERVED ON EAST ENTRANCE STOREFRONT FRAMING*

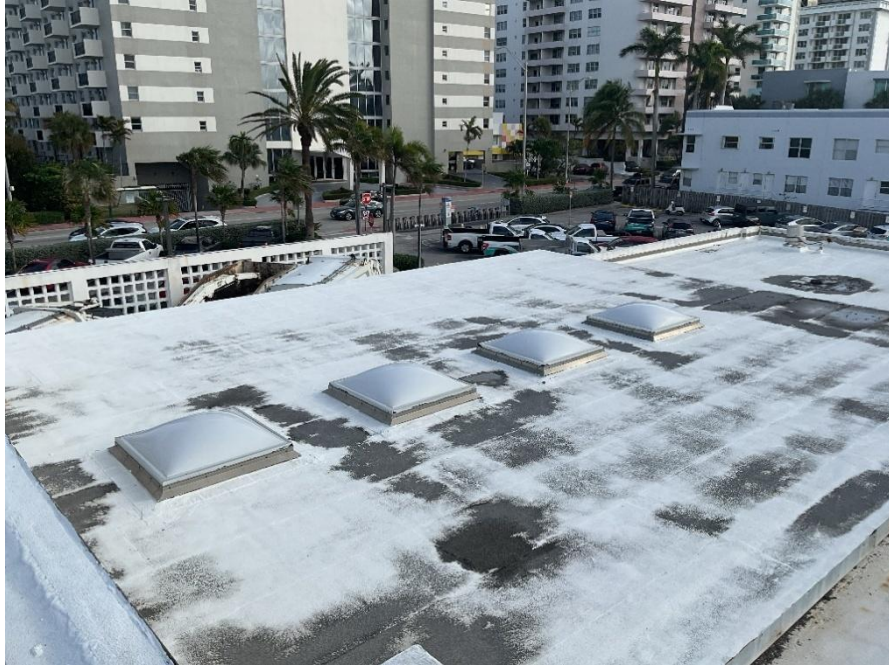
| Item | Rating | Description |
|---|---|---|
| Roofing System | Poor | Multiple areas of the roof show signs of water damage with roofing bubbling and cracking in some areas. |

Several areas of bubbling were observed throughout the roof. Roofing also showing signs of cracking, water damage and general deterioration.

***EAST LOWER ROOFING SYSTEM SHOWS BUBBLING AND SIGNS OF DETERIORATION***

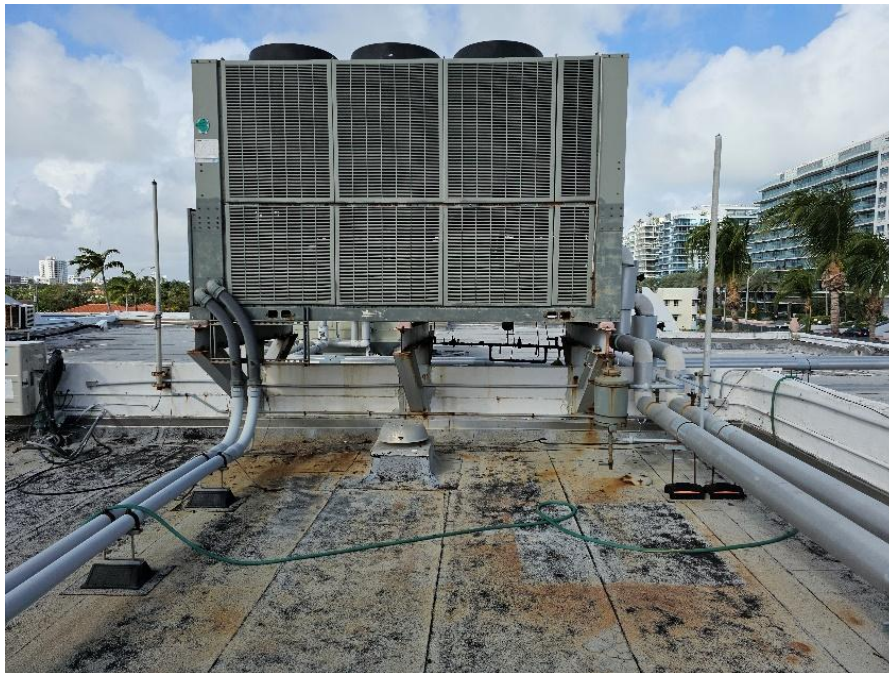
***LOSS OF MEMBRANE AND CRACKING WAS OBSERVED IN THE ROOFING SYSTEM***

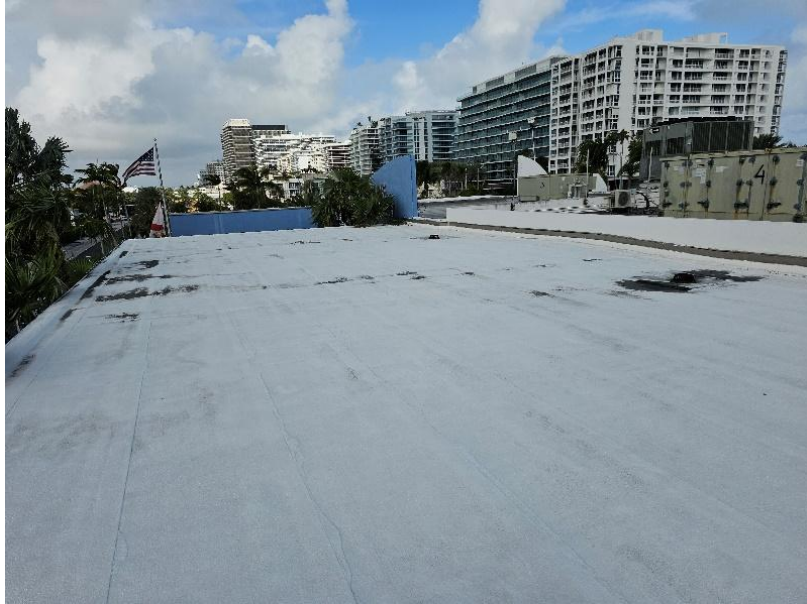
*WEST ROOFING SYSTEM IN FAIR CONDITION*

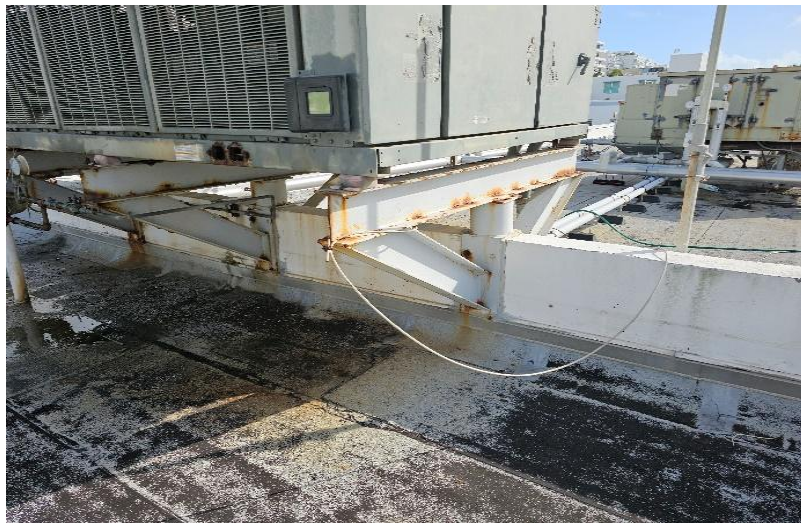
| Item | Rating | Description |
|---|---|---|
| Roof-Tops Units | Poor | Most of the units show multiple rusted areas with general deterioration on the support platforms. Some units have inadequate anchorage to the roof system. |

*RUST WAS OBSERVED ON THE CHILLERS SUPPORT PLATFORM*

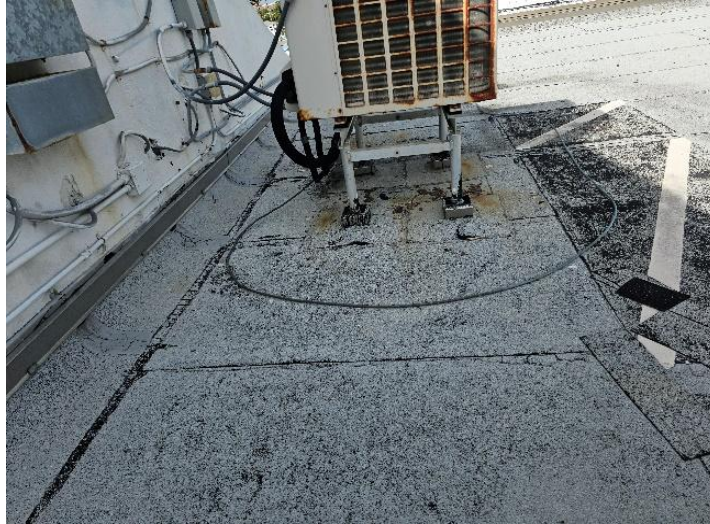
*RUST OBSERVED AT RTU BASE CONNECTION*

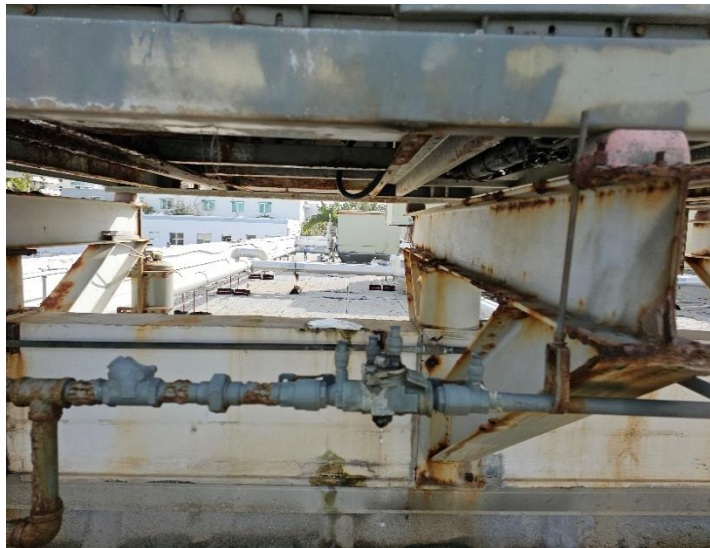
*RUST OBSERVED ON THE CHILLERS SUPPORT PLATFORM BEAMS*

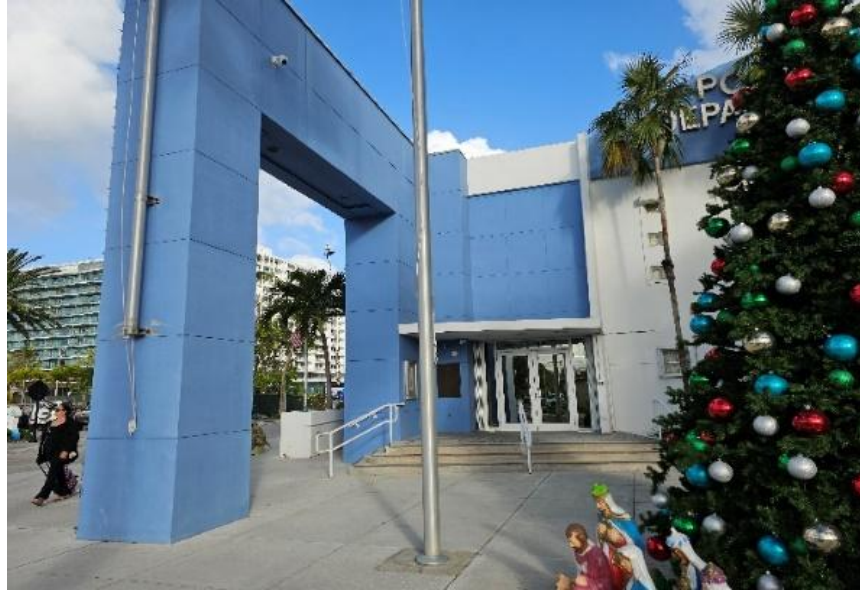
*BUILDING WEST ENTRANCE WALL IN GOOD CONDITION*

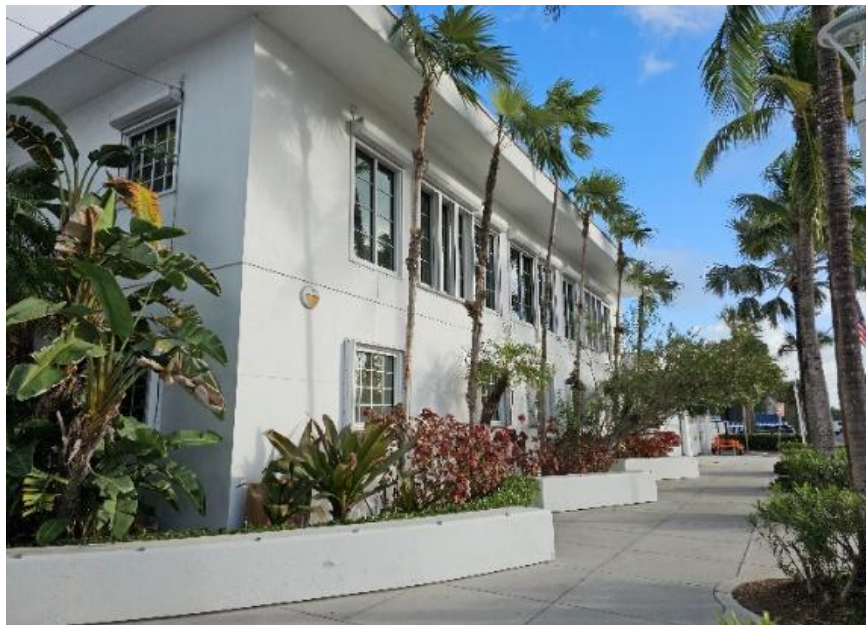
*BUILDING WEST FAÇADE IN GOOD CONDITION*

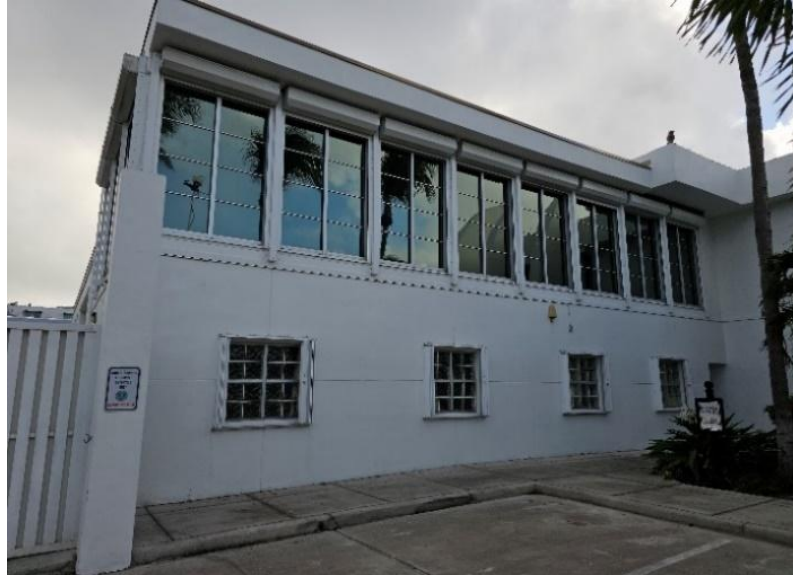
Fine cracks and stucco deterioration in exterior wall finishes, were observed. Paint chipping in certain locations of roof.

*BUILDING EAST FAÇADE IN FAIR CONDITION*

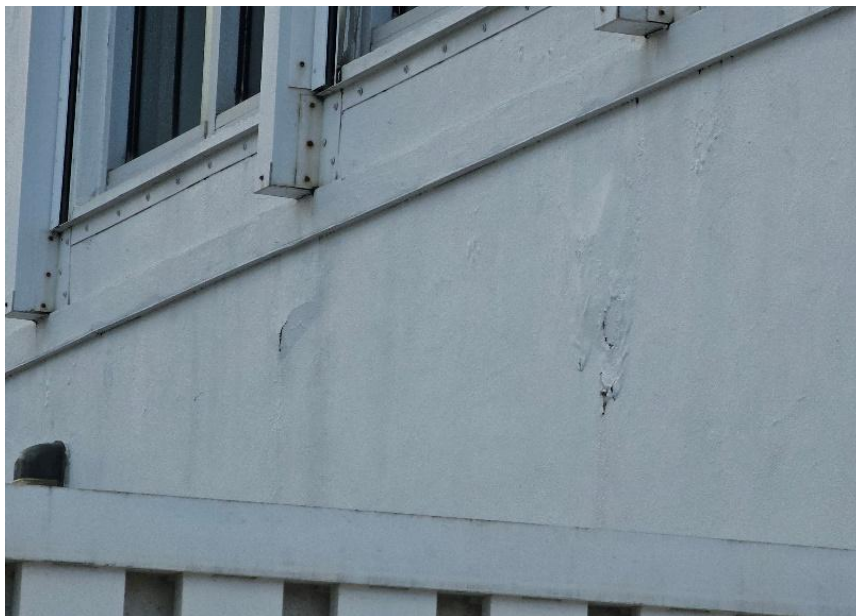
| Item | Rating | Description |
|---|---|---|
| Façade | Fair | The façade was found to be in generally good condition. Shrinkage cracks and minor stucco delamination was observed in some areas. |

*EAST FAÇADE SHOWS SIGN OF STUCCO PEELING AND DETERIORATION*
