**Subject:** Field Observation Project (Bal Harbour Erosion) During December of 2023

## Field Observation Report

Municipality Name:	CC Project Number:
Village of Bal Harbour	77800
Date of Observation:	Time In / Out:
December 18 <sup>th</sup> , 2023	2:00 PM / 4:30 PM
Weather	Temperature:
Partly Cloudy	~72 deg. F
Submitted By:	Date of Report:
Ryan Winslow, E.I., M.Eng.	January 15, 2024

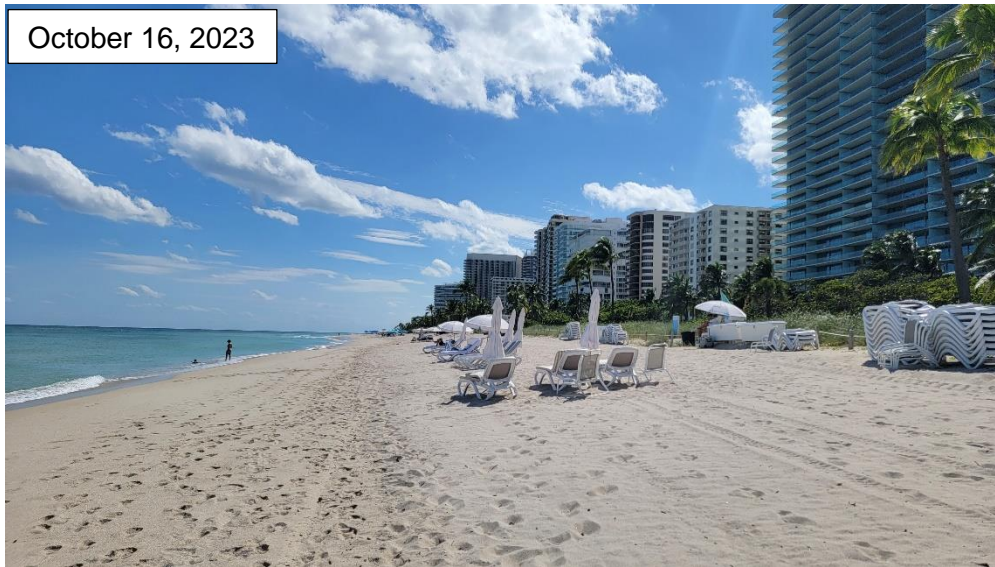
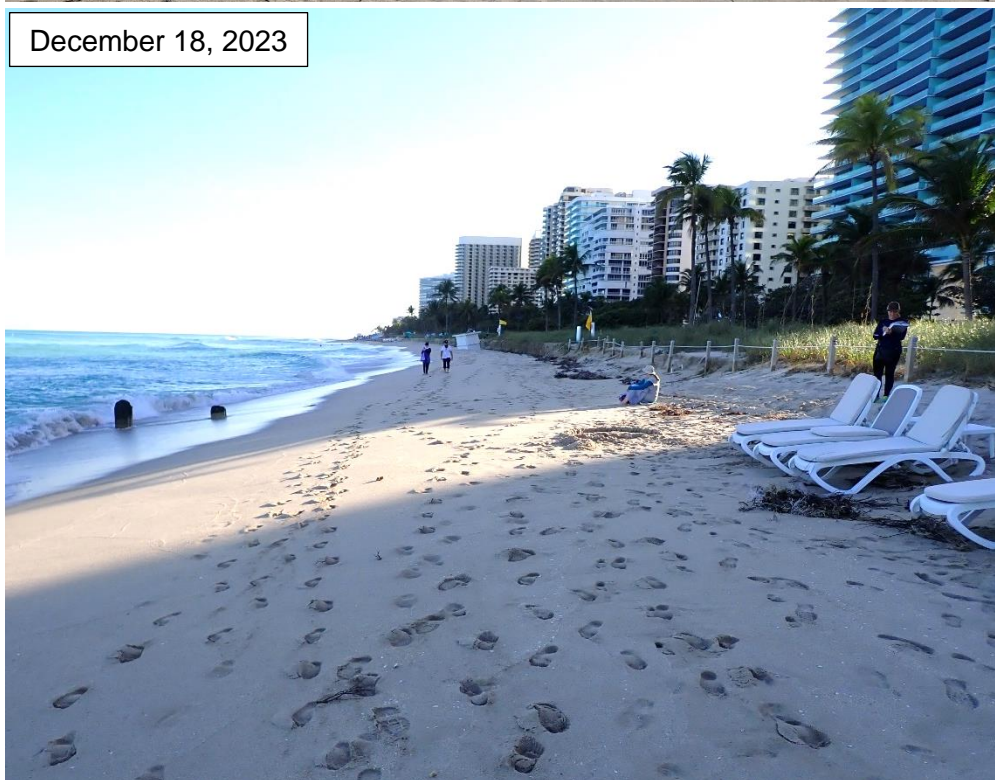
**PHOTO 1. BAL HARBOUR BEACH COMPARISON LOOKING SOUTH FROM ACCESS 17**

The Bal Harbour beach segment was nourished in April 2022 as part of a federal project by the U.S. Army Corps of Engineers to replenish the segment's eroded beaches. The passage of Hurricanes Nicole and Ian in 2022 caused some beach erosion, which was documented in a previous Preliminary Beach Damage Assessment, dated November 10, 2022. Cummins Cederberg conducted its most recent quarterly scheduled walkthrough of the beach on October 16, 2023, where the beach segment was characterized by a uniform, gently sloping beach profile. **Photo 1** shows a comparison between the pre- and post-wind event conditions at the beach.

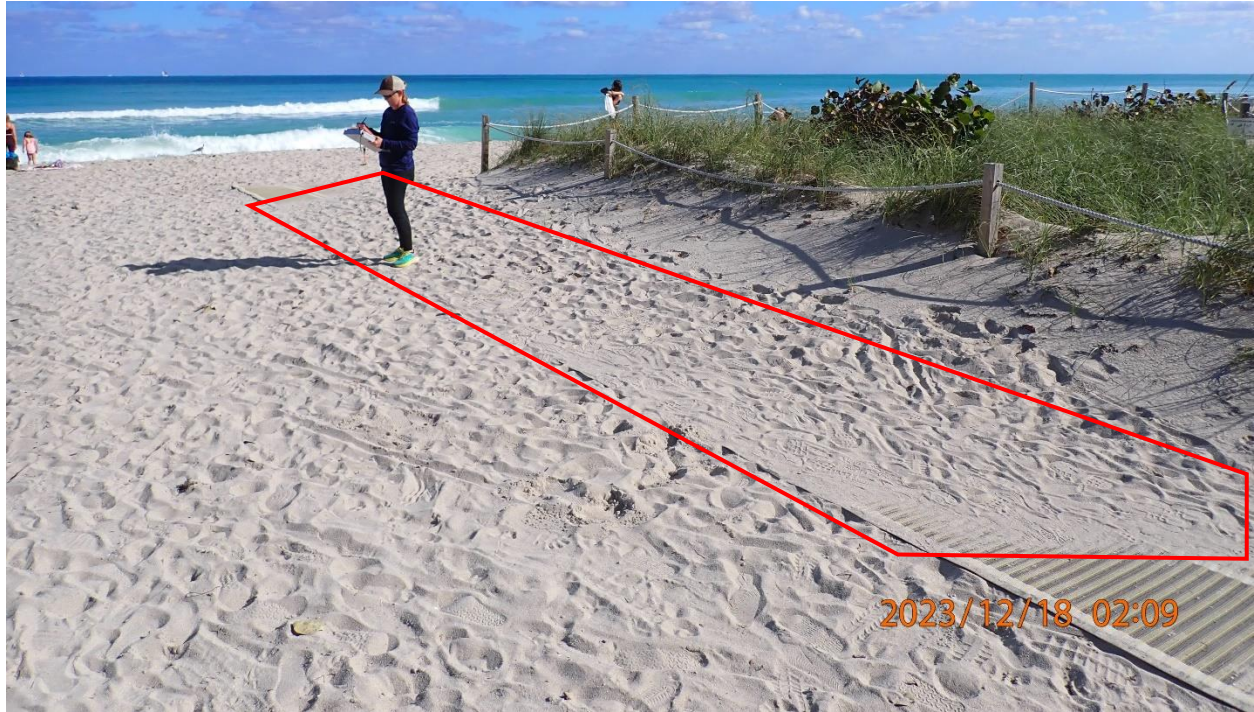
**PHOTO 2. BURIED BEACH ACCESS MAT (ACCESS 1)**

General issues frequently observed included scarping, partial burial of beach access mats (**Photo 2**), spotty dune grass coverage (**Photo 6**), litter and beach furniture storage in the dune (**Photo 7 / Photo 12**), and fence post burial or withdrawal (**Photo 3 / Photo 13**). An intermittent wrack line predominantly composed of octocorals, rope sponges, tube sponges, and upland vegetative debris was observed to have accumulated on the beach face (**Photo 4**), with some lighter wrack material reaching the dune. No wrack line was observed between public beach accesses 13 and 15, where beach erosion was most severe.

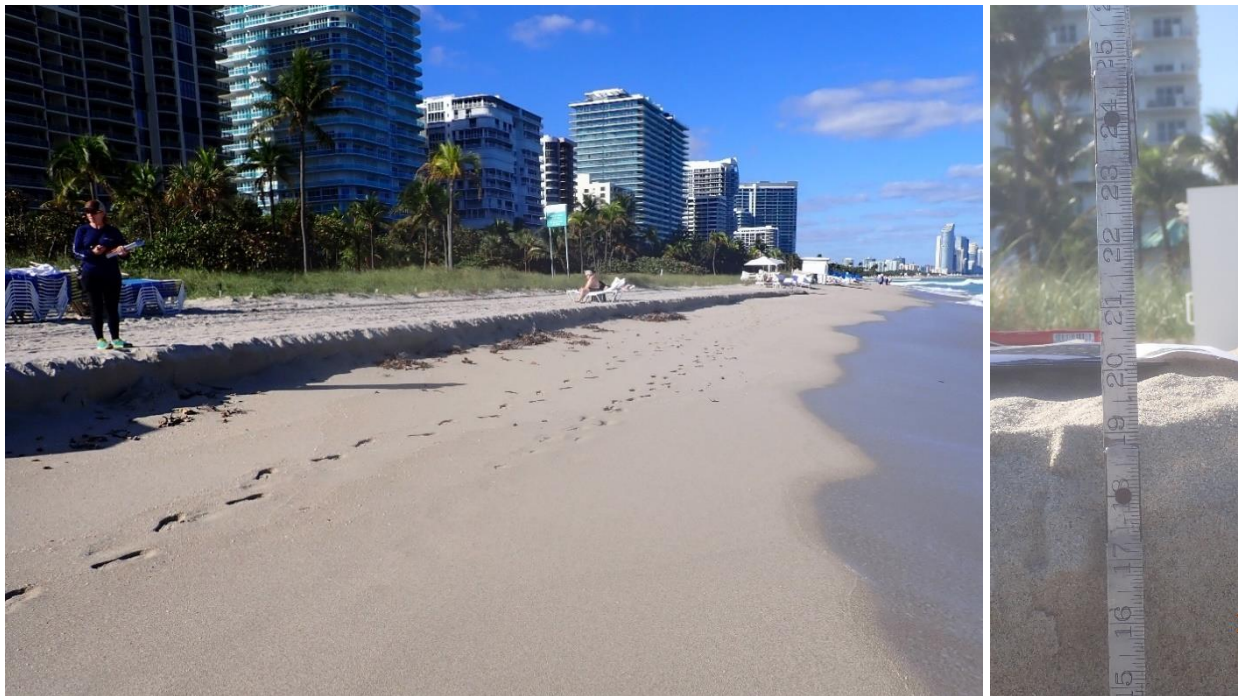
**PHOTO 5. 20-INCH HIGH SCARP, ABOUT 216 FEET IN LENGTH (ACCESS 8-9)**

Access 8-9: **Condition I.** Continuing north along the Village’s beach, a small scarp with a max height of about 20 inches extended for about 216 feet between beach access 8 and 9 (**Photo 5**).

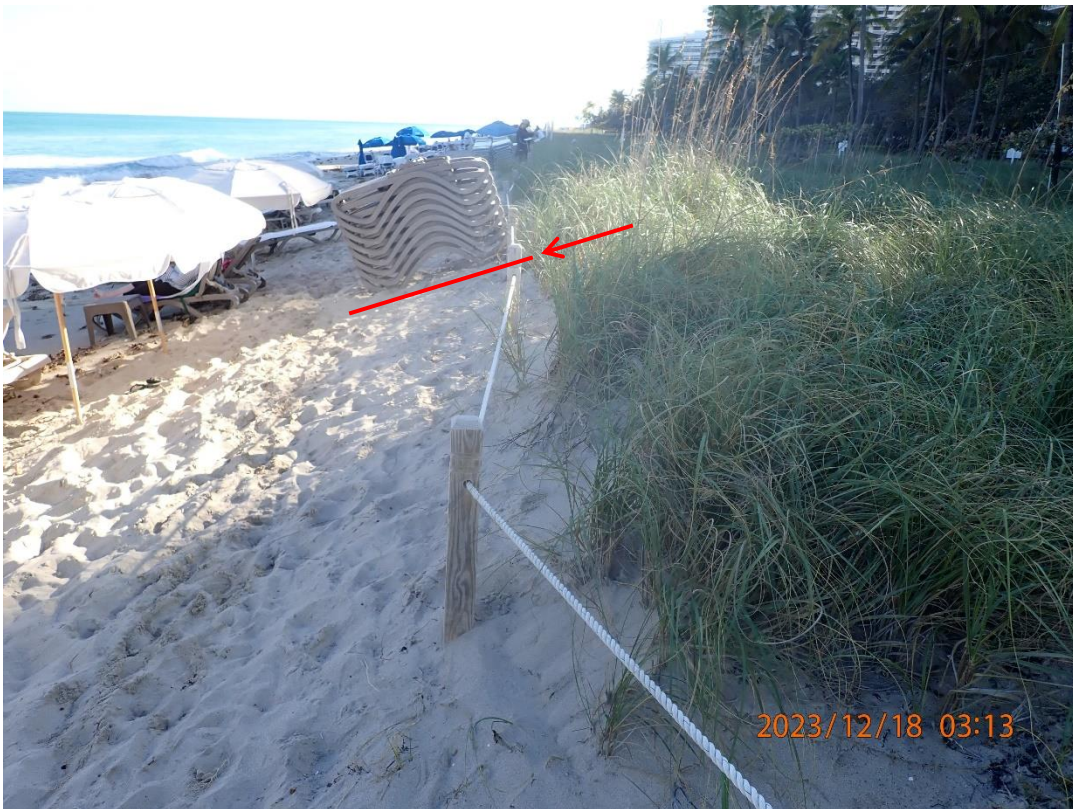
**PHOTO 9. STEEP SLOPE WHERE BEACH MEETS DUNE, SOUTH OF ACCESS 12**

Access 9-14: **Condition II.** Around access 9, the small vertical scarp disappeared from the beach face and the flat berm transitioned into an upwards slope towards the dune (**Photo 9**). This slope progressively steepened to a vertical dune scarp at access 13, with visible dune grass roots.

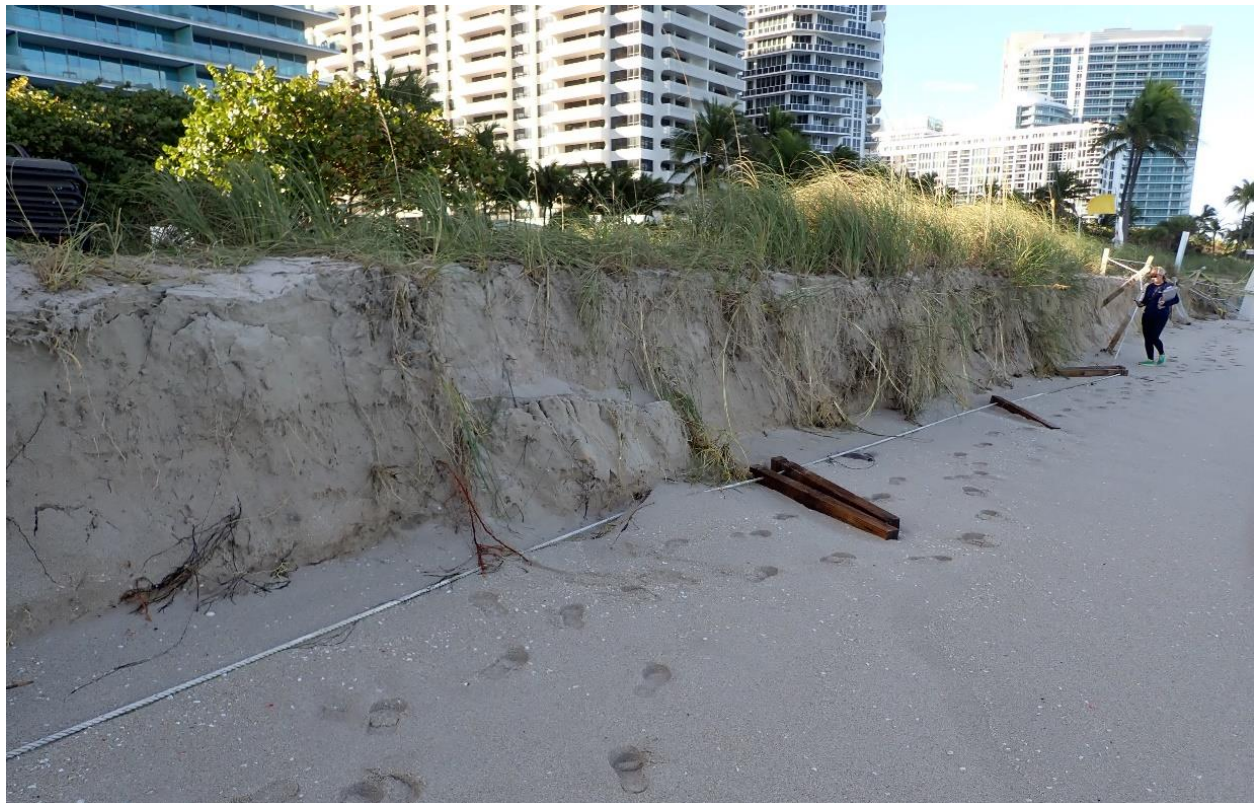
**PHOTO 13. DISLODGED FENCE POSTS AND DUNE GRASSES (ACCESS 14-15)**

Access 14-16: **Condition III.** Near access 14, the dune scarp height increased to beyond 3 feet, with the largest measured at 52 inches (**Photo 14**). Dune grasses near the scarp were uprooted and the majority of fence posts dislodged (**Photo 13**). Accesses 13-15 appeared potentially unsafe for some beach guests to traverse (**Photo 15**); the Village should consider closing these accesses or installing warning signage.

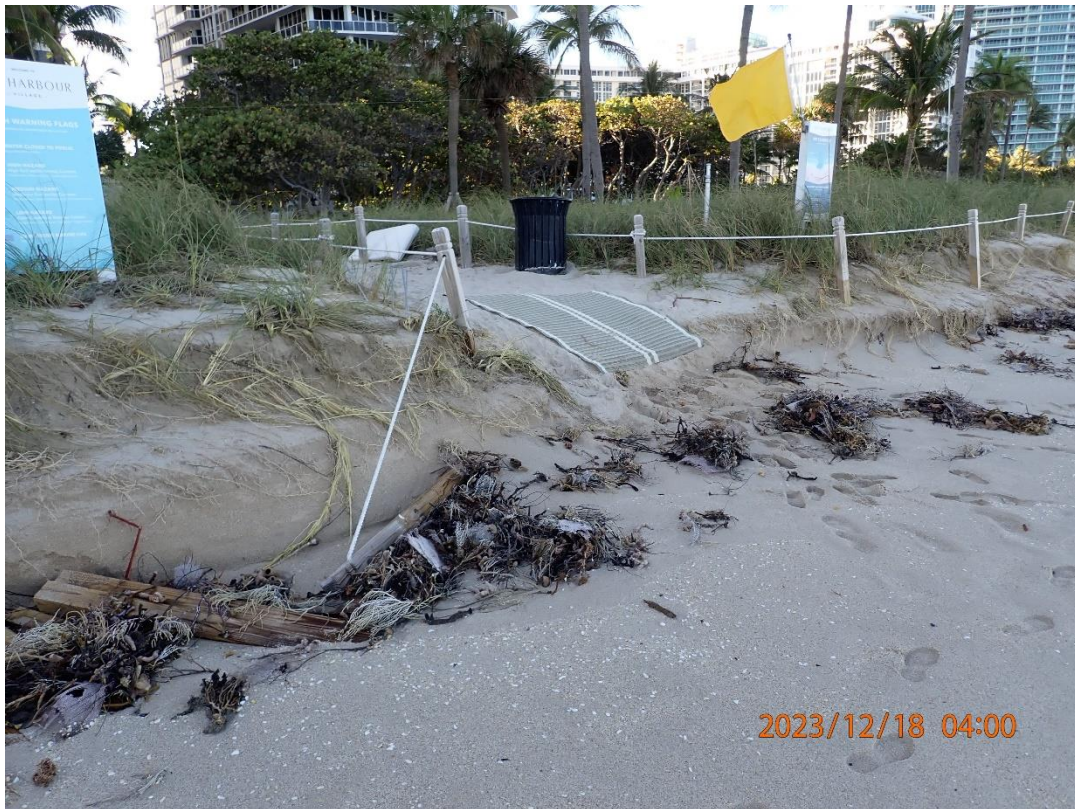
**PHOTO 17. BEACH EROSION AT ACCESS 16**

Access 16-19: **Condition II.** The scarp height abruptly decreased to below 3 feet in the vicinity of access 16 (**Photo 17**).

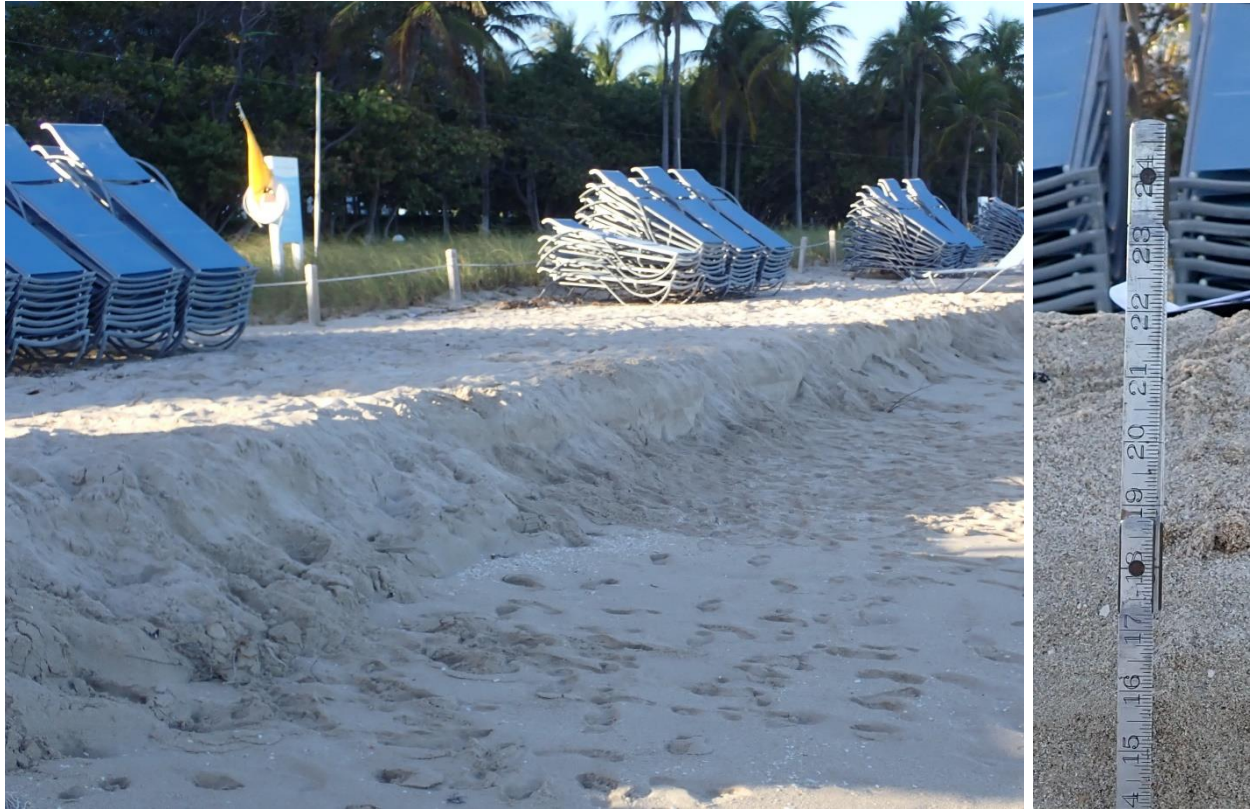
**PHOTO 20. BEACH SCARP NORTH OF ACCESS 19, MEASURED 22 INCHES MAX**

Access 19-20: **Condition I.** By access 19, the scarp had migrated sufficiently waterward of the dune such that dune grass roots were no longer seen protruding from the scarp. The beach scarp height was measured at 22 inches max (**Photo 20**).

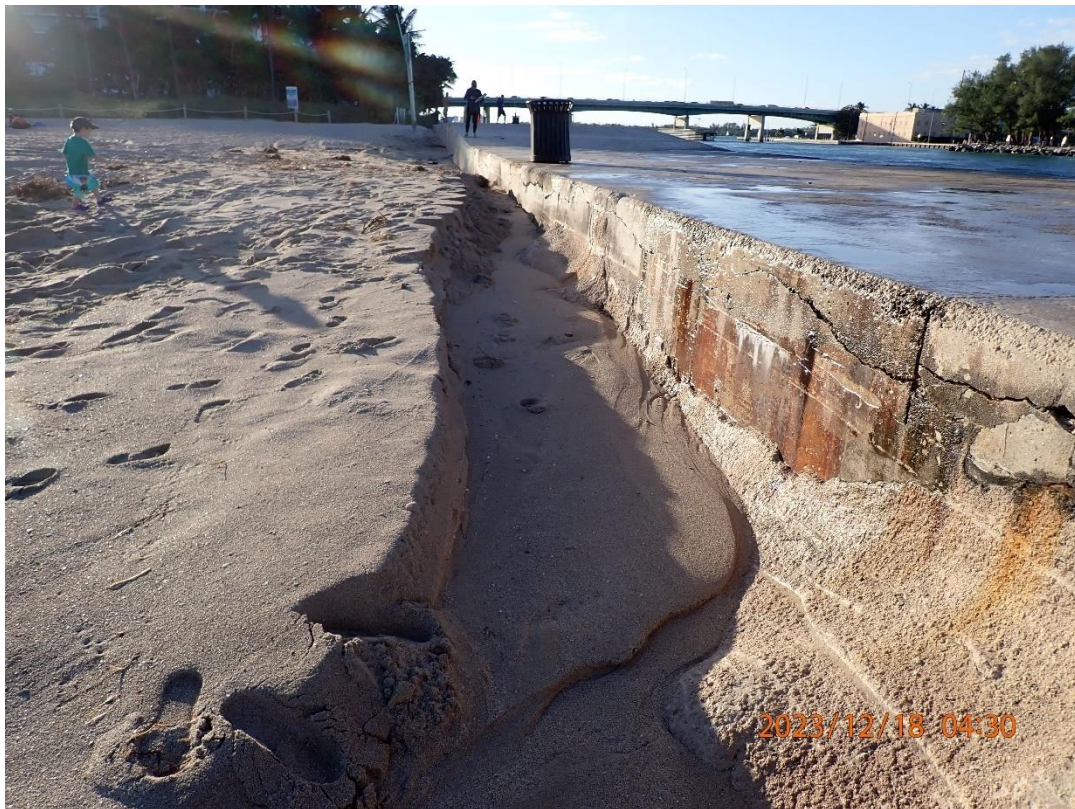
**PHOTO 21. SEDIMENT EROSION SOUTH OF JETTY**

Starting at the south end of Bal Harbour at public beach access 1, damage to the beach was relatively minor and exhibited a wide, flat beach berm, which extended north to access 8. Erosion was also minor north of access 20, where the Bal Harbour Jetty appeared to provide ample protection against the northeast wave action.

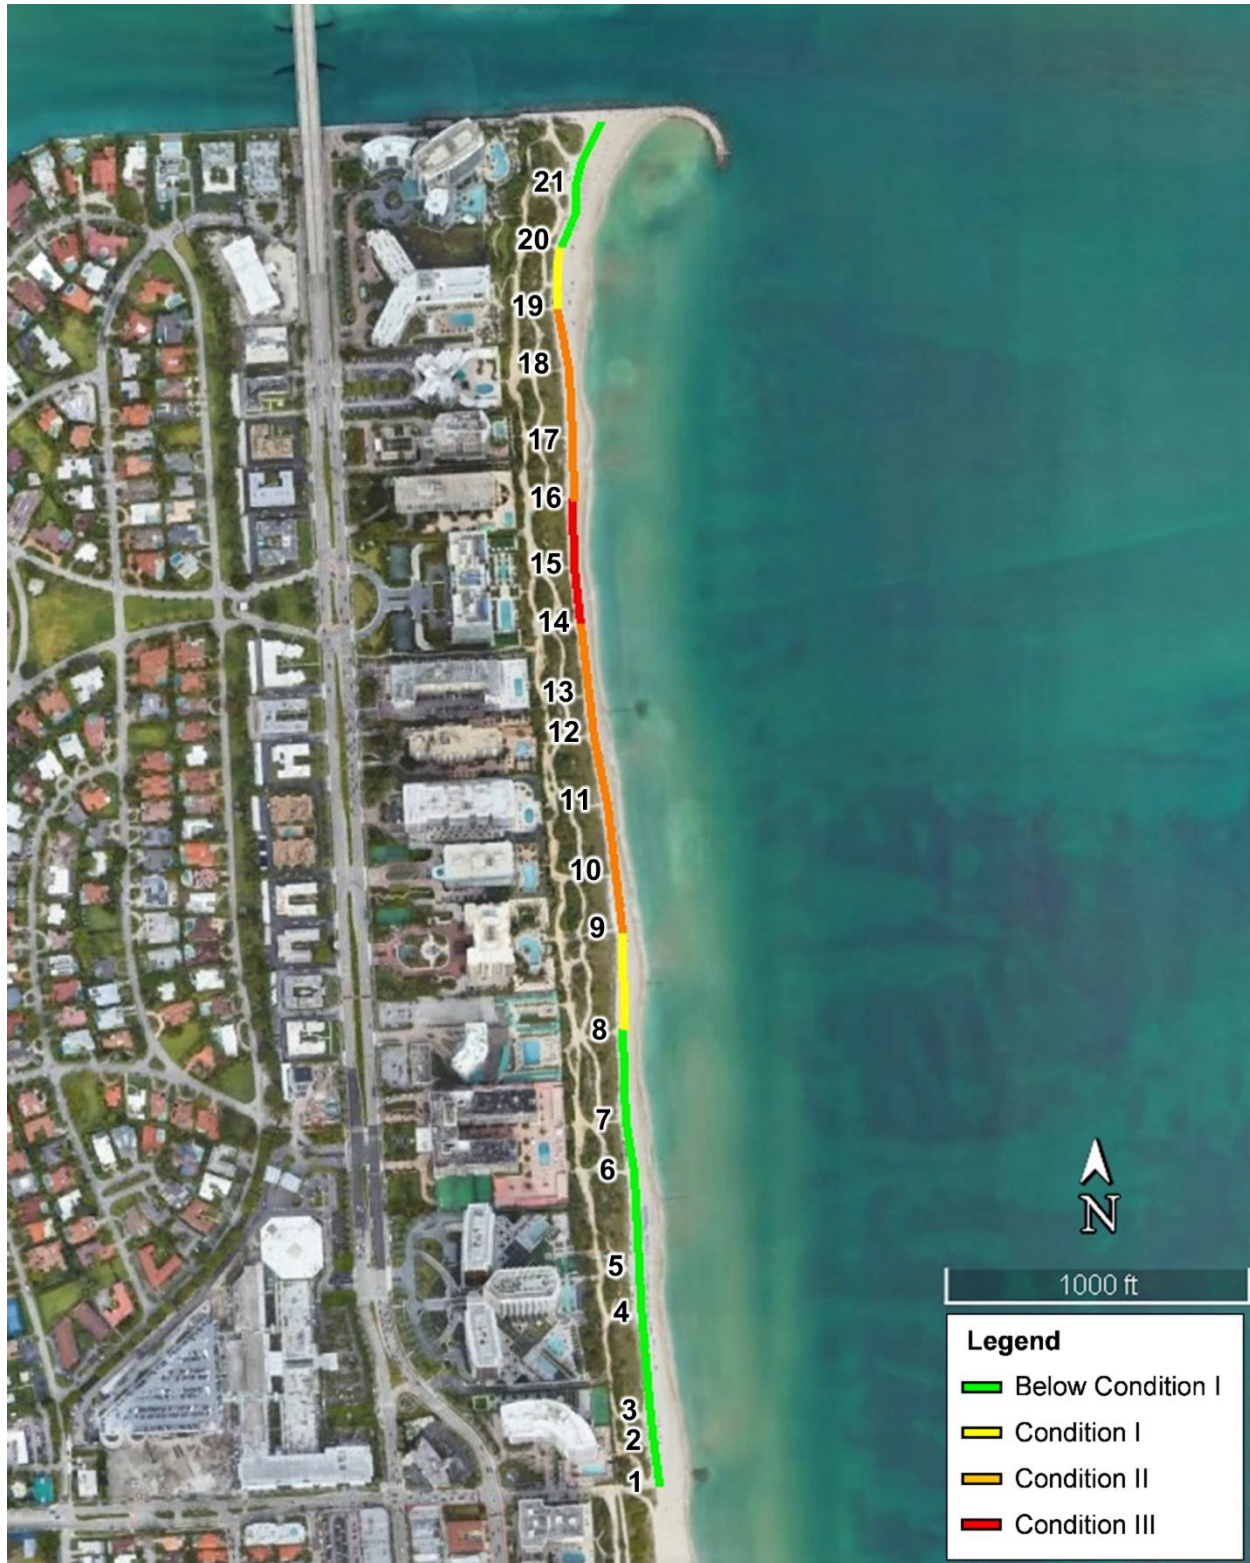
FIGURE 2. BAL HARBOUR BEACH AND DUNE EROSION CONDITION MAP

A summary map outlining the extents of the observed beach and dune erosion conditions is provided in **Figure 2**.
