Subject: **Town of Surfside – Emergency Operations Center Adaption Plan
Feasibility Report**

Town of Surfside - Emergency Operations Center Adaption Plan Feasibility Report

Kimley»Horn

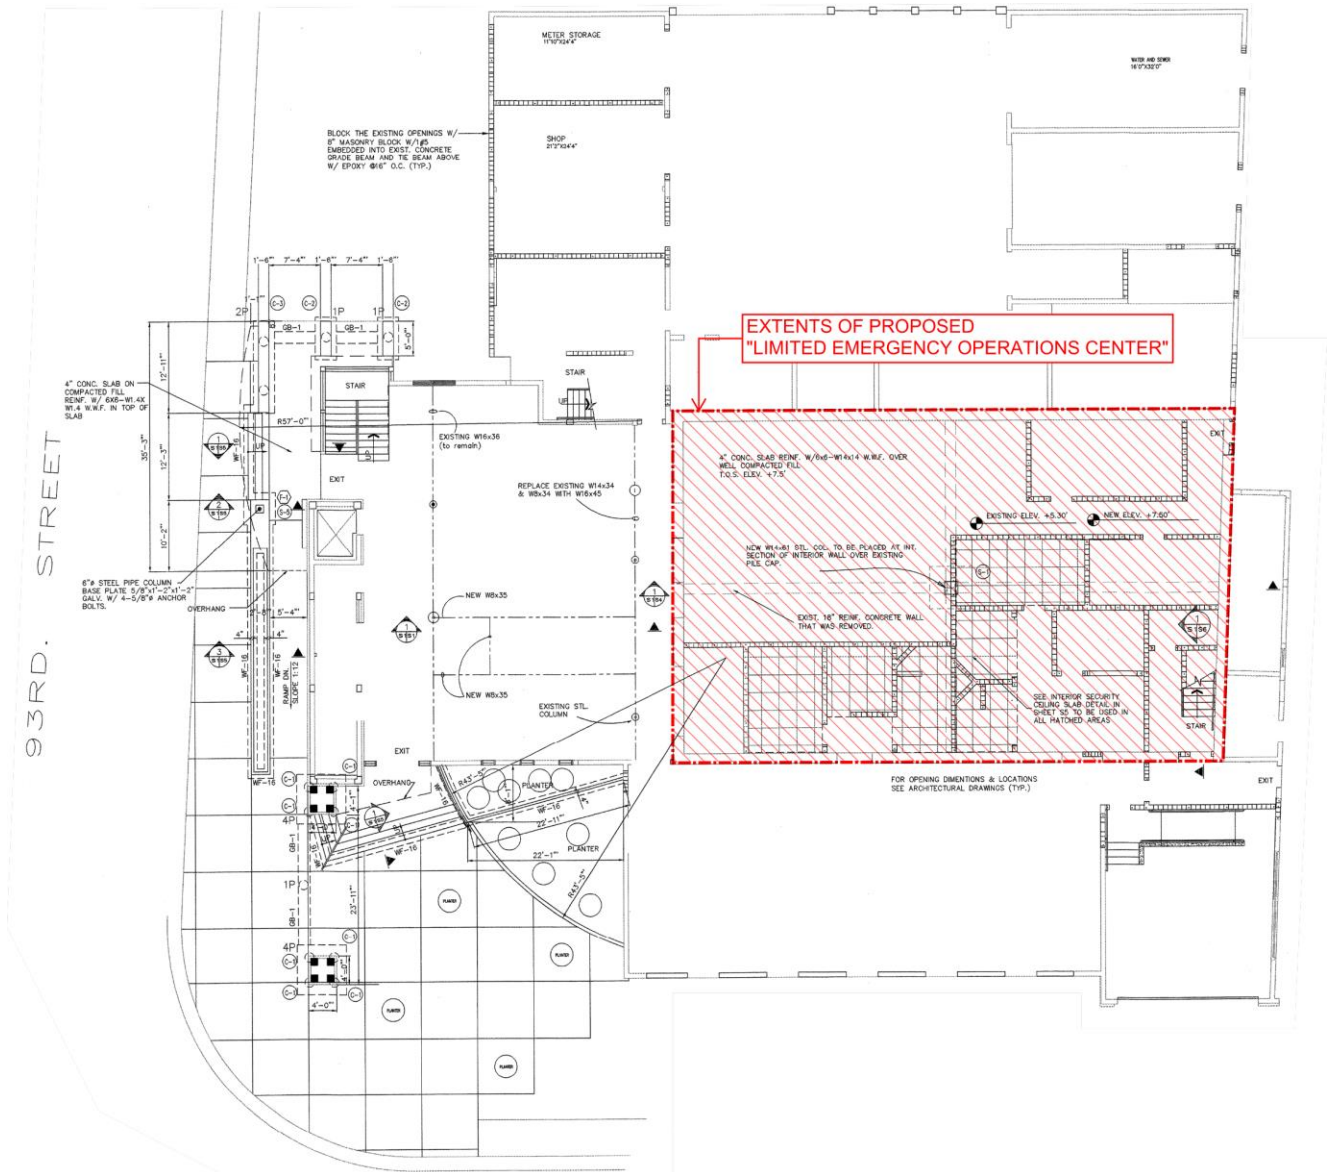
FIGURE 8: EXTENTS OF "LIMITED OPERATIONS EMERGENCY CENTER"

To keep the strengthening to a Level II alteration, a limited portion of the building can be converted to an Emergency Operations Center. The extents of the limited portion of the building that will need to be adapted is shown in Figure 8. The "Limited Operations Emergency Center" will include the first floor and second floor as shown in Figure 8. Areas outside the proposed extents will not be included in the Adaptation Plan.

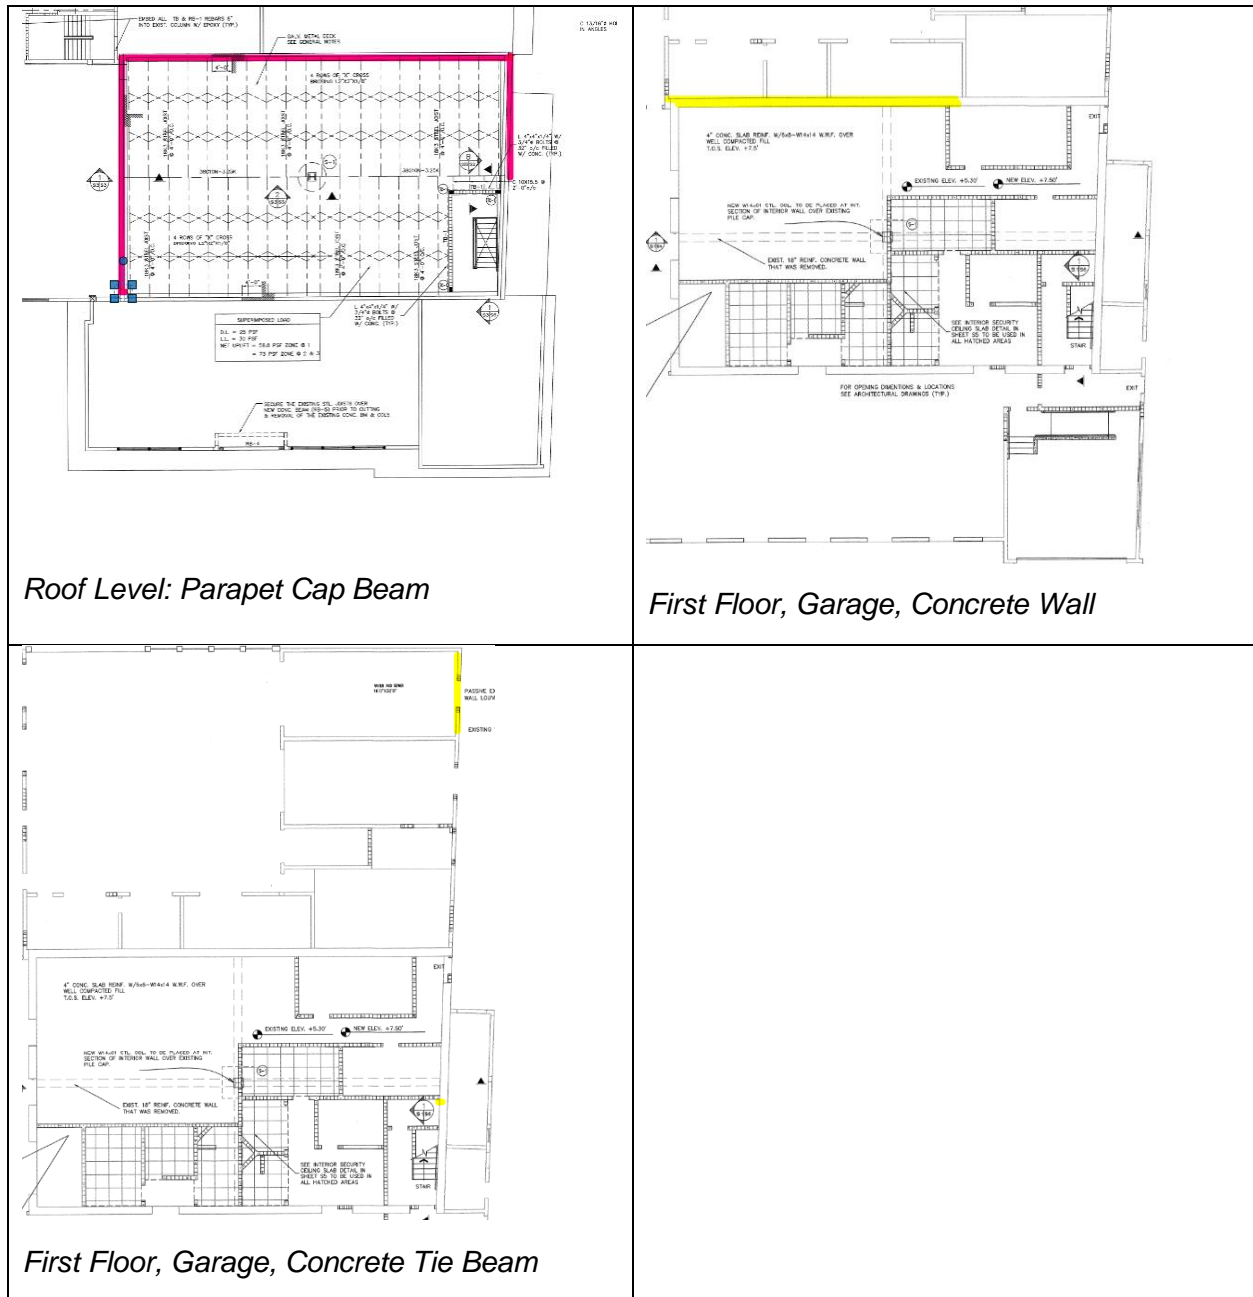
FIGURE 9: LOCATION OF SCHMIDT HAMMER TESTS

The main objective of these tests was to estimate the concrete strength of the reinforced concrete walls and tie beam in the garage, as well as to map the rebar location and size in the masonry walls. The Schmidt hammer measurements were taken as follows: at the parapet cap beam for reference, on the garage concrete wall on the first floor, and on the concrete tie beam on the same floor in the garage. The east walls of the staircase well on floors 1 and 2 were also tested with the Schmidt hammer. Ferro scanner measurements were taken at the masonry walls in the staircase well on floors 1 and 2. Refer Figure 9 and Figure 10 for locations of non-destructive testing completed on the existing structure.
