# Town of Surfside - Emergency Operations Center Adaption Plan

Town of Surfside  
9293 Harding Avenue  
Surfside, Florida 33154

Kimley-Horn and Associates, Inc.  
2 Alhambra Plaza, Suite 500  
Coral Gables, FL 33134

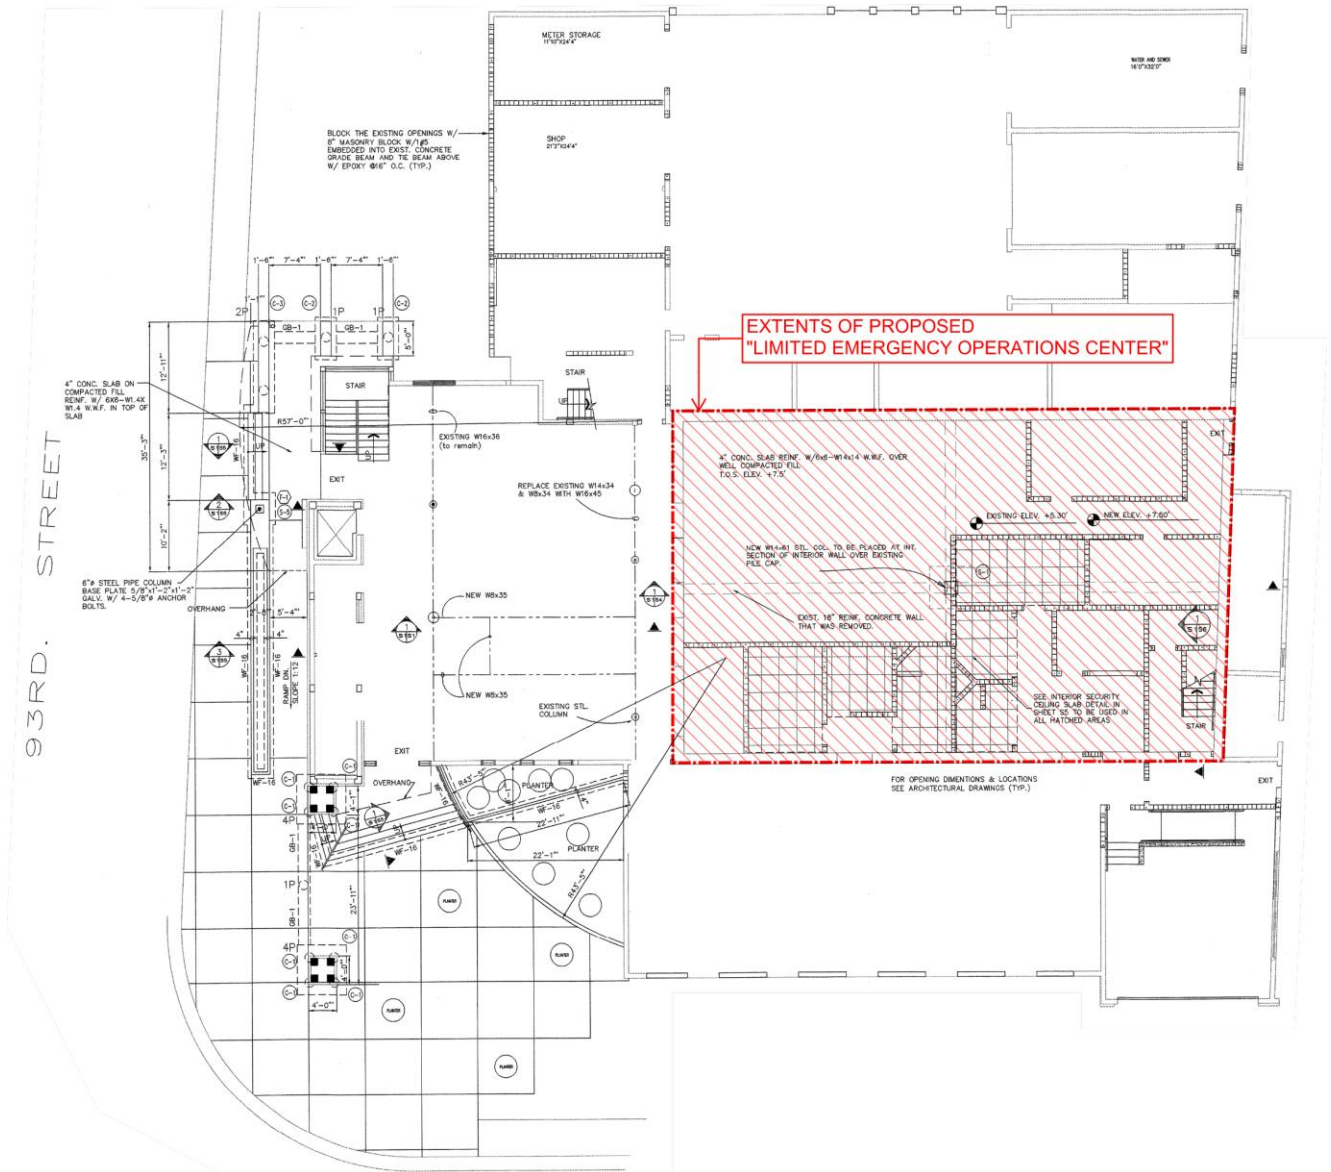
**FIGURE 8: EXTENTS OF "LIMITED OPERATIONS EMERGENCY CENTER"**

**Based on the results of our code review and analysis, the existing structure does not have sufficient capacity to resist the loads required for a hurricane storm shelter. The overall structure will require strengthening that would be classified as a Level III Alteration.**

To keep the strengthening to a Level II alteration, a limited portion of the building can be converted to an Emergency Operations Center. The extents of the limited portion of the building that will need to be adapted is shown in Figure 8. The "Limited Operations Emergency Center" will include the first floor and second floor as shown in Figure 8. Areas outside the proposed extents will not be included in the Adaptation Plan.

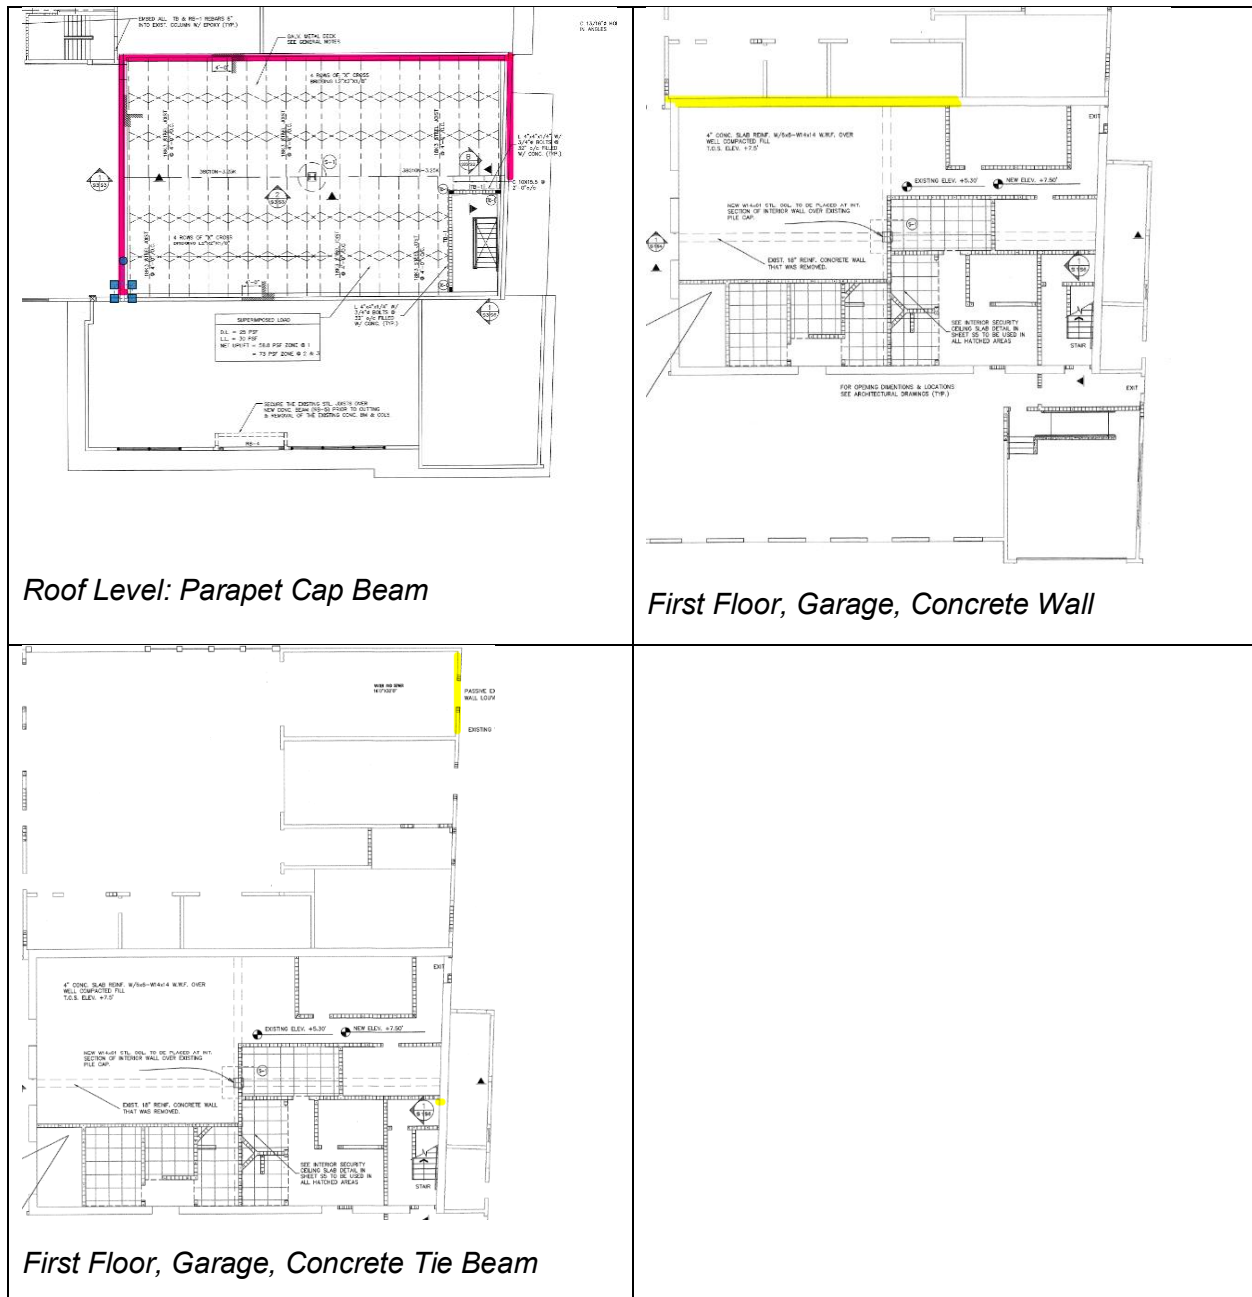
**FIGURE 9: LOCATION OF SCHMIDT HAMMER TESTS**

The main objective of these tests was to estimate the concrete strength of the reinforced concrete walls and tie beam in the garage, as well as to map the rebar location and size in the masonry walls. The Schmidt hammer measurements were taken as follows: at the parapet cap beam for reference, on the garage concrete wall on the first floor, and on the concrete tie beam on the same floor in the garage. The east walls of the staircase well on floors 1 and 2 were also tested with the Schmidt hammer. Ferro scanner measurements were taken at the masonry walls in the staircase well on floors 1 and 2. Refer Figure 9 and Figure 10 for locations of non-destructive testing completed on the existing structure.

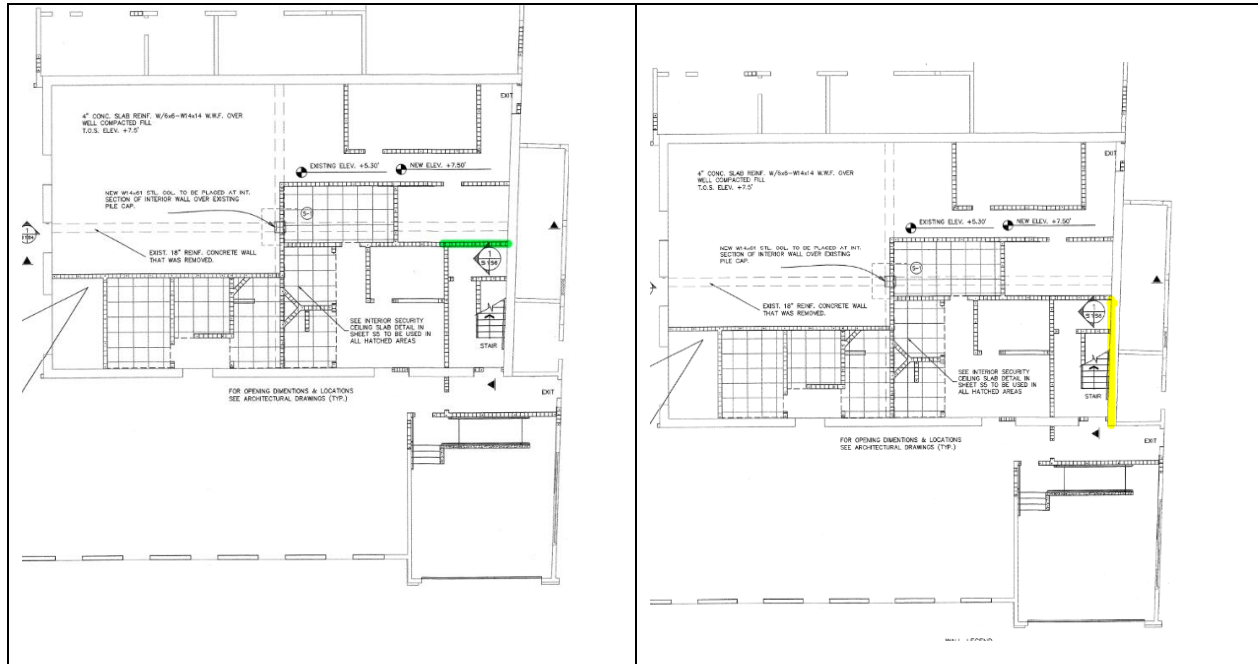
**FIGURE 10: LOCATION OF FERRO SCANNER TESTS**

Additionally, a ferro scanner was used to detect and map the location, depth, and size of reinforcement bars (rebar) within concrete and masonry walls. This technique provides information about embedded rebar locations, aiding in structural assessments and ensuring safe modifications without damaging the concrete.
